NUMBER: 23-036-14

DATE: December 16, 2014

Water Leak At Hard Top Rear Seam

2015 (JK) Jeep Wrangler

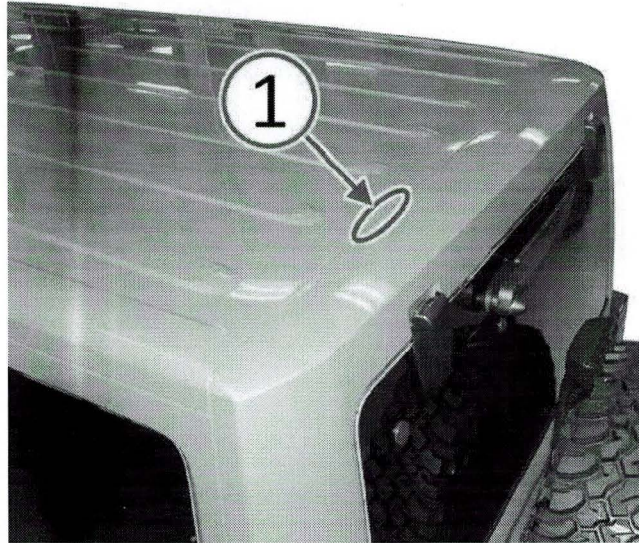
Fig. 1 Area Of Leak Concern

Water leak path through top rear bonded seam at area identified in (Fig. 1). The customer may describe water dripping from the top, running down the inside of the back glass, or running down the inside rear D-pillar.

1 - Water Leak Path At Identified Location

This bulletin involves replacing the hard top.

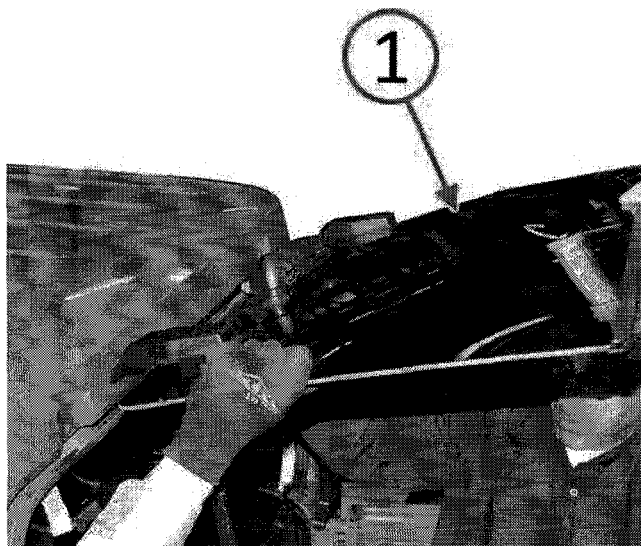
Fig. 2 Remove Backlite

1 - Backlite

1. Remove the backlite (Fig. 2). Refer to the detailed service procedures available in DealerCONNECT> TechCONNECT under: Service Info> 23 - Body/Stationary Glass/BACKLITE/Removal.

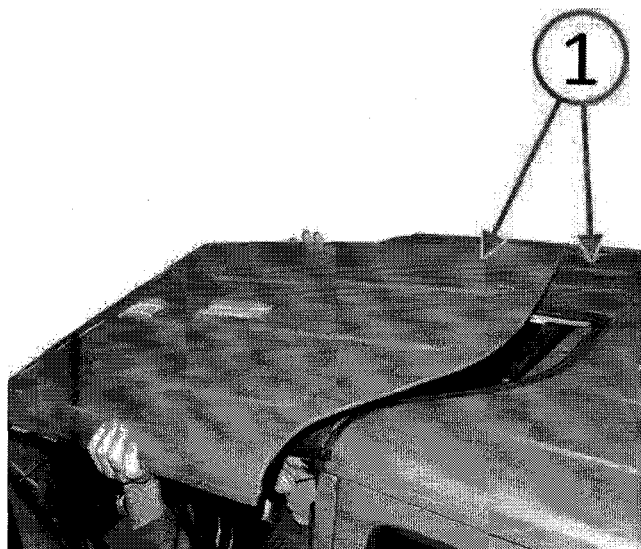
Fig. 3 Remove Both Freedom Top Panels

1 - Freedom Top™ Panels

2. Remove both Freedom Top™ panels (Fig. 3). Refer to the detailed service procedures available in DealerCONNECT> TechCONNECT under: Service Info> 23 - Body/Removable Top, Hard/Removal.

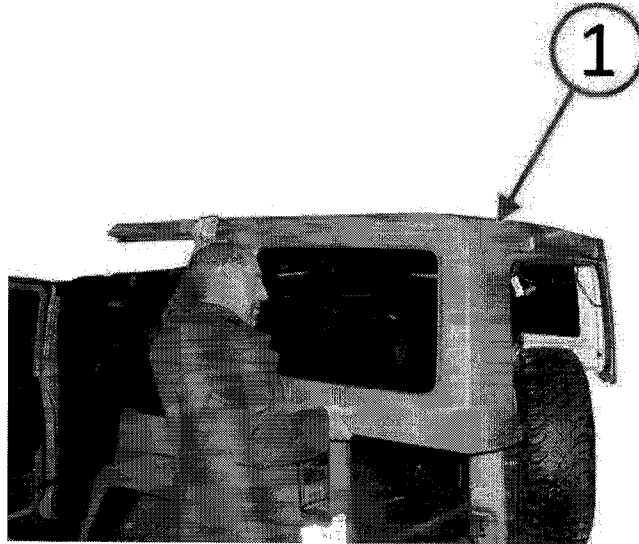
Fig. 4 Remove Hard Top

1 - Hard Top

3. Remove the hard top (Fig. 4). Refer to the detailed service procedures available in DealerCONNECT> TechCONNECT under: Service Info> 23 - Body/Removable Top, Hard/Removal.

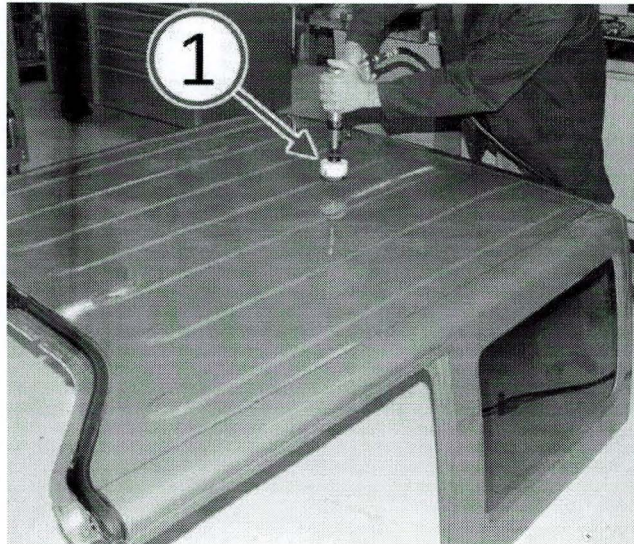
Fig. 5 Destroy Defective Hard Top To Prevent Reuse

1 - Hole Saw

-
4. To prevent reuse, structurally destroy the defective hard top by drilling two holes approximately 2 in. diameter or larger through roof surface (Fig. 5).
