NUMBER: 23-037-14

Wind Noise At The Left And/Or Right Door

2015 (LA) Dodge Challenger

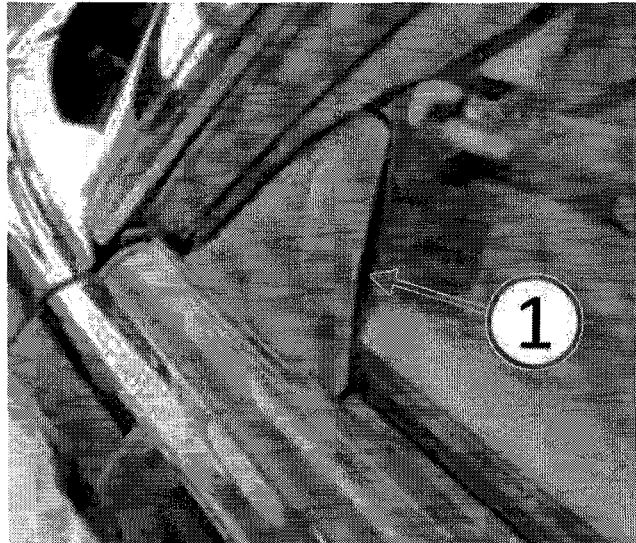
Fig. 1 Window Flag Gap Inspection

1. Raise the door window glass to the full up position.
2. Inspect both doors for a gap between the outer door mounted window seal flag and the door window glass (Fig. 1).

1 - Gap

-
3. Is there a gap between the outer door mounted window seal flag and the door window glass?
 - a. YES>>> Continue with the Repair Procedure.
 - b. NO>>> This Bulletin does not apply. Further diagnosis is required.
 4. Fully lower the door window glass.
 5. Apply slight pressure to the outboard side of the seal flag. This will reposition the metal tab inside the seal flag moving the seal flag tighter to the glass surface (Fig. 2).

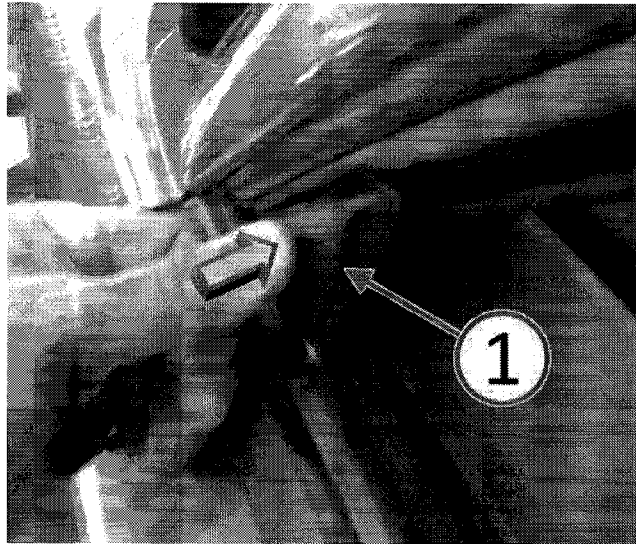
Fig. 2 Push In On The Window Flag

1 - Seal Flag

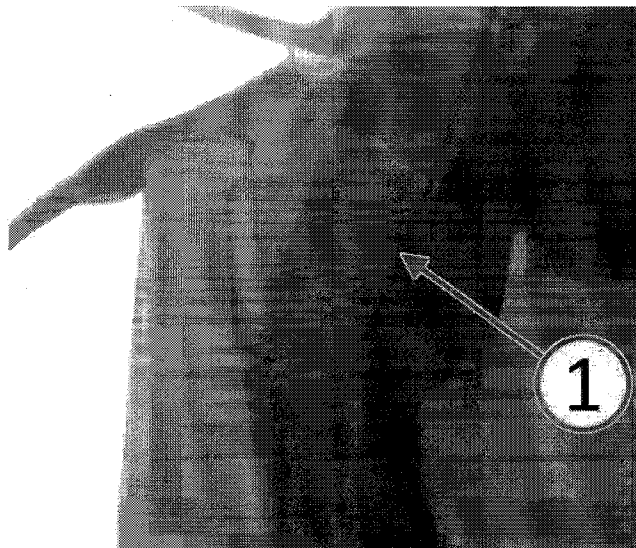
Fig. 3 Window Flag In Proper Position

1 - No Visible Gap

6. Raise the door window glass to the full up position.
7. Confirm that the gap has been eliminated between the outer door mounted window seal flag and the door window glass (Fig. 3).
