NUMBER: 25-002-14

GROUP: Emissions Control

Malfunction Indicator Lamp Illumination Due To Oxygen Sensor

2010 - 2012	(DJ)	Ram Pick Up (2500)
2010 - 2012	(D2)	Ram Pick Up (3500)

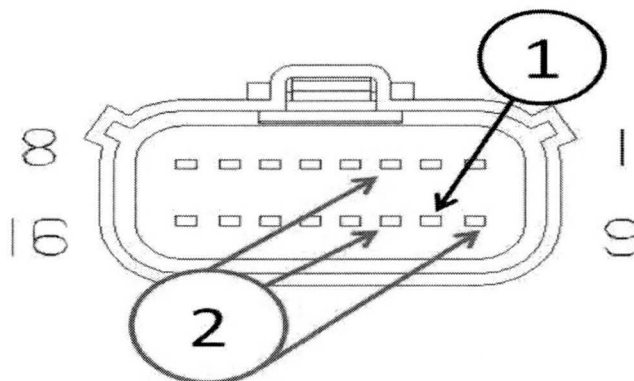
Fig. 1 FOUR WIRES FROM TRUCK MUST BE TRANSFERED TO OVERLAY HARNESS

1 - Terminal 10 - Always a Gold Plated Terminal

2 - Terminals 3, 9 and 11- Must be Inspected on Model Year 2011 For Gold Plating

- b. For Model Year 2011 only; Inspect terminal end for gold plating, (compare to terminal #10 previously inspected in Step #15). If plating of terminal is **NOT** gold, replace the terminal pigtail with gold plated terminals supplied in the kit, p/n 68250763AA by proceeding to Step 16 (d). Repeat this for terminals in cavities 9 and 11.

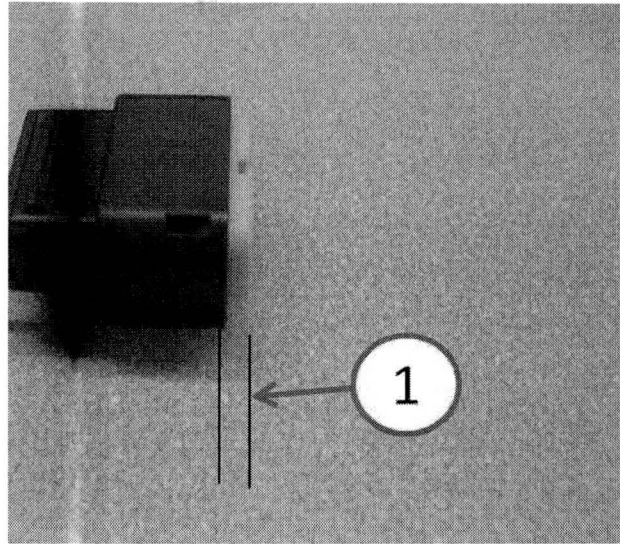
Fig. 3 PROPER EXTENSION OF TPA

1 - TPA Extended .2" (5MM)

-
14. To release the terminals from the original Oxygen Sensor Module connector; use a narrow blade, flat screwdriver (3 mm wide max), and pry the white TPA (white cover seen when looking in connector). Notice the travel of white TPA is only .2" (5 mm) or until a "click" is heard. This is the release point of the TPA. The TPA is a device that locks the release finger so that when seated, terminal will not and cannot be disengaged, (Fig. 2) and (Fig. 3). Do not extend the TPA past .2" (5 mm) or the TPA may be damaged.

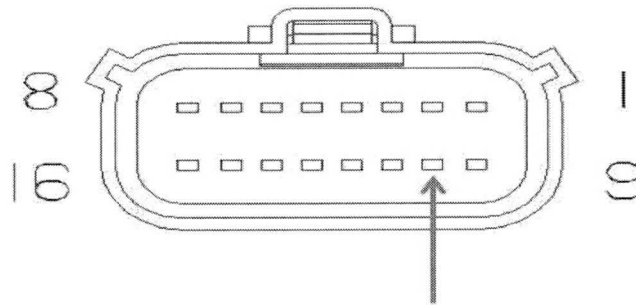
Fig. 4 TERMINAL 10 IS A GOLD TERMINAL

NOTE: Terminal #10 is ALWAYS gold plated and is not required to be changed ON ANY APPLICATION. Inspect terminal #10 to see what the gold terminals look like for a reference when inspecting terminals #3, 9 & 11 in the following steps.

15. Starting with terminal #10 (Fig. 4), push the wire into the connector from the back, and while keeping the tool or drill at 90° angle to the face of the TPA, push the tool or drill in until it releases the lock finger in the connector as shown in (Fig. 5). At this point the wire should pull out the back. As the terminal is removed; note the orientation of the terminal in the connector for ease of installation later.

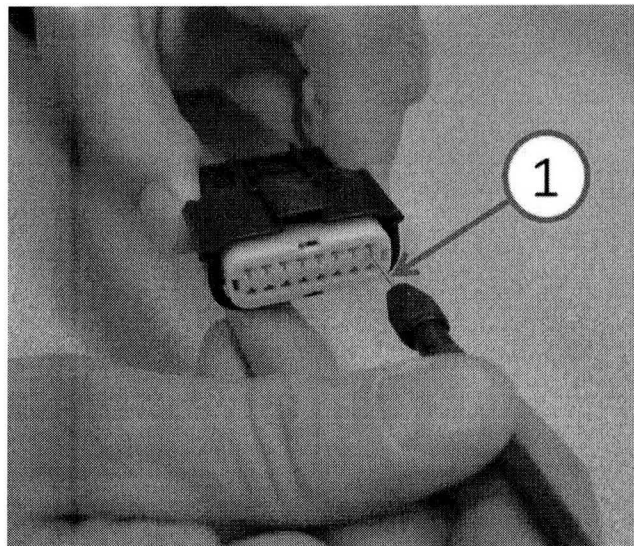
Fig. 5 INSERT TOOL IN SERVICE PORT ADJACENT TO THE TERMINAL TO BE REPLACED

1 - 1MM Drill Bit Used as Service Tool
