NUMBER: 26-001-14

Incorrect Vehicle Data / Vehicle Information Label

2014	(DD)	3500 Cab Chassis
2014	(DP)	4500/5500 Cab Chassis

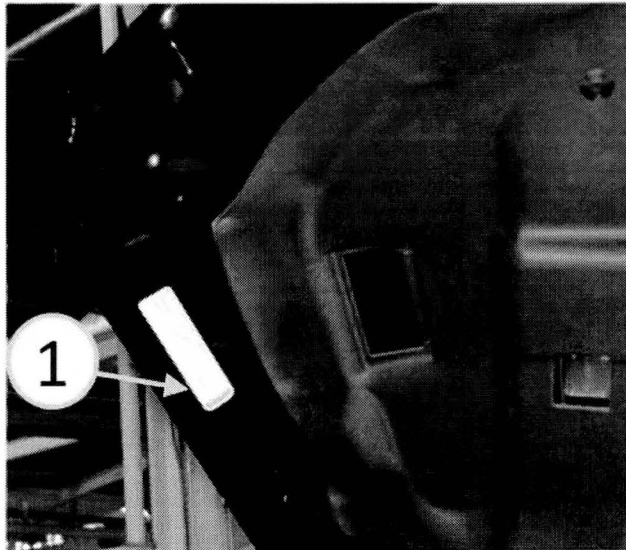
Fig. 1 VECI Label

1. Open hood.
2. Inspect vehicle for VECI label on underside of hood on right side (passenger side) of vehicle in location shown in (Fig. 1). Is a VECI label located in the identified location?
 - a. YES>>> Continue with next step.
 - b. NO>>> Proceed to Step #5

-
3. Remove existing VECI label by hand.
 4. Remove any remaining label adhesive with adhesive remover.
 5. Clean entire label area (2) with isopropyl alcohol and allow to dry (Fig. 2).
 6. Ensure the information printed on the replacement label (1) reflects the equipment content of the vehicle it is being placed on (Fig. 2).
 - a. (DD) 3500 Cab Chassis with sales codes (ETK) plus (TTV) or (TV2) or (TV3), install label following instructions below.
 - b. (DP) 4500/5500 Cab Chassis with sales codes (ETK) plus (TUV) or (TUY), install label following instructions below.
 - c. (DP) 4500/5500 Cab Chassis with sales codes (ETK) and (TUZ), install label following instructions below.
