Entune Audio Head Unit Software Update (Panasonic)

Service Category Audio/Visual/Telematics

YEAR(S)	MODEL(S)	ADDITIONAL INFORMATION
2014	4Runner	
2014	Sequoia	
2014	Tacoma	
2014	Tundra

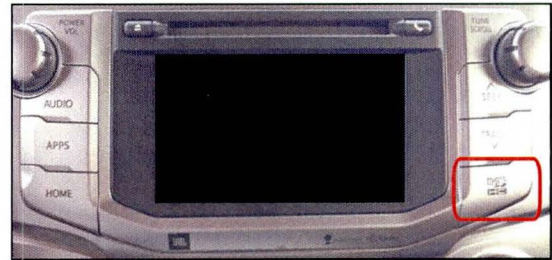
Figure 17.

If update fails and the error message "New software is not compatible with the system." displays, cycle the ignition OFF, remove the Map Micro SD Card from the head unit, and repeat steps 2 – 11.

Software update error is more likely to occur in areas with more traffic information.

Once update is complete, reinsert the Map Micro SD card into the head unit, cycle the ignition OFF, and proceed to step 13.
