TECHNICAL BULLETIN
JTB00350NAS1
09 JUL 2014

SECTION: 307-07

Transfer Case Control Module Software Update Required at Transfer Case Oil Change

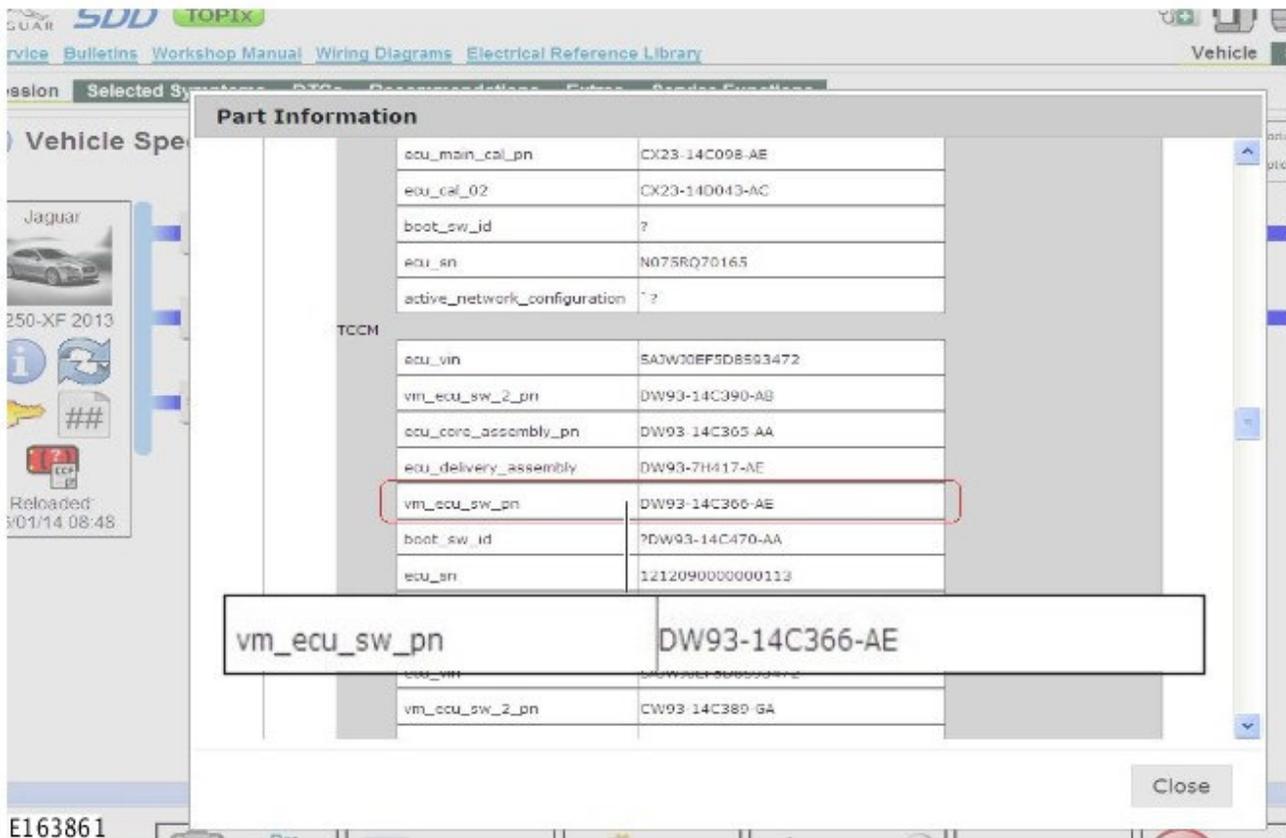
E163860

1. Connect the Jaguar Land Rover-approved Midtronics battery power supply to the vehicle battery.
2. Turn ignition 'ON' (engine not running).
3. Connect the Symptom Driven Diagnostics (SDD) system to the vehicle and begin a new session.
4. Follow the on-screen prompts, allowing SDD to read the VIN and identify the vehicle and initiating the data collect sequence.
5. Check the software level of the Transfer Case Control Module (TCCM):
 - Found under 'Part Information' in the Vehicle Statement Of Health (VSOH) screen.

6. Select 'Part Information' to display the hardware and software levels.

- Check the TCCM software level (vm_ecu_sw_pn):
 - If the TCCM software level is **DW93-14C366-BA or later**, replace the transfer case oil (see TOPIX Workshop Manual, section 307-07) and then proceed to step 7.
 - If the TCCM software level is **DW93-14C366-AE or earlier**, replace the transfer case oil (see TOPIX Workshop Manual, section 307-07) and then proceed to step 10.
