TECHNICAL BULLETIN
JTBO0379NAS1
12 SEP 2014

SECTION: 417-00

Front / Rear Lamp Condensation - Information Only

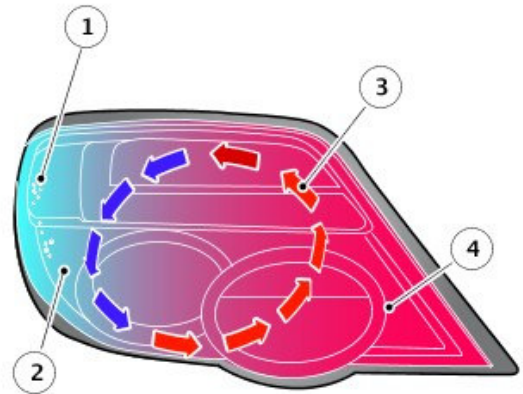
E170120

2. The illustration shows the following.

- 1. Moisture formation
- 2. Cool surfaces
- 3. Air circulation
- 4. Warm surfaces

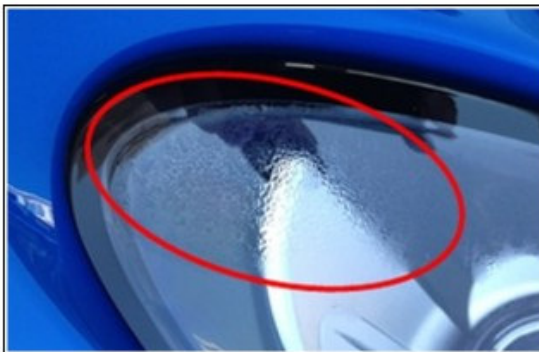
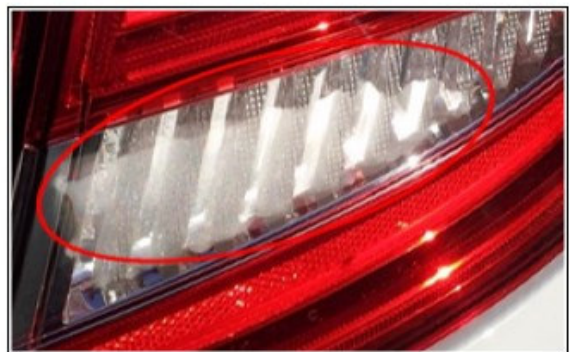
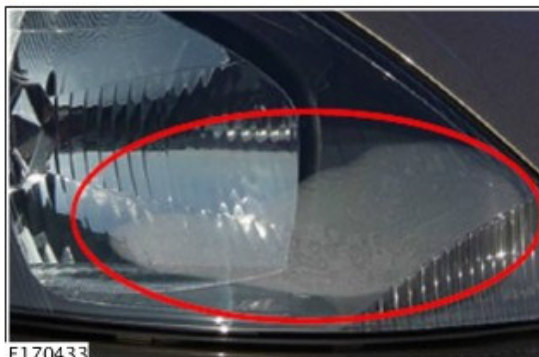
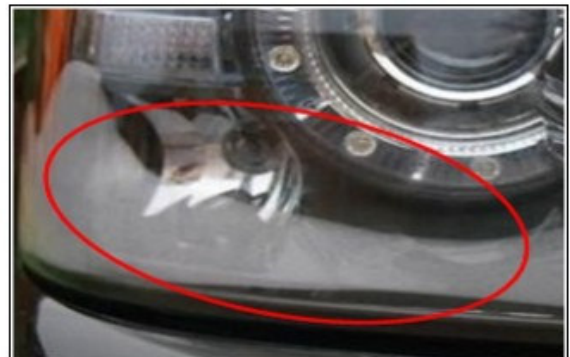
E170433

These are examples of normal exterior lamp condensation. This would NOT be covered by Warranty and the lamp should not be replaced.

3. No visible streaks, drip marks or droplets in the condensation mist.

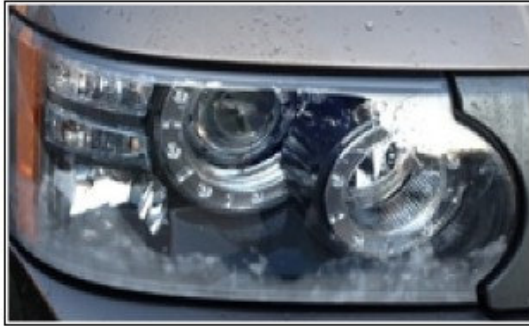
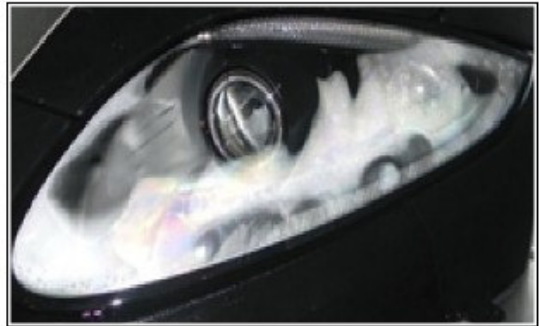
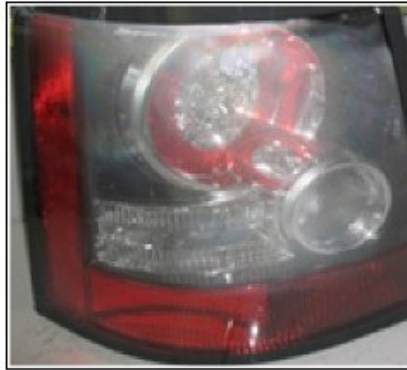
E170434

4. Condensation mist that

does not obstruct the view of the lamp interior.

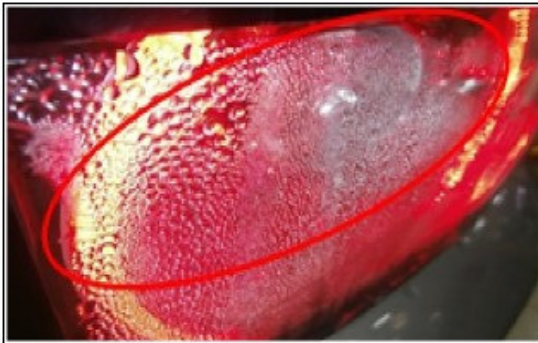
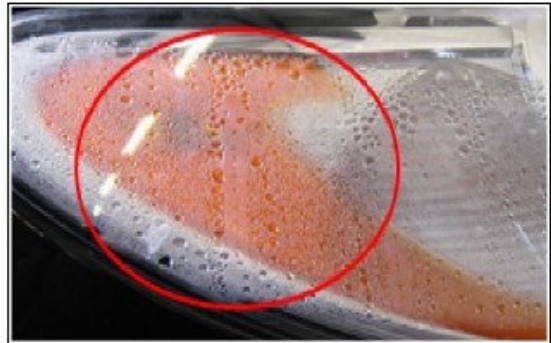
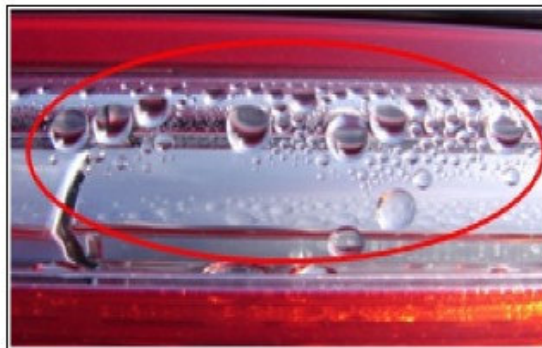
E170435

These are examples of abnormal exterior lamp condensation that may be covered by Warranty. Warranty may be accepted providing the lamp does not exhibit any visible signs of external damage.

5. Large water droplets.

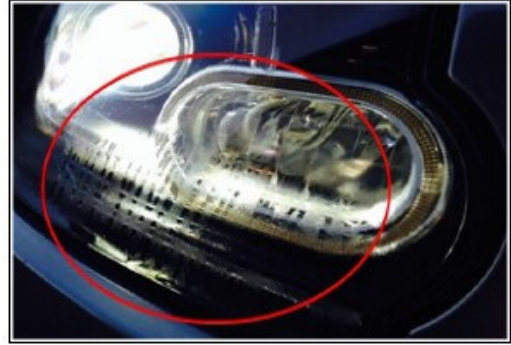
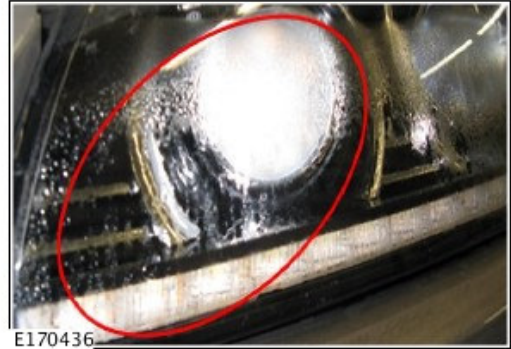
E170436

6. Drip marks or streaks in the condensation.

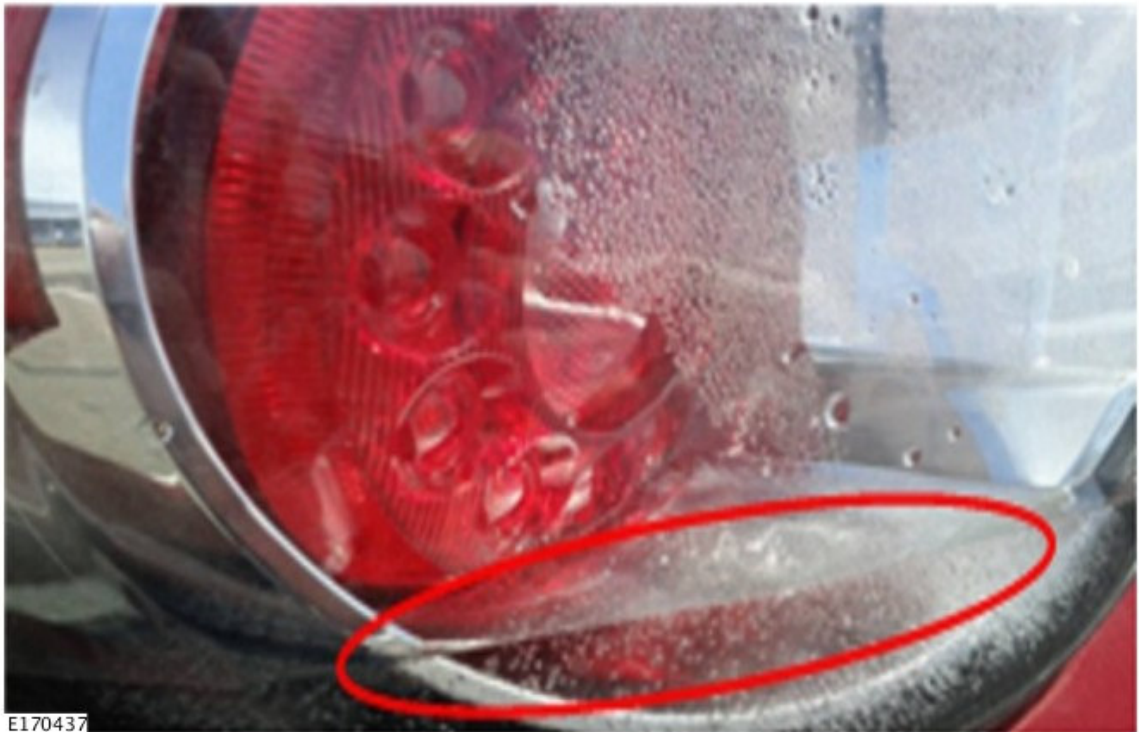
E170437

7. Standing water within the lamp.

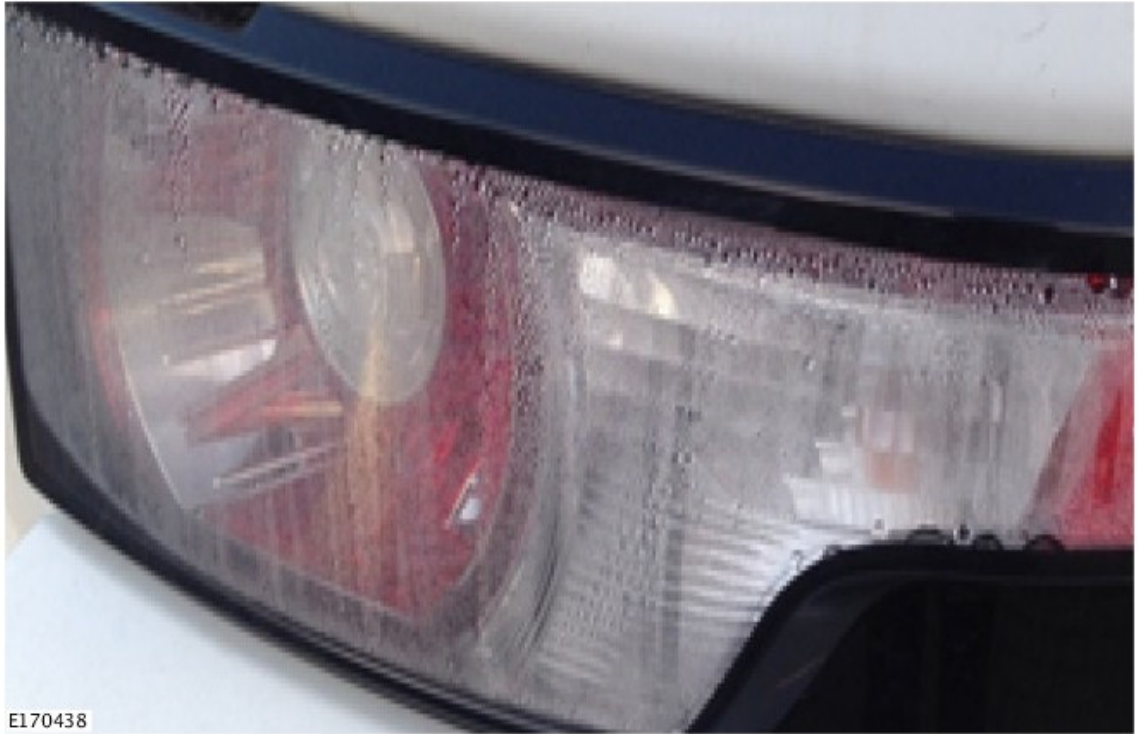
E170438

8. A thick mist covering the lens with water droplets.
