TECHNICAL BULLETIN
K214 UPS0114-3bNAS1
11 APR 2014

Update Prior to Sale: Door Sill Applique

F-TYPE (X152)

Model Year: 2014
VIN: K00001-K08070

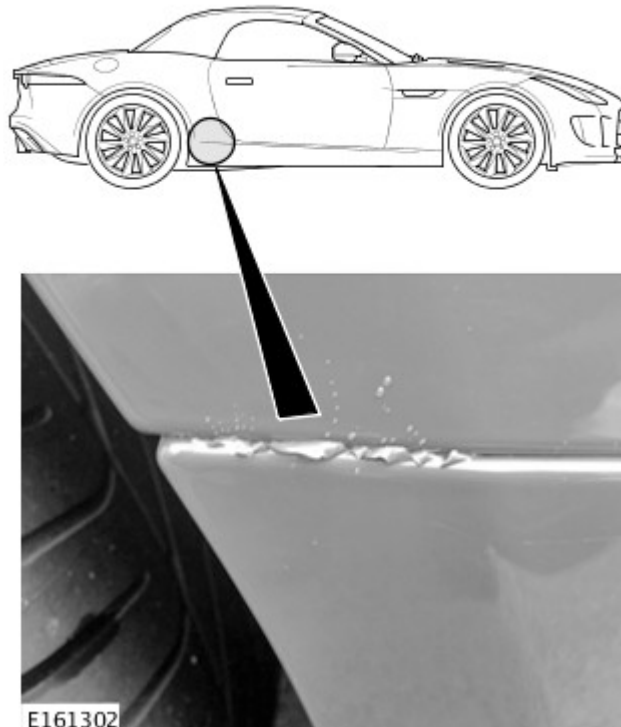
Situation: A potential issue has been identified on 2014 model year F-TYPE (X152) vehicles within the listed VIN range where paint is not adhering to the rear panels and that the paint is peeling where the sill meets the rear quarter.

Identify the area of damage.

- Remove the rocker panel moulding (see TOPIX Workshop Manual, Section 501-08).

3. Repair and paint the damaged area on the rocker sill moulding.
