TECHNICAL BULLETIN
K245 UPS5314-3bNAS1
29 SEP 2014

Update Prior to Sale: Driveshaft Fixings

XJ Range (X351)

Model Year: 2014
VIN: V71369-V71498

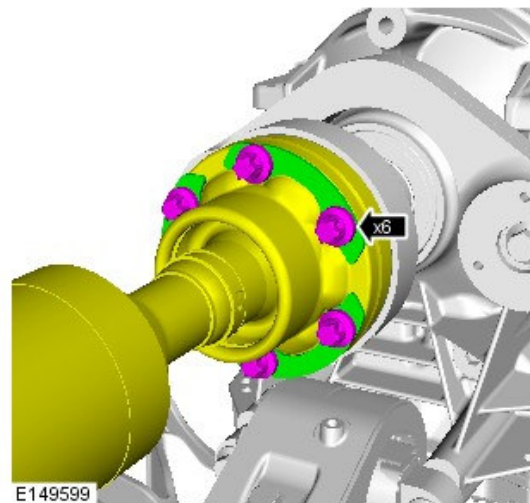
8.

Situation: A potential issue has been identified on a number of 2014 model year XJ (X351) vehicles, fitted with the 3.0L V6 supercharged engine only, where the driveshaft fixings may not have been tightened to the correct torque value.

**NOTE: Retain the locators for use with the new retaining bolts.**

**NOTE: Tighten the fixings in sequence directly across/180 degrees (criss-cross).**

Install the six (6) new retaining bolts.

- Torque: 75 Nm
