TECHNICAL BULLETIN
J048NAS1
21 NOV 2014

Safety Recall: Brake Pipe Torque Integrity

XJ Range (X351)	
Model Year:	2014-2015
VIN:	V67632-V76050

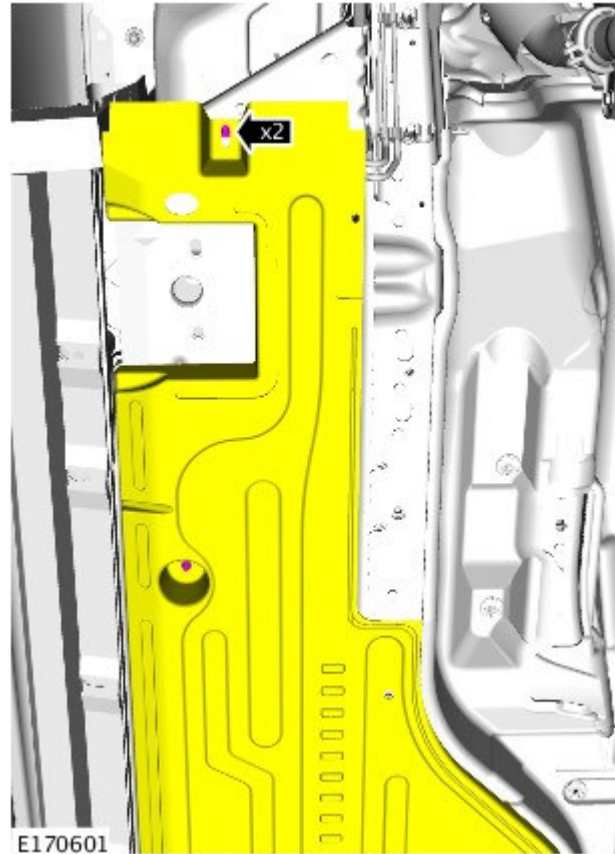
2.

**NOTE: Right-hand drive shown; left-hand drive similar.**

Remove the two fixings and lower the underfloor panel to access the underbody brake pipe unions.

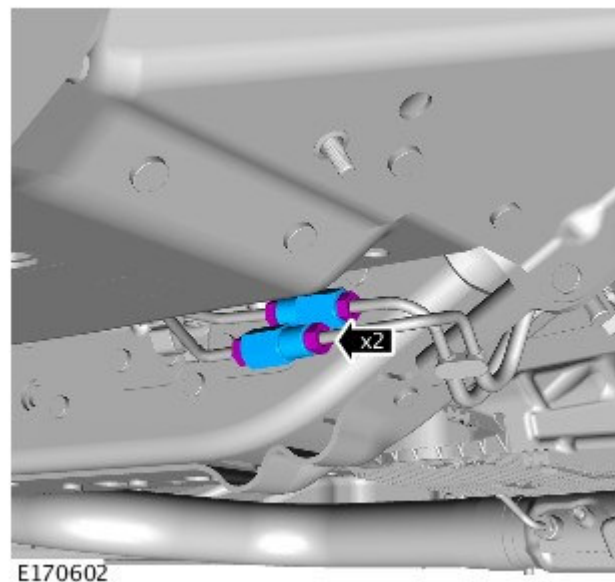
3.

**NOTE:** Right-hand drive shown; left-hand drive similar.

Inspect the brake pipe unions for signs of moisture or brake fluid leakage.

- If there are no signs of moisture / brake fluid leakage, reverse steps 1-2. No further action required.
- If there are signs of moisture / brake fluid leakage, continue to the next step.

**NOTE: Clean any moisture / brake fluid leakage from the brake pipe unions.**

Check the tightness of the brake pipe unions.

- Torque: 17.5Nm.
