TECHNICAL BULLETIN
K255 UPS6314-2bNAS1
17 SEP 2014

Update Prior to Sale: Parcel Shelf Separation

F-TYPE (X152)
Model Year: 2015
VIN: K07480-K15910
Body style: Coupe

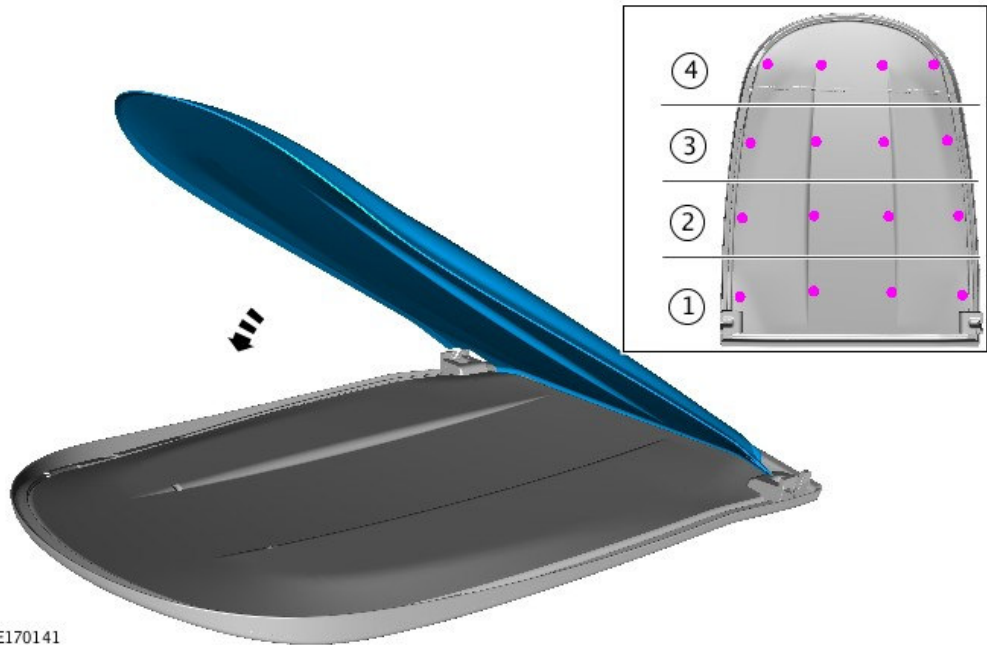
E170141

**CAUTION:** Make sure when bonding is complete, the glue manufacturer's curing guidelines are followed. Failure to do so may lead to the NVH pad separating from the parcel shelf in the future.

Using a hot melt glue gun, bond the NVH pad to the parcel shelf.

- Apply a sufficient amount of glue shown.
- Install the NVH pad in stages (one row at a time).

- Press down firmly on the NVH pad and allow the hot melt glue to cure before proceeding to the next row.
