Technical Service Bulletin

01 MIL on (DTC P0456 or DTC P0442 (EVAP emission control system leak detected))

01 14 65 2035519/4 February 4, 2014. Supersedes Technical Service Bulletin Group 01 number 14-58 dated January 14, 2014 for reasons listed below.

Model(s)	Year	VIN Range	Vehicle-Specific Equipment
Q7	2013 - 2014	All	Not Applicable

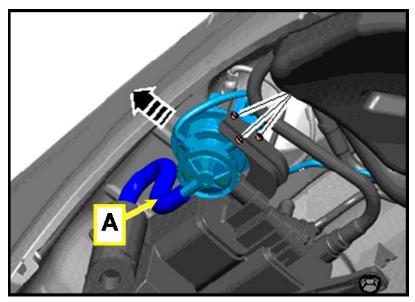
Figure 1. Hose leading to LDP air filter (A).

- 1. Visually inspect the EVAP system for any loose connections or damaged parts. If found, repair the loose connections and/or replace the damaged parts.
- 2. Pressurize the EVAP system using the KLI9210 Smoke/Pressure test:
 - Clamp off the hose that leads to the LDP air filter (Figure 1). Use hose clamps up to 25 mm diameter (Figure 2).
 - Pressurize the EVAP system to 12 inch/water (30mbar), and check pressure loss over time.
