Bulletin No.: 10-06-01-008M

# Service Bulletin

**Subject:** Engine Oil Consumption on Aluminum Block/Iron Block Engines with Active Fuel Management (AFM) (Install AFM Oil Deflector and Clean Carbon from Cylinder and/or Install Updated Valve Cover)

**Models:** 2007-2014 Cadillac Escalade Models  
2007-2013 Chevrolet Avalanche, Silverado  
2007-2014 Chevrolet Suburban, Tahoe  
2010-2012 Chevrolet Colorado  
2010-2015 Chevrolet Camaro  
2007-2013 GMC Sierra, Sierra Denali  
2007-2014 GMC Yukon Models  
2010-2012 GMC Canyon  
2008-2009 Pontiac G8 GT  
Vehicles Built Prior to February 1, 2011 Require Updated Valve Cover and October 2010 Require AFM Shield  
Equipped with Any of the Following Engines:  
– Aluminum Block V8 Engine with Active Fuel Management (AFM) (RPOs LH9, L94, LZ1, L99, LC9, LH6, L76, L92, LFA (Hybrid))  
– Iron Block V8 Engine with Active Fuel Management (AFM) (RPOs LMG, LY5)

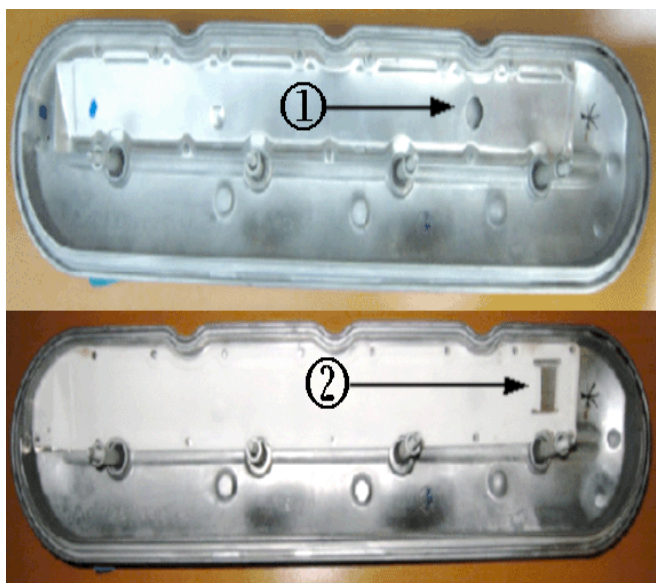
2740641

- 1) Old Design
- 2) New Design

PCV pullover or an overactive lifter can cause oil to be pulled through the PCV system even at low vehicle mileage. A correctly functioning PCV system will only leave a film of oil in the intake manifold. Inspect the intake manifold to see if there is any oil puddling in the bottom. If there is you will need to replace the left valve cover. Two new left rocker arm covers have been released for trucks and vans. Technicians should replace the left rocker arm cover with GM P/N 12570427 for 2007-2008 or GM P/N 12642655 for 2009-2011. Refer to the Parts Information below for the Camaro. This rocker arm cover has a relocated PCV drain hole that prevents oil from entering the intake manifold. Refer to Valve Rocker Arm Cover Replacement - Left Side in SI.

**Note:** These rocker covers are for specific years. The PCV orifice is different for each. The correct cover must be used or an SES light may set.
