Technical Service Bulletin

19 Coolant temperature too high when vehicle is being driven - 4.0 TFSI

19 14 51 2037994/1 August 4, 2014.

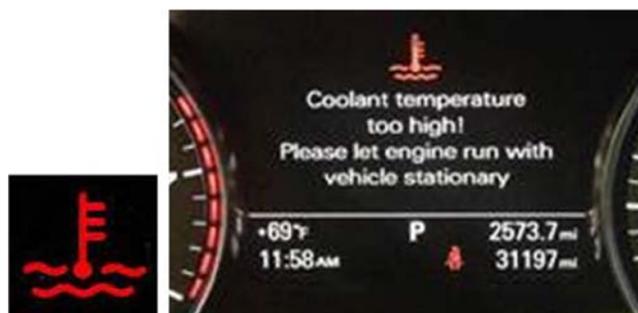
- While the vehicle is being driven:
 - The red coolant warning lamp illuminates, or a coolant-related warning appears in the DIS (Figure 1).
 - The coolant temperature gauge rises.
- After the ignition key is cycled, the temperature may return to normal.
- No coolant leaks are found.
- Guided fault finding (GFF) shows no clear symptoms.

Figure 1. Coolant warnings.

In certain operating conditions, a function in the internal thermal management system can increase the engine temperature.

1. Follow all instructions in TSB 2011732: *00 Software Version Management (SVM), operating instructions.*
2. Update the ECM, J623 (address word 01), using the SVM action code as listed in the table below, if necessary.
