# Technical Service Bulletin

#### 23 Excessive whining or intake noise from turbocharger

23 14 31 2038105/1 August 18, 2014.

ſ	Model(s)	Year	VIN Range Vehicle-Specific Equ	
	Q7	2013 - 2015	All	TDI clean diesel

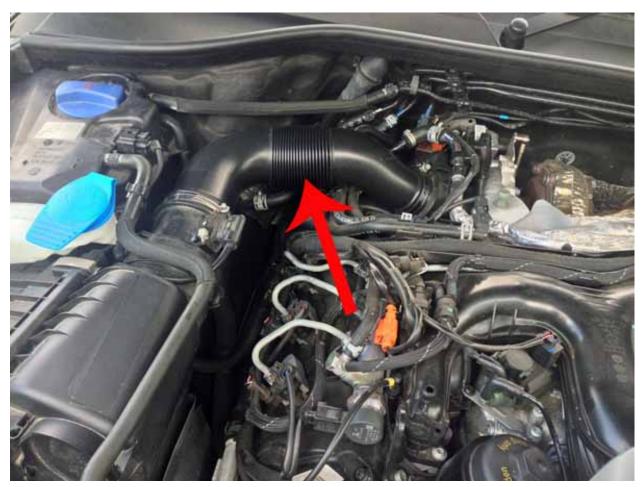
- Customer states excessive turbocharger resonance or intake air noises during acceleration. The concern can be reproduced at approximately 30% throttle loading and medium RPM.
- No intake leaks found.

Production tolerances in intake hose can cause amplification of normal turbocharger noises.

Figure 1. Location of air intake hose

- 1. Before proceeding, ensure that the *Condition* matches exactly. If any DTC codes are stored for turbocharger or boost pressure issues, or if any drivability complaints are reported, this bulletin does not apply. Follow GFF and continue diagnosis outside of this bulletin.
- 2. Test drive vehicle to reproduce the noise complaint. The complaint should be easily reproducible at approximately 30% throttle load. Listen to the attached sound file for reference of excessive turbo noise.
- 3. If the complaint can be reproduced, replace intake hose 4L0129628E (Figure 1).
