Technical Service Bulletin

42 Loud cracking or rubbing noises when steering (vehicles without Audi magnetic ride suspension)

42 14 21 2021724/5 July 9, 2014. Supersedes Technical Service Bulletin Group 42 number 12-16 dated November 13, 2012 for reasons listed below.

Model(s)	Year	VIN Range	Vehicle-Specific Equipment
A3	2006 - 2013	All	Without Audi magnetic ride
TT	2008 - 2015	All	Without Audi magnetic ride

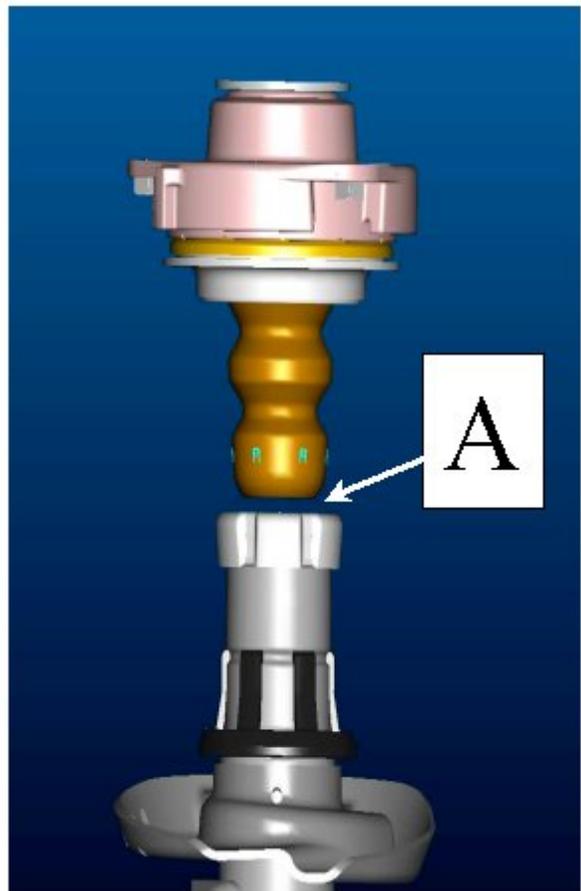
- When vehicle is being steered, the shock absorber stop can chafe on the plastic cap of the suspension strut.
- If the vehicle is lifted up, the noise disappears.
- The boot is not properly secured/installed, or is deformed.

Figure 1. The contact surface of the plastic cap of the suspension strut (A).

1. Brush silicon grease (G 000 405 A2) on the contact surface of the plastic cap of the suspension strut where it makes contact with the rubber stop (Figure 1).
