Service Bulletin

Bulletin No.: 12-06-04-003A

Subject: Malfunction Indicator Lamp (MIL) Illuminated, Reduced Engine Power Message Displayed, DTC P2135 Set

Models: 2009-2011 Buick Lucerne
2006-2008 Chevrolet Malibu
2006-2009 Chevrolet Uplander
2006-2011 Chevrolet Impala
2007-2009 Chevrolet Equinox
2006-2009 Pontiac G6
2006-2009 Pontiac Montana SV6
2007-2009 Pontiac Torrent
2006-2009 Saturn Vue
2007 Saturn Relay
2007-2009 Saturn Aura
Equipped with Engine — RPO LGD, LZ4, LZ8, LZE, LZ9, LNJ or LZG

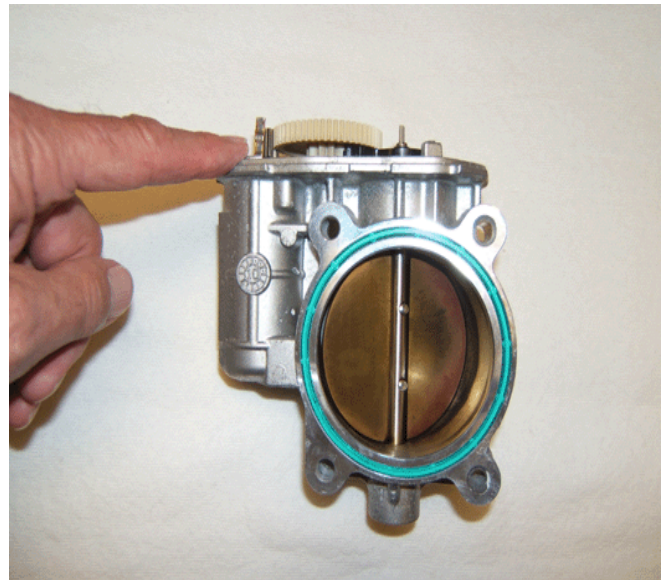
2909872

12. Inspect the TP sensor cover and verify that the TP sensor cover gasket **has remained** in the TP sensor cover as shown. Ensure that the gasket is accounted for and remains with the old TP sensor cover.

13. Observe the TP sensor cover for missing female throttle actuator motor terminals (1). Verify that the female throttle actuator motor terminals **have remained** in the TP sensor cover and **have not** been retained on the throttle actuator motor male terminals as shown. Discard the old TP sensor cover, gasket and terminals.

⇒ If one or both of the TP sensor cover female throttle actuator motor terminals have been retained on the throttle actuator motor male terminals, remove and discard those female terminals.

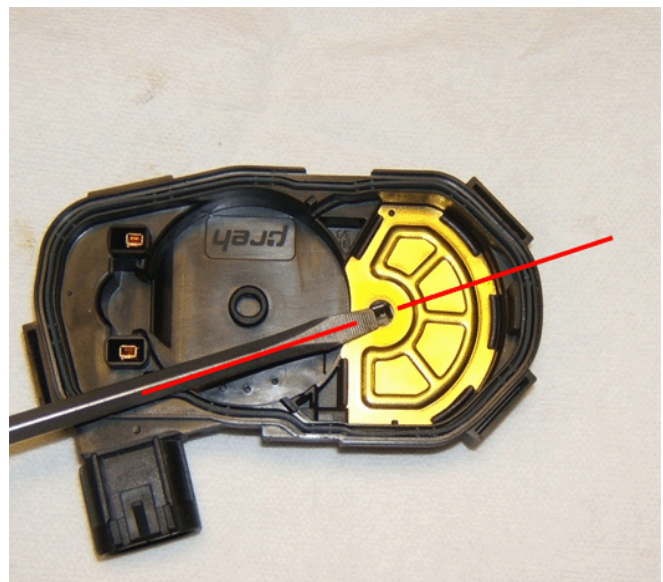
2911366

15. Place the TP sensor cover in the position as shown. Confirm the TP sensor drive slot orientation is aligned in the TP sensor cover as shown.

⇒ If the TP sensor drive slot orientation is not aligned as shown, use a small flathead screwdriver to gently rotate the TP sensor drive slot **clockwise** to the wide open throttle (WOT) position as shown.

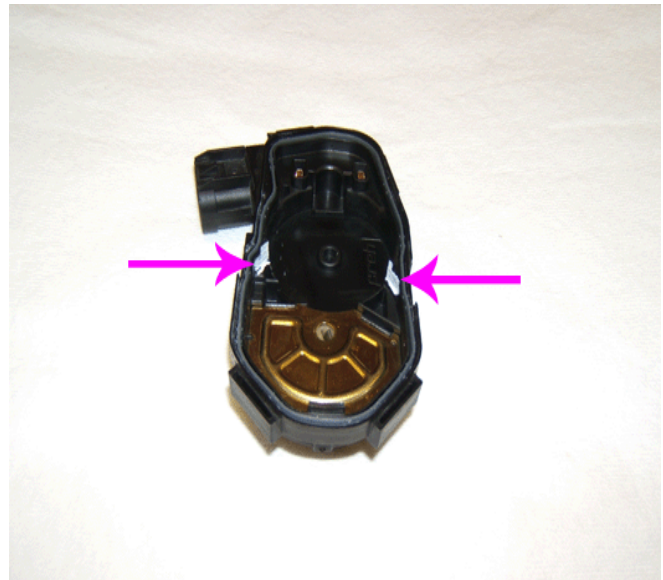
2910195

Notice: The three TP sensor cover alignment tabs are highlighted in white for identification purposes only.

17. Verify that all three of the TP sensor cover alignment tabs are present and are not damaged.
