# Service Bulletin

Bulletin No.: 14-06-01-002A

**Subject:** Crankshaft Rear Oil Seal — Oil Leak

**Models:** 2012-2013 Buick Enclave, LaCrosse  
2012-2013 Cadillac CTS, SRX  
2013 Cadillac ATS, XTS  
2012-2013 Chevrolet Camaro, Captiva, Equinox, Impala, Traverse  
2012-2013 GMC Acadia, Terrain  
Equipped with 6 CYL, 3.0L — RPO LFW  
Equipped with 6 CYL, 3.6L — RPO LFX or LLT

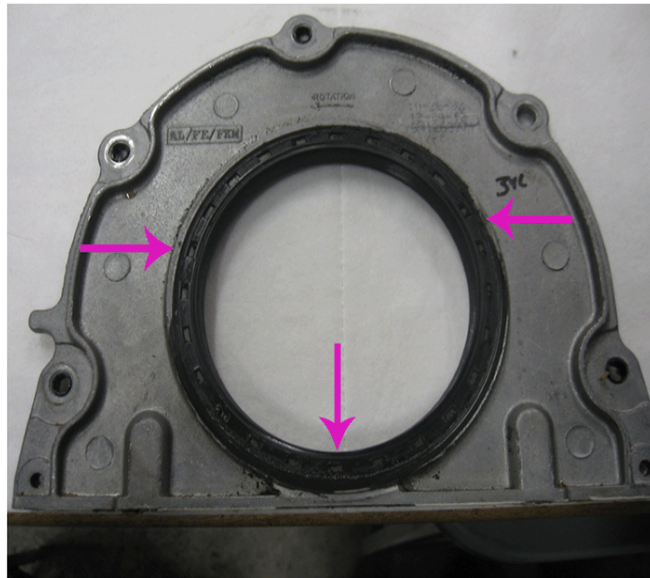
3959004

The Service Technician can check for excessive crankshaft end play by removing the accessory drive belt and checking for excessive crankshaft movement. Use a pry tool on the crankshaft pulley/dampener, being careful not to damage the crankshaft front cover seal.

⇒ If excessive crankshaft end play is observed, the engine oil pan will have to be removed for further diagnosis of the crankshaft #3 thrust bearing. Go to Step 1.

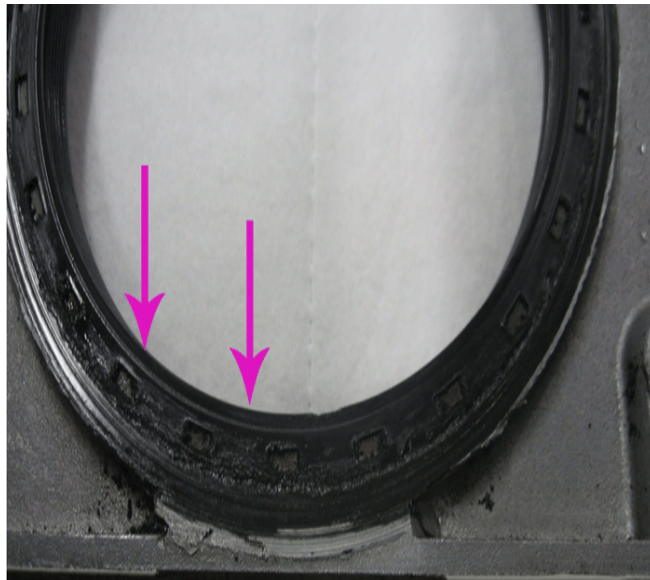
3959023

Another check that can be performed if the transmission has been removed for crankshaft rear oil seal and housing replacement, is to inspect the crankshaft rear oil seal and housing for friction rub marks.

⇒ If the crankshaft rear oil seal and housing display friction rub marks, the engine oil pan will have to be removed for further diagnosis of the crankshaft #3 thrust bearing. Go to Step 1.

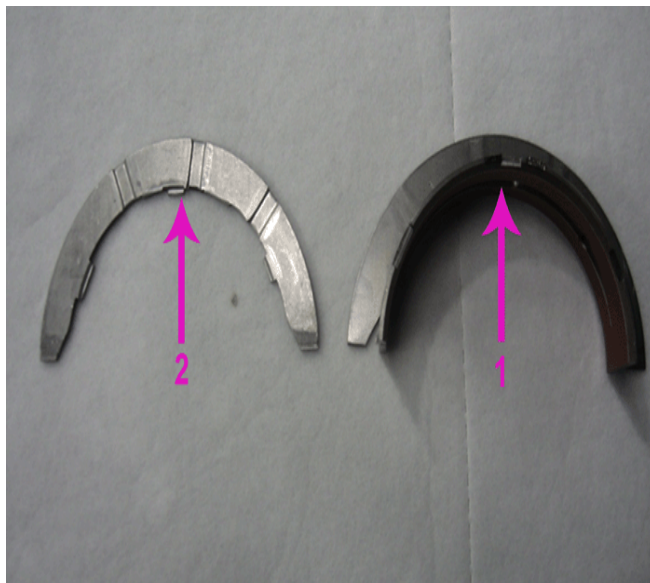
3958981

This may be caused by the crankshaft #3 thrust bearing wing separating from the thrust bearing, resulting in excessive crankshaft end play and damaging the crankshaft rear oil seal and housing.

5. Typical view of a good crankshaft #3 thrust bearing with both thrust wings in place and a view of the crankshaft #3 thrust bearing (1) with one wing (2) broken off. The thrust bearing wing (2) is usually found in the engine oil pan, sometimes under the oil pan scraper. Ensure the failed thrust bearing wing is removed from the engine oil pan.
