PRODUCT SAFETY RECALL

SUBJECT: Front Axle Right Half Shaft Fracture

MODELS: 2013-2014 Chevrolet Cruze
Equipped with 1.4L Turbo Engine (LUV)

GM Recall #14079

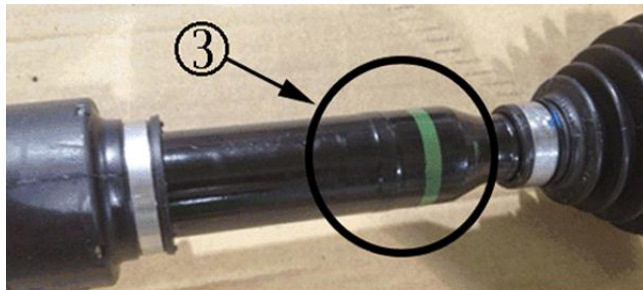
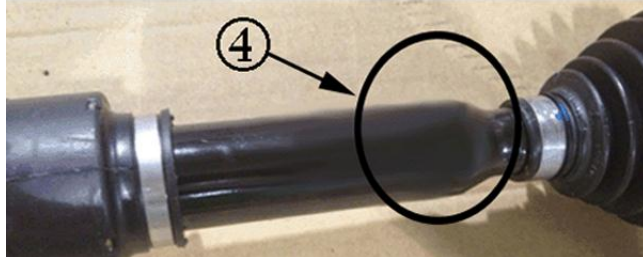
3924829

1. Inspect the inboard side of the shaft (shorter portion between rubber isolator and boot) for a green stripe, green dot or combination of green stripe and green dot.

- If one of these markings (3) are present, this is a good part.
- If there are no green markings on the inboard portion of the shaft (4) this part should be returned to General Motors under special return message G_0000187857 dated March 18, 2014 (US) or GMP 2014-073 dated March 17, 2014 (CN).

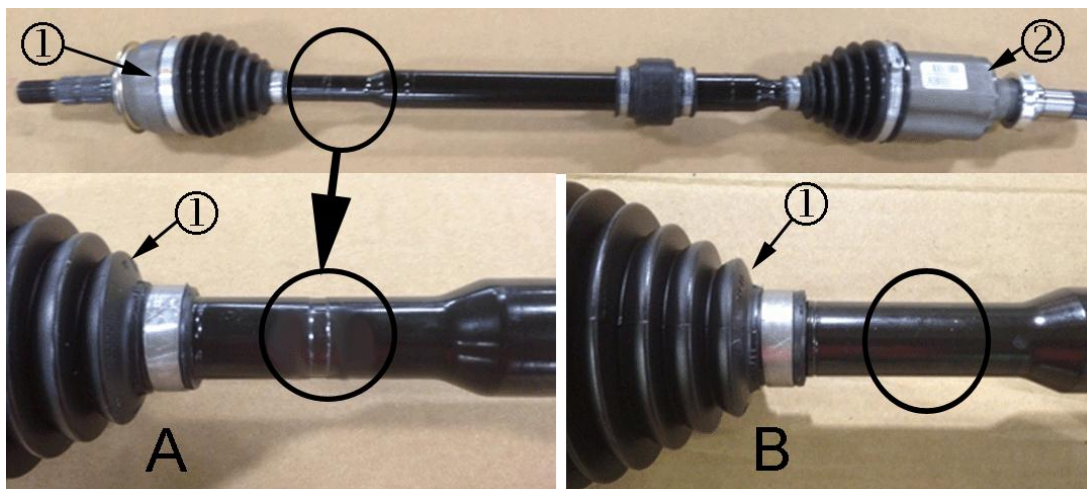
3773590

1. Inspect outboard side of the half shaft (longer portion of shaft between CV joint and isolator). Determine if a machined groove is present on the half shaft.
 - If the machined groove is present (A) on the half shaft, the part can be used for service.
 - If the machined groove is NOT present (B) on the half shaft, proceed to step 2.
2. Inspect the inboard side of the shaft (shorter portion between rubber isolator and boot) for a green stripe, green dot or combination of green stripe and green dot.
 - If these markings are present, this part can be used for service.
 - If no green strip, green dot, or green stripe and dot is present, this part should be returned to General Motors under special return message G_0000187857 dated March 18, 2014 (US) or GMP 2014-073 dated March 17, 2014 (CN).

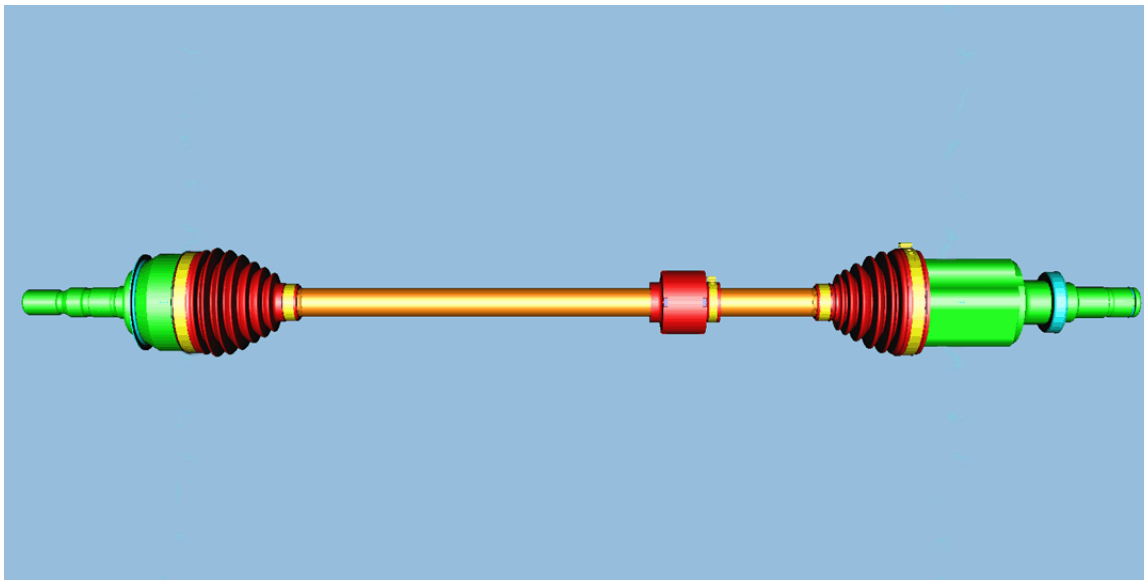
3919719

Solid Shaft

Note: Any additional paint marks found on a solid axle shaft can be disregarded.

1. The outboard side of the half shaft (longer portion of shaft between CV joint and isolator) is a solid painted bar shaft. Same diameter across entire shaft. There are no other identifications on the half shaft to look for. This part can be used for service.

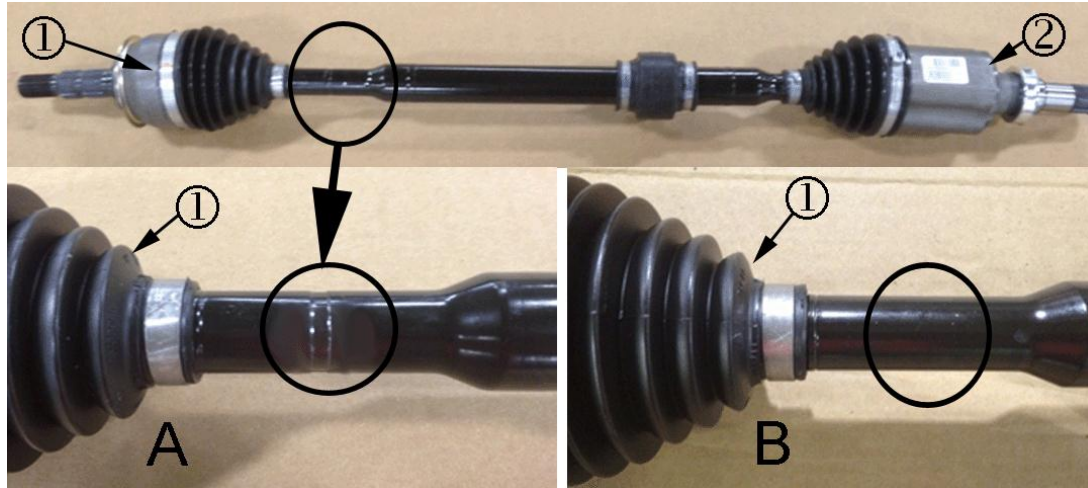
3773590

1. Raise and support the vehicle. Refer to *Lifting and Jacking the Vehicle* in SI.
2. Inspect the right (passenger side) half shaft near the front wheel. Determine if a machined groove is present on the half shaft.

(1) Wheel Side of Half Shaft (2) Transmission Side of Half Shaft (A) Machined Groove (B) No Groove

- If the machined groove is present (A) on the half shaft, no further action is required. Lower the vehicle.
 - If the machined groove is NOT present (B) on the half shaft, proceed to step 3.
3. Inspect the right (passenger side) half shaft near the transmission. Determine if a green stripe, green dot, or green stripe and green dot is present on the half shaft bar.

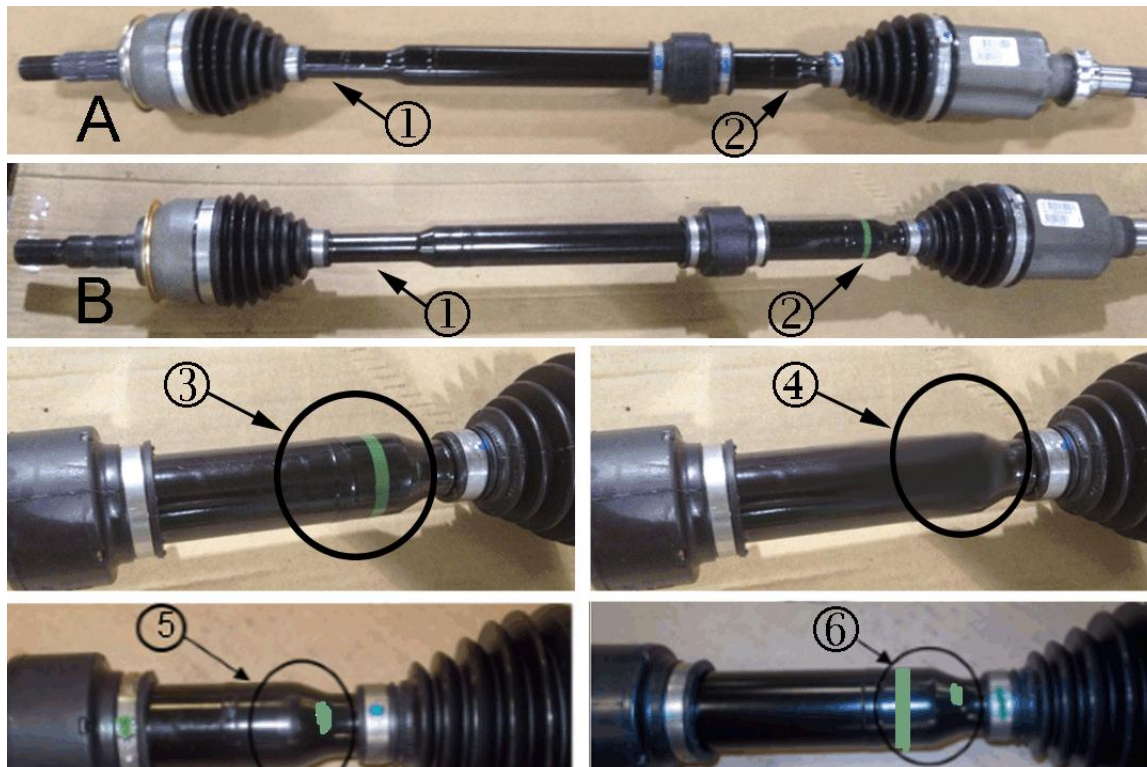
3802789

(1) Wheel Side of Half Shaft (2) Transmission Side of Half Shaft (A) Automatic Transmission (B) Manual Transmission (3) Green Stripe (4) No Stripe (5) Green Dot (6) Green Stripe and Green Dot

- If a green stripe, green dot, or a green stripe and green dot is present (3, 5, or 6) on the half shaft, no further action is required. Lower the vehicle.

Note: Replace the half shaft if a blue stripe, blue dot or no stripe (4) is present.

- If a green stripe, green dot or green stripe and green dot is NOT present on the half shaft, replace the half shaft. Refer to *Front Wheel Drive Shaft Replacement ---Right Side* in this bulletin.
