Recall Bulletin

PRODUCT SAFETY RECALL

SUBJECT: Driver's Airbag Module

MODELS: 2009-2010 Pontiac Vibe

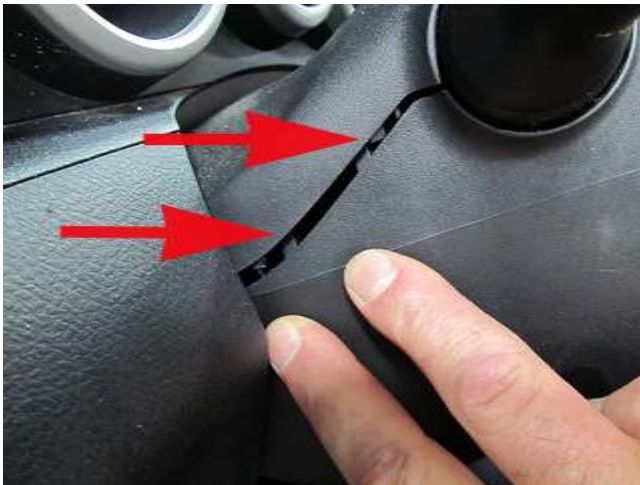
3946765

Note: when removing the upper and lower steering column trim covers, use care to fully release all of the attachments. Do not force the clips, they will break off of the trim.

1. Remove the steering wheel air bag coil. Refer to Steering Wheel Airbag Coil Replacement in SI. Discard the coil, it is not re-usable.

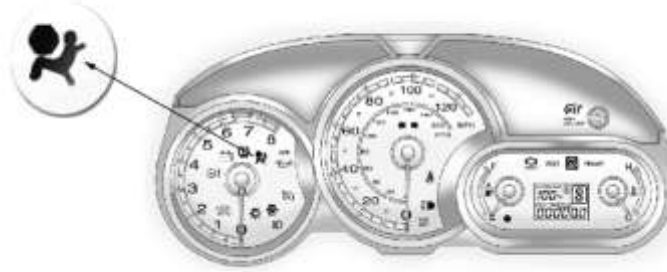
3902383

Until your vehicle can be repaired, please pay close attention to the air bag readiness light. The air bag readiness light is designed to come on during the ignition cycle check function when the engine switch is turned to the "ON" position. The light then goes off after about six seconds. **This means the system is operating as designed.** If the air bag readiness light (1) illuminates or remains illuminated **after** this six second check period, or (2) comes on while driving, or (3) at times previously stayed illuminated while driving, please contact your GM dealer immediately for diagnosis and appropriate repair. If the condition is related to this recall, the repair will be performed at **no charge**.
