Recall Bulletin

F/CMVSS NONCOMPLIANCE RECALL

SUBJECT: Instrument Panel Storage Bin Door Compliance – Add Reinforcement Bracket

MODELS: 2006-2008 Chevrolet HHR

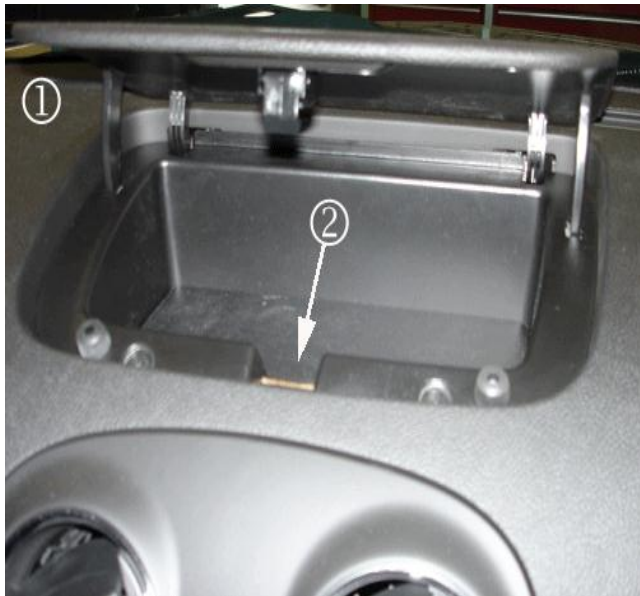
2200528

1. Locate and open the instrument panel storage bin (1).
2. Locate the instrument panel storage bin latch (2).

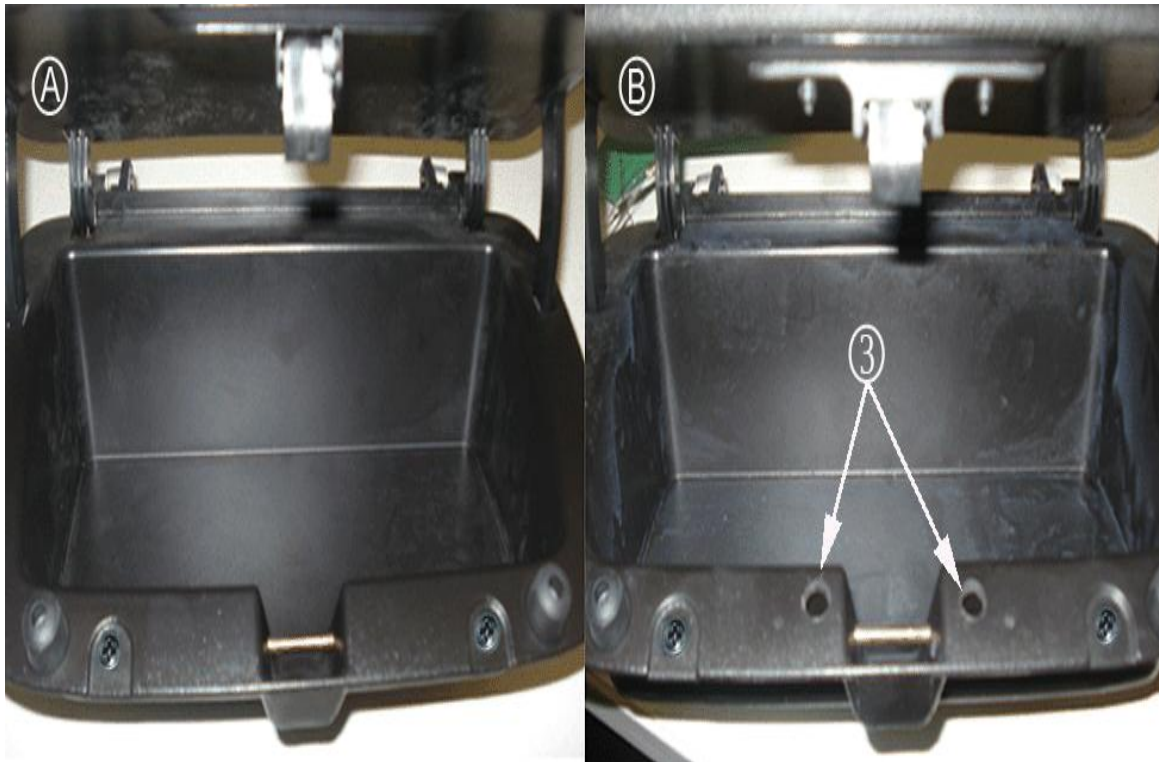
2219118

3. Determine if the storage bin is a first (A) or second (B) design storage bin. The second design storage bin (B) includes latch pin holes (3) on the left and right side of the latch.
 - If the vehicle is equipped with a first design storage bin (A), installing a reinforcement latch plate bracket IS required. Proceed to Step 4.
 - If the vehicle is equipped with a second design storage bin (B), installing a reinforcement latch plate bracket is NOT required. No further action is required.
