GM Bulletin No.: 12286A

SUBJECT: Service Update for Inventory Vehicles Only

Rear Side Door Reveal Molding Contact

MODELS: 2012-2013 Cadillac Escalade ESV, Escalade EXT

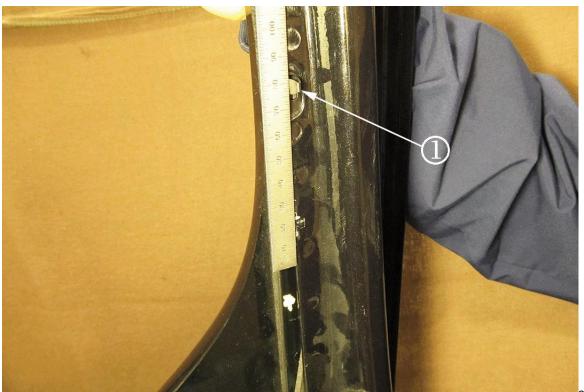
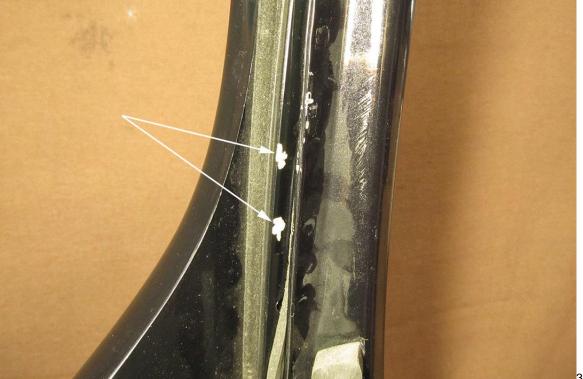
3274937

Note: The window reveal molding has a recessed flat area in the approximate location to mount the spacer.

Locate the lowest clip (1) on the rear edge of the window reveal molding. Measure 75mm (3 in) below the clip and mark the location on the molding. Measure 25mm (1 in) down from the first mark and mark the lower point.

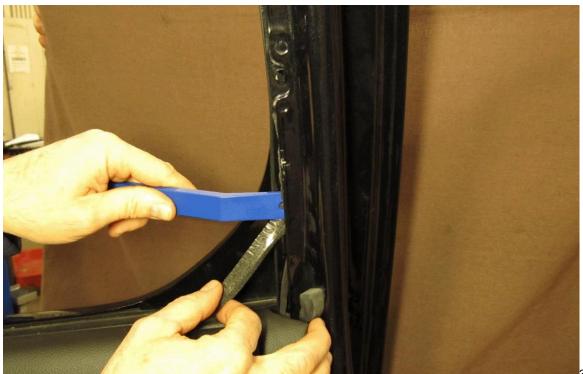
3274867

Note: The added weatherstrip is a wind / road noise measure.

- 9. Cut a section of 3/8" x 5/16" closed cell self-adhesive Kent Industries material P/N P46490, or the equivalent, to 210mm (8.26 in) length, and then remove the adhesive backing.
- 10. Using a trim stick, insert the weatherstrip just below the reveal molding clip, then around the spacer, and down toward the end of the molding below the beltline.
