Technical Service Bulletin

57 Rattle noise inside the door

57 14 05 2038961/1 November 24, 2014.

Model(s)	Year	VIN Range	Vehicle-Specific Equipment
Q7	2015	All	Not Applicable

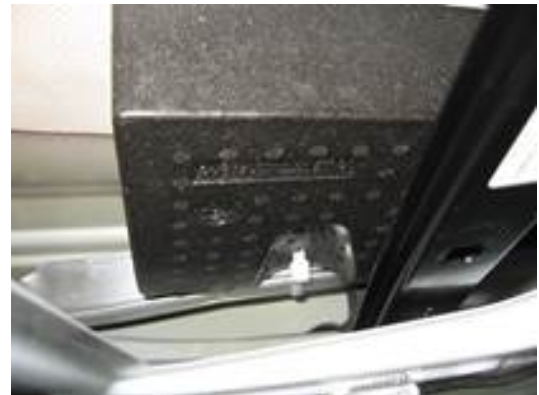
The lower foam pad on the inside of the front door skin may loosen and vibrate against the door skin.

3. With the cover removed, the lower pad will be visible. It is secured to the impact beam using a zip tie (Figure 3).

Figure 3. Lower pad secured to impact beam.

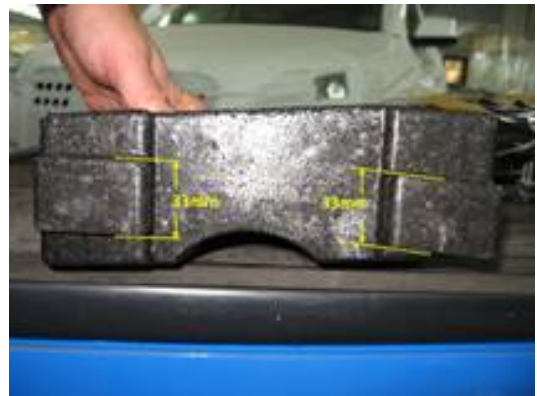
Figure 8. Pad legs with an original width of 33mm.

- Review the images at right (Figure 8 and Figure 9) to see how the pad legs will be modified in the next step. 15 mm of width must be removed.

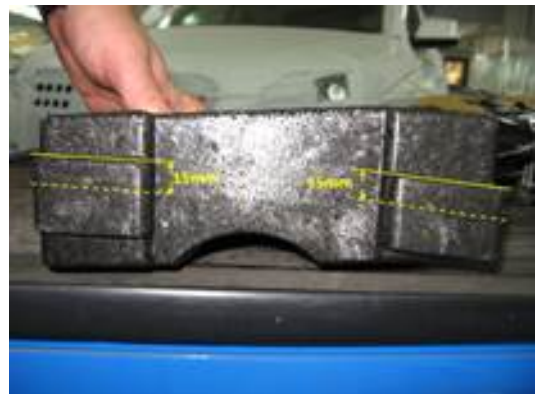
Figure 9. 15mm section of the pad legs to be removed.

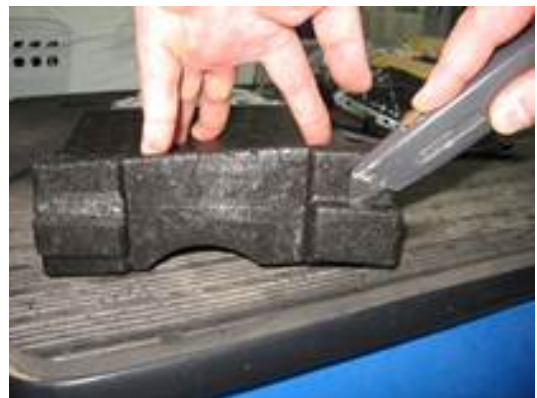
Figure 10. Making the horizontal cut.

- Using a razor knife, make a horizontal cut flush with the pad body and 15mm deep (Figure 10). Then make an intersecting vertical cut 15mm from the outer face of the pad (Figure 11). Remove the cut-out.

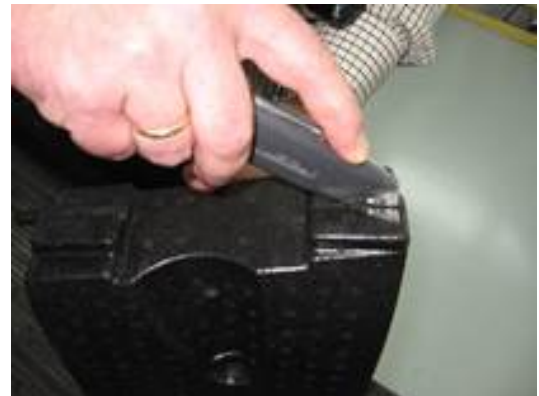
Figure 11. Making the vertical cut.

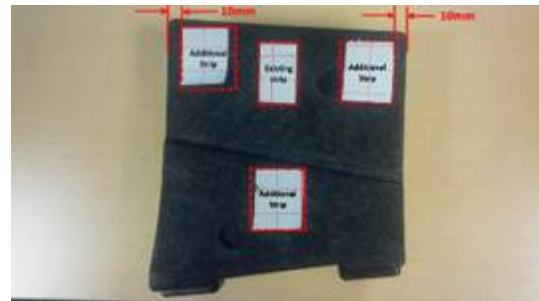
Figure 12. Positioning of the butyl strips.

8. Three additional butyl strips need to be applied to the pad in addition to the existing butyl strip. Each strip is approximately 40mm x 20mm. The upper strips need to be spaced 10mm from the edge of the pad as shown in the illustration (Figure 12). The center strip needs to be placed on the raised section of the pad directly above the hole as shown. Remove the protective foil.

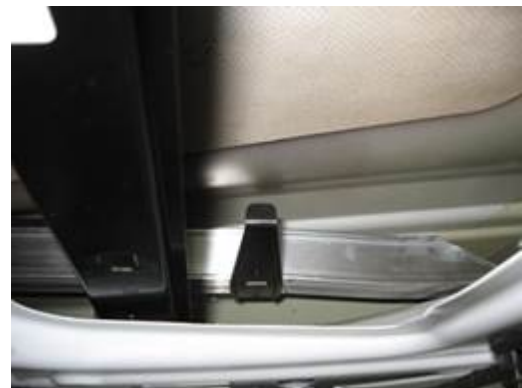
Figure 13. Retaining bracket installed on the impact beam.

9. Snap the retaining bracket for the pad onto the impact beam (Figure 13).

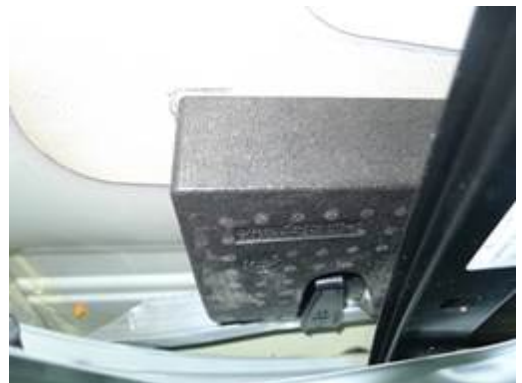
Figure 15. Lower pad installed to the correct position.

11. Using the mark that was previously made on the inside of the door skin as a guide, install the lower pad (Figure 15). The legs should rest on the top of the impact beam. Press the pad against the door skin so that the butyl strips stick the pad securely to the door skin. If necessary, slide the bracket along the impact beam so that the bracket correctly engages the slot in the pad.
