Technical Service Bulletin

70 Noises from the upper-center dashboard area

70 14 37 2029280/4 April 24, 2014. Supersedes Technical Service Bulletin Group 70 number 14-36 dated March 31, 2014 for reasons listed below.

Model(s)	Year	VIN Range	Vehicle-Specific Equipment
A6, A7	2012 - 2014	All	Not Applicable

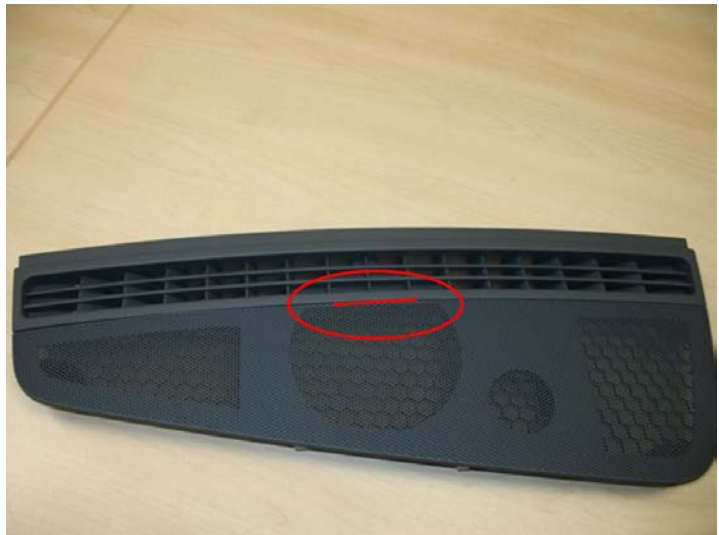
The noise can be caused by unfavorable tolerances between the instrument panel speaker and the center speaker trim. A speaker that has been incorrectly installed can make the condition worse.

Because there is no attachment to the trim carrier in the speaker cut-out, this area is the likely source of the vibration (Figure 1).

Figure 1. The affected area of the speaker grille, circled in red.

Replace the center defroster vent and the speaker trim. Review the steps below before proceeding:
