Technical Service Bulletin

74 Seat pneumatics system activates without driver input

74 14 20 2035757/3 June 2, 2014. Supersedes Technical Service Bulletin Group 74 number 14-17 dated February 21, 2014 for reasons listed below.

Model(s)	Year	VIN Range	Vehicle-Specific Equipment
A6, A7	2012 - 2013	All	Not Applicable
A8	2011 - 2013	All	Not Applicable

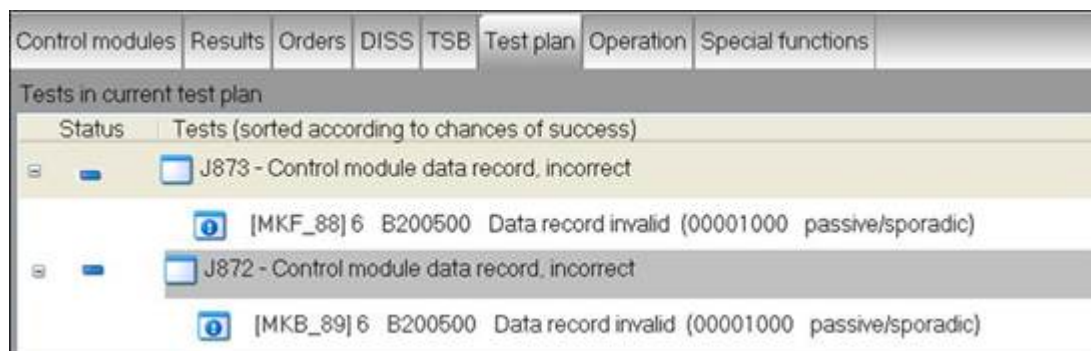
- After the SVM code is performed, one DTC will be set for each control module (Figure 4). Clear the DTCs before finalizing the procedure.

Figure 4. Example of DTC set for the control module after SVM code is performed.
