Technical Service Bulletin

91 Navigation plus (RNS-E) poor AM reception

91 14 43 2037125/1 May 2, 2014.

Model(s)	Year	VIN Range	Vehicle-Specific Equipment
TT	2014	003350-016006	Radio Navigation (RNS-E)

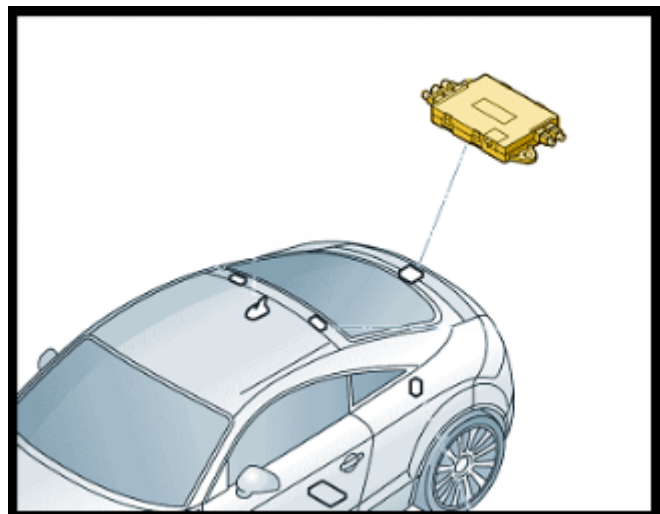
Figure 1. Aerial amplifier 2 -R111-.

The poor AM radio reception is due to an internal hardware issue of aerial amplifier 2 –R111- (Figure 1). All service parts have been checked and faulty parts were cleared out of stock.

4. Remove the aerial amplifier 2 –R111- according to the Elsa repair manual (*Electrical System*>>91 *Communication*>>*Removal and Installation*>>*Antenna Systems*>>*Antenna Amplifier 2 R111*).
