Technical Service Bulletin

91 MMI screen display carrier movement noise or shudder

91 14 45 2028446/6 June 20, 2014. Supersedes Technical Service Bulletin Group 91 number 13-05 dated September 12, 2013 for reasons listed below.

Model(s)	Year	VIN Range	Vehicle-Specific Equipment
A6, A7	2012	All	Not Applicable

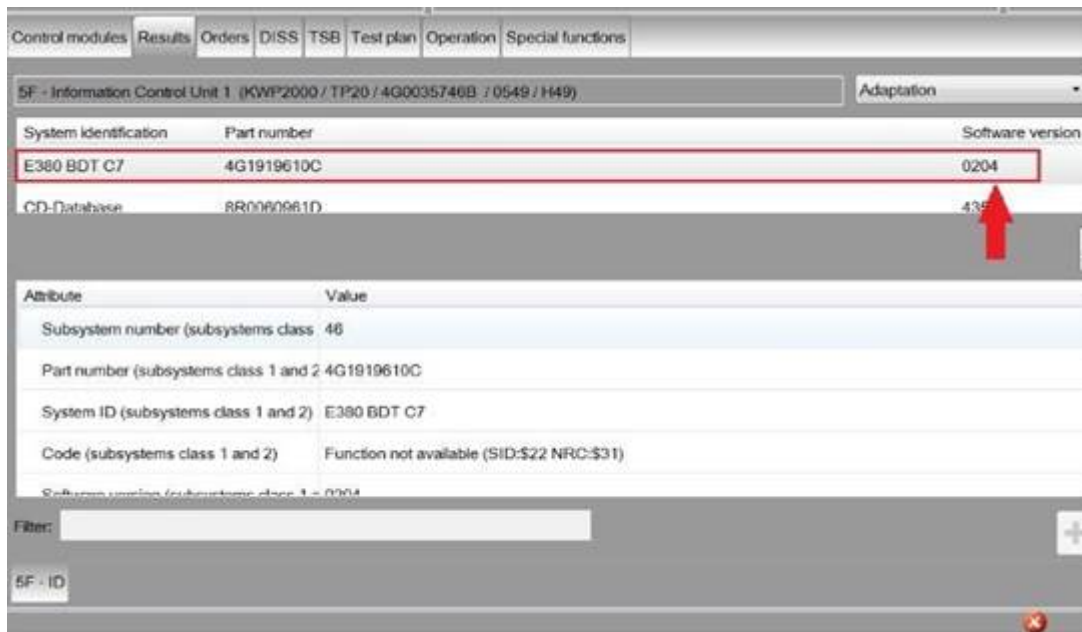
Figure 1. Location of E380 software version.

1. Replace the MMI display carrier with part number **4G8857346E** according to Elsa Repair Manual instructions.
2. Using GFF, determine the software level of the E380 controller. This information can be accessed through *On Board Diagnostic (OBD) >> 5F- Information Electronics 1 >> Identification* (Figure 1).

- If the software is *below* 0204, continue with this bulletin.
- If the software is 0204 or above, no update is required and the rest of this bulletin does not apply.

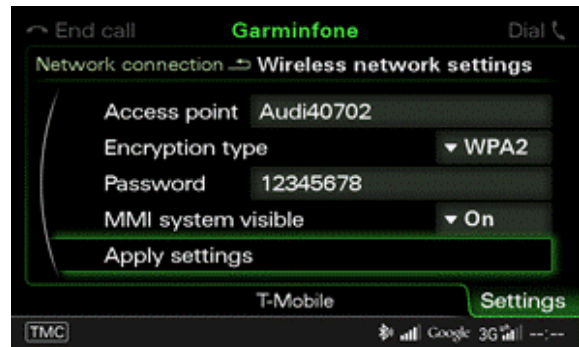
Figure 2. Wireless network settings.

- As part of the update, wireless settings and paired devices will be deleted. All devices will need to be re-paired after the update, and all wireless settings restored to the customer's settings. To access the Wireless Network Settings on the MMI (Figure 2), press *TEL >> Settings >> Wireless network connection >> Wireless network settings*. Record all settings so they can be re-entered at the end of the procedure.

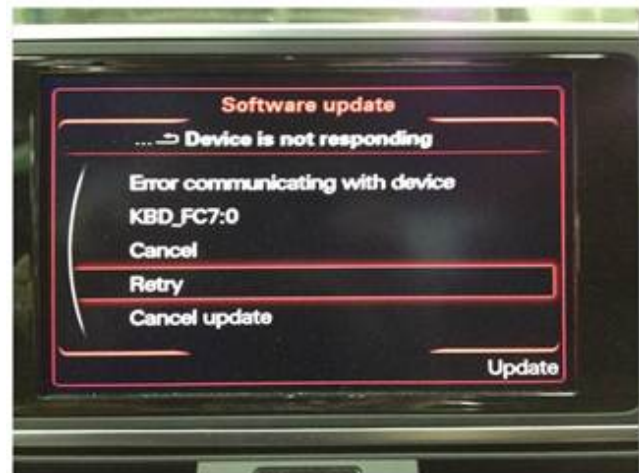
Figure 3. A device requiring a 'Cancel' selection.

Certain modules in some earlier model year 2012 vehicles or in vehicles equipped with Bose sound systems may not update properly during Step 16 of TSB 2028141. If this occurs, choose either 'Cancel' (Figure 3), or 'Skip device' (Figure 4), depending on the type of error. Do *not* choose 'Cancel update', as this may cause the software update to fail entirely.

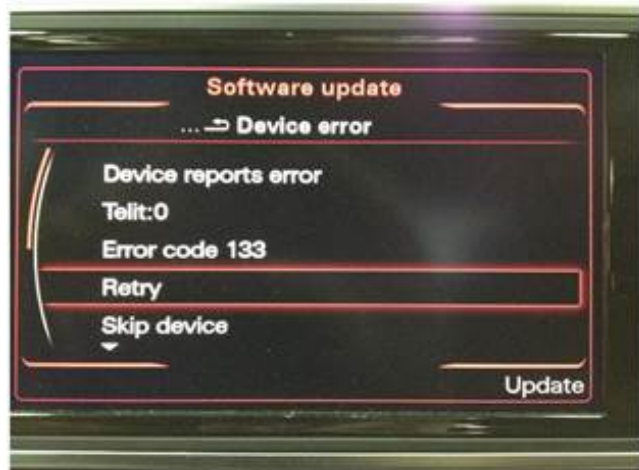
Figure 4. A device requiring a 'Skip device' selection.

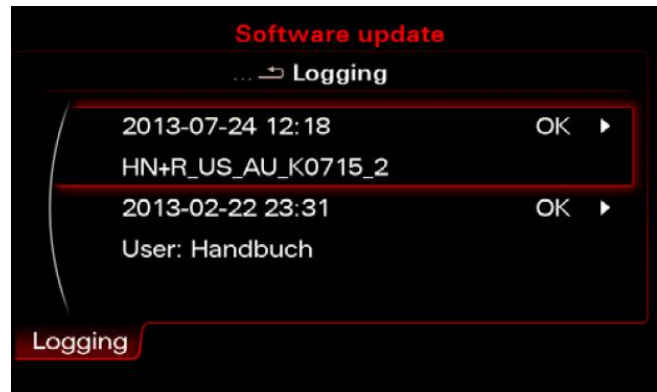
Figure 5. Software update log showing a successful software installation.

5. Verify that the software update has been completed successfully by accessing the logging page (Figure 5). To access this screen, proceed to step 8 in TSB 2028141 and press the lower left softkey. A successful update will show the date that the update was performed and the software that was installed (HN+R_US_AU_K0715_X), with 'OK' listed on the right. The 'X' may be one of several different numbers. If K0715_X does not have any rows with 'OK', the update must be retried until it is successful.

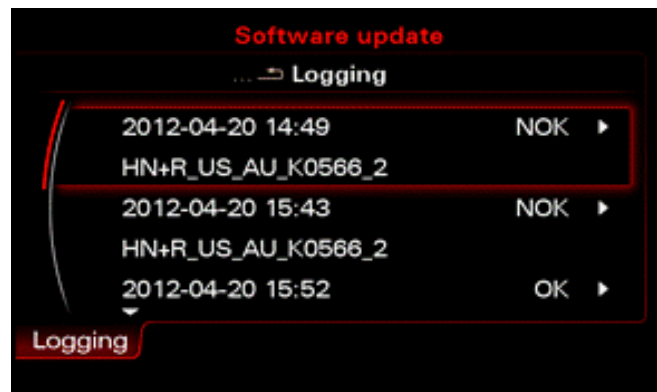
Figure 6. Software update log showing 2 failed attempts before a successful installation.

Tip: If the update must be performed two or more times due to modules not updating correctly, a screenshot of the software update log is required (Figure 6). This should be kept on-hand for warranty auditing purposes. To take a screenshot, insert an SD card into slot 1 and press and hold the left and right arrow keys at the same time. All four softkeys will flash when the screenshot is taken. A screenshot should be taken of each page in the logging display.
