Technical Service Bulletin

91 MMI screen display carrier movement noise or shudder

91 14 47 2028446/7 June 26, 2014. Supersedes Technical Service Bulletin Group 91 number 14-45 dated June 20, 2014 for reasons listed below.

Model(s)	Year	VIN Range	Vehicle-Specific Equipment
A6, A7	2012	000001 - 078292	Not Applicable

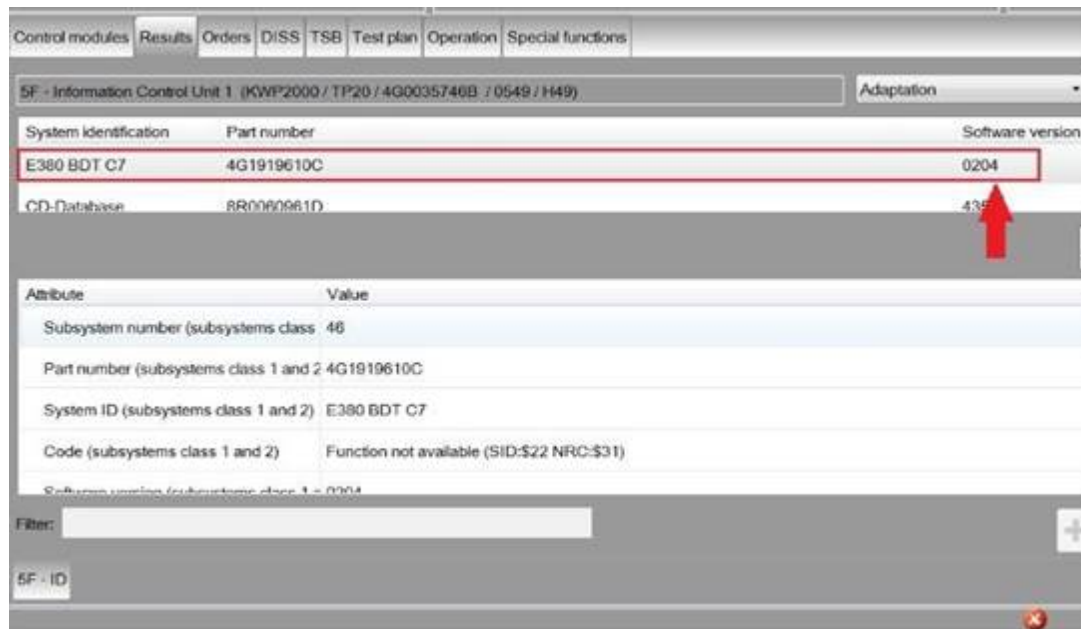
Tip: Be sure you are viewing the software level of the E380 controller and not the software level of the 5F module.

- If the E380 software level is *below* 0204, continue with this bulletin.
- If the E380 software level is 0204 or above, no update is required and the rest of this bulletin does not apply.

Figure 1. Location of E380 software version.

1. Replace the MMI display carrier with part number **4G8857346E** according to Elsa Repair Manual instructions.
2. Using GFF, determine the software level of the E380 controller. This information can be accessed through *On Board Diagnostic (OBD) >> 5F- Information Electronics 1 >> Identification* (Figure 1).

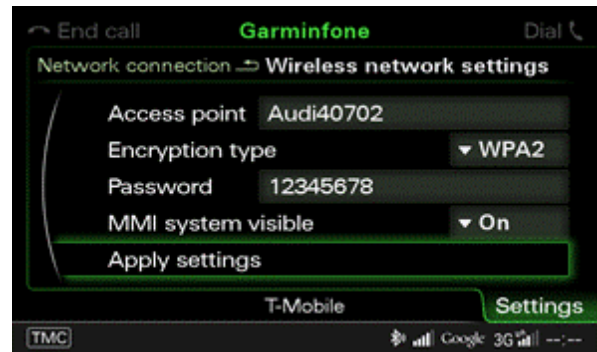
Figure 2. Wireless network settings.

- Record all settings so they can be re-entered at the end of the procedure. As part of the update, wireless settings and paired devices will be deleted. All devices will need to be bonded again after the update, and all wireless settings restored to the customer's settings. To access the Wireless Network Settings on the MMI (Figure 2), press *TEL >> Settings >> Wireless network connection >> Wireless network settings*.

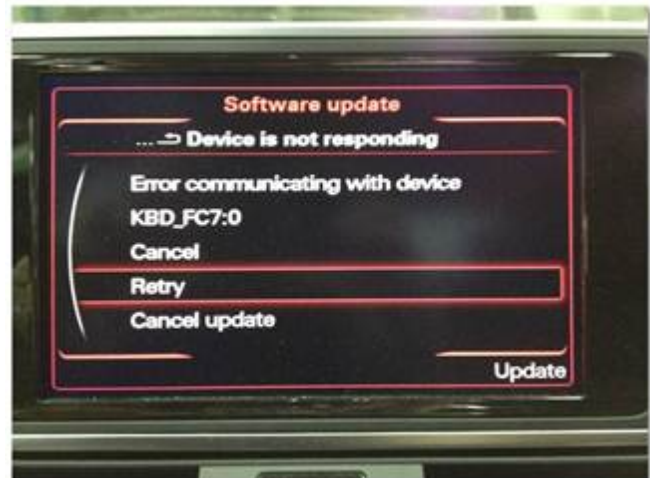
Certain modules in some earlier model year 2012 vehicles or in vehicles equipped with Bose sound systems may not update properly during Step 16 of TSB 2028141. If this occurs, choose either 'Cancel' (Figure 3), or 'Skip device' (Figure 4), depending on the type of error. Do *not* choose 'Cancel update', as this may cause the software update to fail entirely.

Figure 3. A device requiring a 'Cancel' selection.

After the update is finished and the summary page is shown, select 'Retry' at the bottom of the list (if it is available) to attempt to update the modules again. If 'Retry' is greyed out, then the software update was successful; select 'Continue' to proceed. In some cases, 'Retry' may need to be repeated two or three times to get all modules to update successfully.

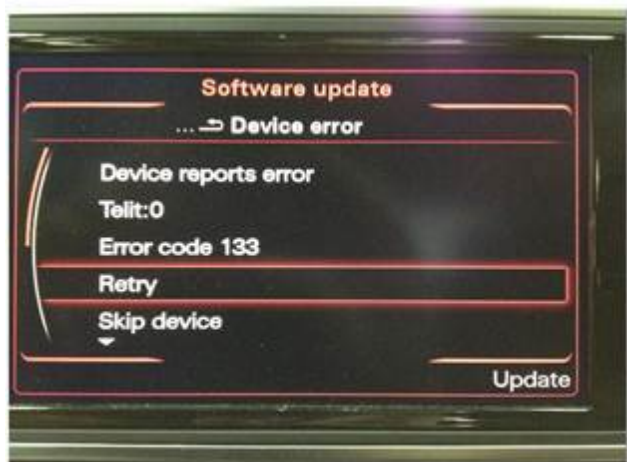
Figure 4. A device requiring a 'Skip device' selection.

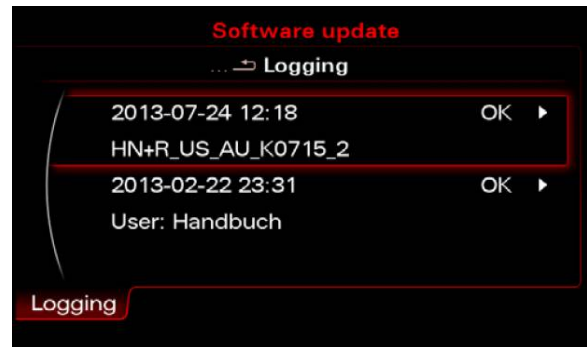
Figure 5. Software update log showing a successful software installation.

5. Verify that the software update has been completed successfully by accessing the logging page (Figure 5). To access this screen, proceed to step 8 in TSB 2028141 and press the lower left softkey. A successful update will show the date that the update was performed and the software that was installed (HN+R_US_AU_K0715_X), with 'OK' listed on the right. The 'X' may be one of several different numbers. If K0715_X does not have any rows with 'OK', the update must be retried until it is successful.

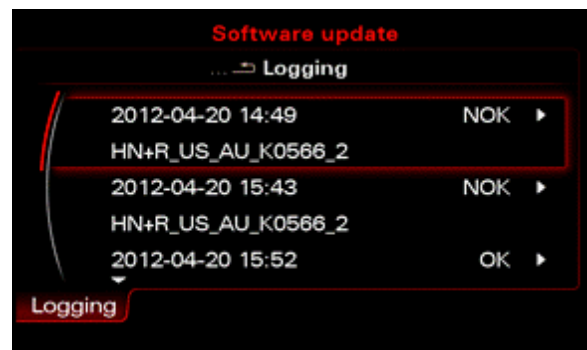
Figure 6. Software update log showing 2 failed attempts before a successful installation.

Tip: If the update must be performed two or more times due to modules not updating correctly, a screenshot of the software update log is required (Figure 6). This should be kept on-hand for warranty auditing purposes. To take a screenshot, insert an SD card into slot 1 and press and hold the left and right arrow keys at the same time. All four softkeys will flash when the screenshot is taken. A screenshot should be taken of each page in the logging display.
