Technical Service Bulletin

PSS 91 MMI 3G+ GPS location is inaccurate (MY14 & MY13)

91 14 53 2035919/3 July 24, 2014. Supersedes Technical Service Bulletin Group 91 number 14-41 dated April 30, 2014 for reasons listed below.

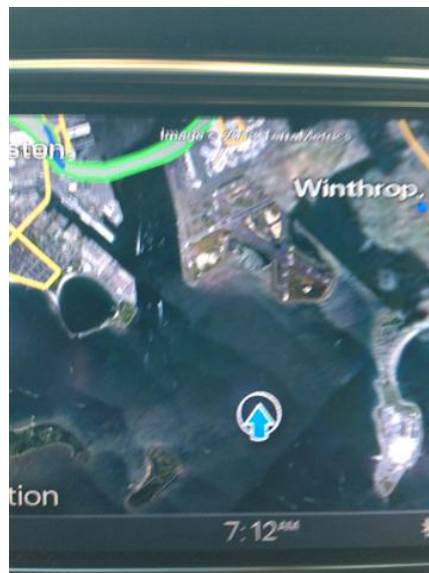
The vehicle is a model year 2013 vehicle and TSB 2036607: *91 MMI3G+ Navigation GPS Location is inaccurate*, has been completed. The GPS location or vehicle direction indicated on the navigation map does not match the vehicle's actual location or direction of travel (Figure 1).

Figure 1. GPS location incorrect.

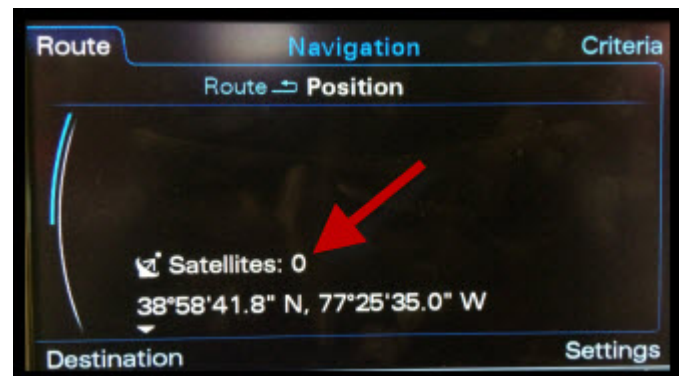
To view the number of satellites being received, go to *Nav >> Route >> Current Position (first item in list) >> Scroll up (Figure 2)*. If the system does not receive any satellites during this timeframe, submit a Technical Assistance Center ticket.

Figure 2. Number of satellites received.
