Technical Service Bulletin

91 MIB Infotainment system cannot be turned on, or sporadic concerns

91 14 57 2038073/1 August 11, 2014.

Model(s)	Year	VIN Range	Vehicle-Specific Equipment
A3	2015	All	Not Applicable

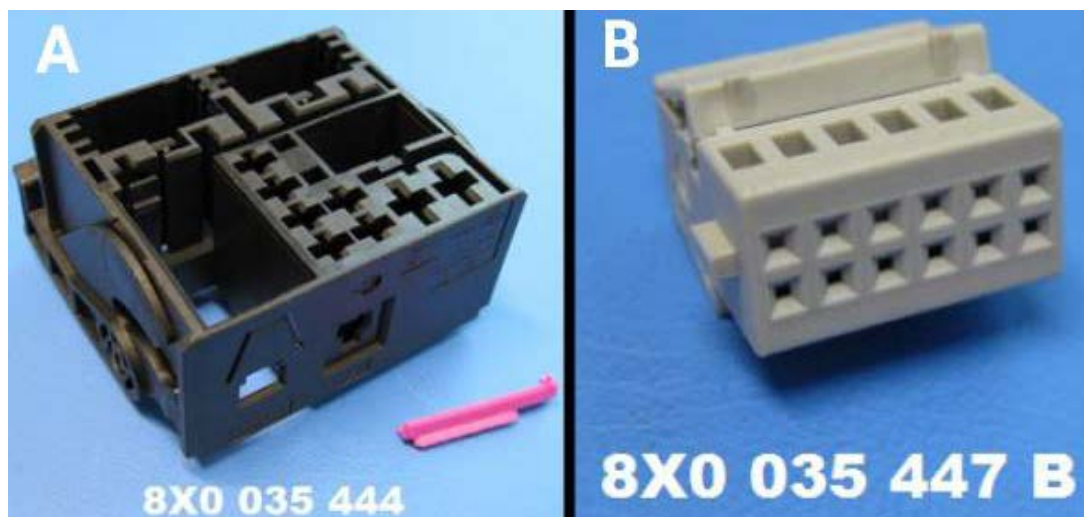
The grey 12-pin flat contact lock (Figure 1, B) is not correctly slotted in the quad lock housing (Figure 1, A).

Figure 1. Quad lock housing (A) and 12-pin flat contact lock (B).

4.
 - If the grey 12-pin flat contact lock is correctly slotted into the quad lock, this TSB does not apply. Continue diagnosis outside of this bulletin.
 - If the grey 12-pin flat contact lock is not (and cannot be) correctly slotted into the quad lock, replace both the quad lock and the grey 12-pin flat contact lock.
5. Make sure that all contacts and locks are in the correct position.

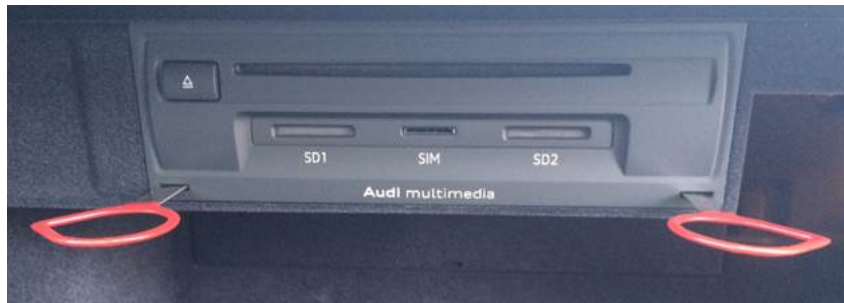
Figure 2. Remove the J794 module.

1. Perform GFF to confirm that both **DTC U111000** and **DTC U006500** are found. If both faults are not found, this TSB does not apply. Continue diagnosis outside of this bulletin.
2. If both faults are found, open the glove box and remove the information electronics control module 1 (J794) (Figure 2).

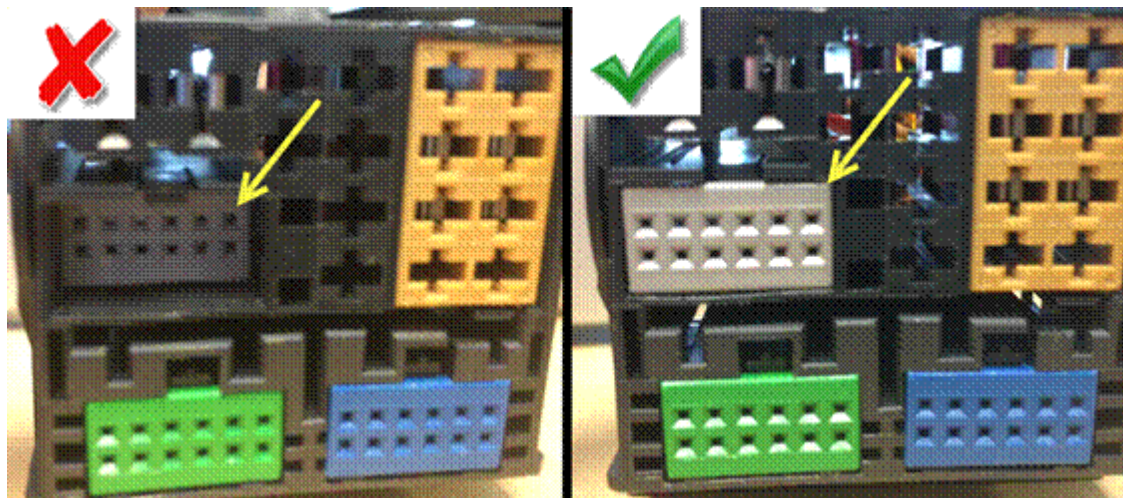
Figure 3. Grey 12-pin flat contact lock incorrectly slotted (left) and correctly slotted (right).

3. Remove the quad lock. Check the grey 12-pin flat contact lock to see if it is correctly slotted in the flat contact housing (Figure 3).
