# Technical Service Bulletin

## 91 Navigation plus (RNS-E) poor AM reception

91 14 65 2037125/2 October 3, 2014. Supersedes Technical Service Bulletin Group 91 number 14-43 dated May 2, 2014 for reasons listed below.

Model(s)	Year	VIN Range	Vehicle-Specific Equipment
TT	2014 - 2015	All	Radio Navigation (RNS-E)

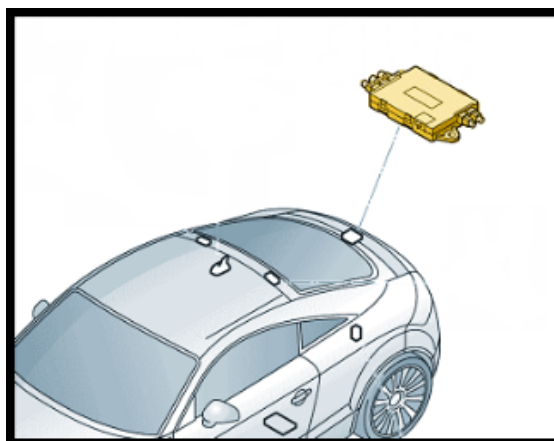
The poor AM radio reception is due to an internal hardware issue of aerial amplifier 2 –R111- (Figure 1). All service parts have been checked and faulty parts were cleared out of stock.

Figure 1. Aerial amplifier 2 -R111-.

4. Remove the aerial amplifier 2 –R111- according to the Elsa repair manual (*Electrical System*>>91 *Communication*>>*Removal and Installation*>>*Antenna Systems*>>*Antenna Amplifier 2 R111*).

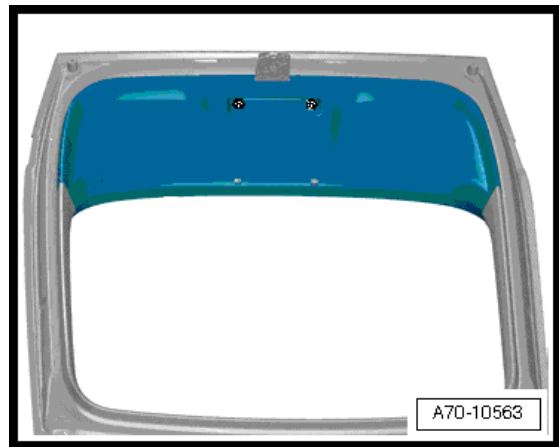
Figure 2: TT Coupe rear lid trim.

Remove the rear lid lower trim panel (Figure 2) according to the Elsa repair manual (*Body>>Body Interior>>70 Interior Trim>>Removal and Installation>>Luggage Compartment Trim Panels>>Rear Lid Lower Trim Panel*).

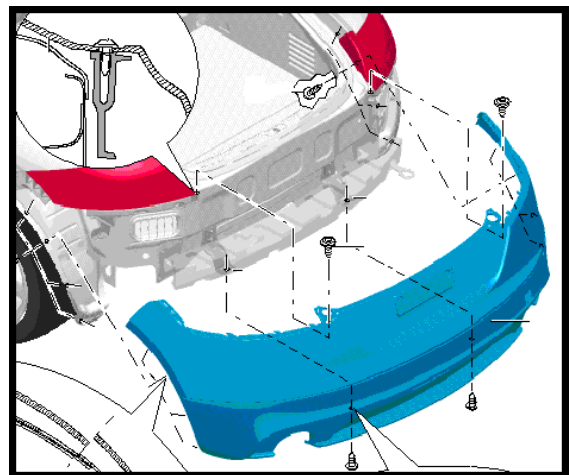
Figure 3: TT Roadster rear bumper cover.

Remove the rear bumper cover (Figure 3) according to the Elsa repair manual (*Body>>Body Exterior>>63 Bumpers>>Removal and Installation>>Rear Bumper Cover*).

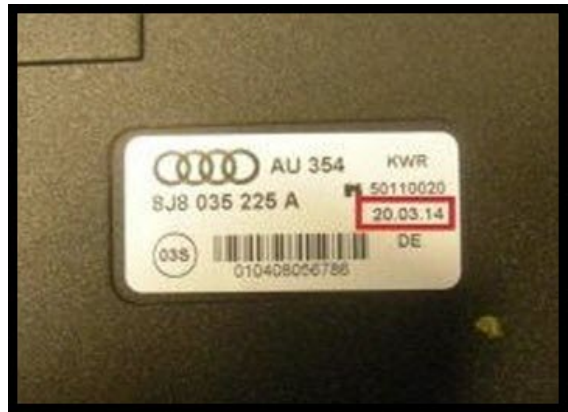
3. Check the manufacturing date shown on the part label of the aerial amplifier. Note the date format is: DD.MM.YY (Figure 4).
  - **If the manufacturing date *is* between 12.07.13 (July 12, 2013) and 21.03.14 (March 21, 2014):**  
The aerial amplifier needs to be replaced. Proceed to the next step.
  - **If the manufacturing date *is not* between 12.07.13 (July 12, 2013) and 21.03.14 (March 21, 2014):**  
This TSB does not apply. Continue with diagnosis.

**Figure 4:** Manufacturing date on the aerial amplifier part label.
