Technical Service Bulletin

94 Rear side marker light inoperative in lower rear bumper (DTC 02911, 02912)

94 14 37 2029782/3 April 7, 2014. Supersedes Technical Service Bulletin Group 94 number 12-95 dated October 25, 2012 for reasons listed below.

Model(s)	Year	VIN Range	Vehicle-Specific Equipment
Q5	2010 - 2013	All	Not Applicable

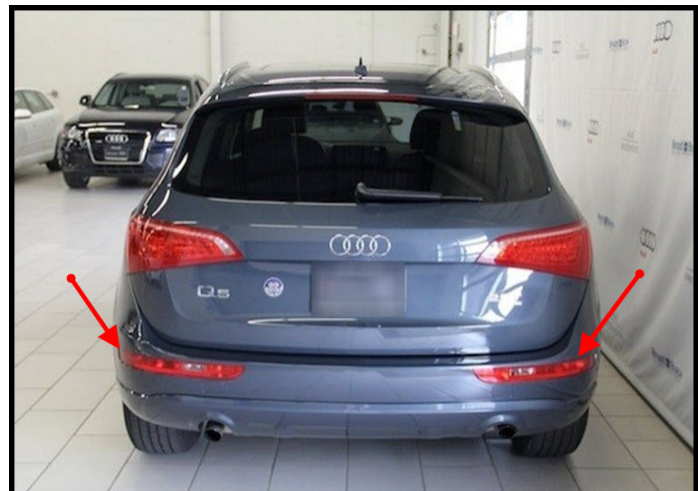
- A “bulb out” warning is displayed in the driver information system.
- One or both of the rear side marker lights (M37 and/or M38 bulbs) is burnt out (Figure 1).
- One or both of the following DTCs is stored in the comfort system central control module, J393 (address word 46):
 - **DTC 02911:** Left Rear Side Marker Lamp - M37 -- Electrical fault in circuit
 - **DTC 02912:** Right Rear Side Marker Lamp - M38 -- Electrical fault in circuit

Figure 1. Rear side marker lights.

- Moisture and debris may enter into the lower taillight housing and cause one or more of the bulbs to burn out.
- The GE brand side marker bulbs (used in production from approximately February 2011 through September 2012) are prone to failure.

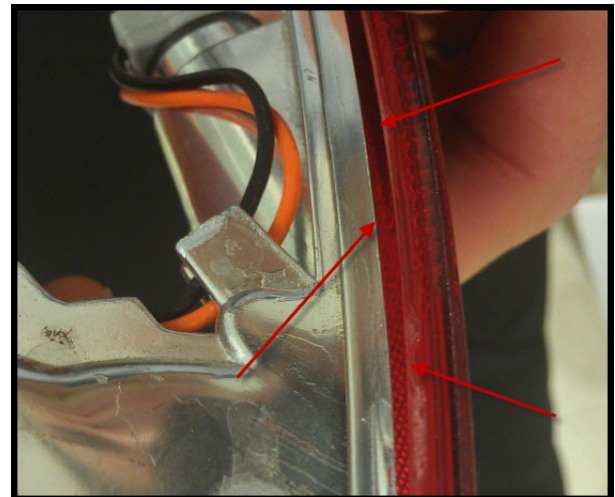
1. Before proceeding, visually inspect both lower taillight housings on the vehicle to ensure there is no damage due to outside influence. If damage due to outside influence is found, do not proceed with this bulletin.
2. Uninstall both lower rear taillight housings.
3. Inspect the lens for any separation around the red reflecting edge of the taillight lens (Figure 2). Areas of the seam that have separated will appear more opaque and be a different shade of red than the rest of the seam.

Figure 2. Taillight lens separation.

4. If any separation is found, replace the complete taillight housing.
Re-use any good bulbs and wiring; only replace burnt-out bulbs. Wipe the bulbs with alcohol before installing, and ensure that they are free of any dirt, grease, oil from hands, etc.
5. Inspect the bulb holders for corrosion and debris. Repair and clean as necessary.
