Technical Service Bulletin

94 Daytime running light (DRL) inoperative (DTC 02895 or 02897)

94 14 43 2032184/4 June 9, 2014. Supersedes Technical Service Bulletin Group 94 number 14-38 dated April 7, 2014 for reasons listed below.

Model(s)	Year	VIN Range	Vehicle-Specific Equipment
Q5	2013 - 2015	All	Audi xenon plus daytime running lights with LED

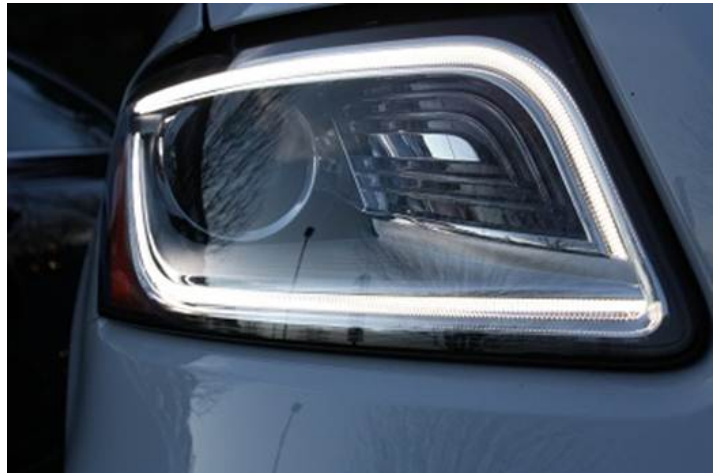
The MY2013+ Audi Q5 LED DRLs use light-emitting “pipes” or “guides” instead of multiple, individual LEDs. There are two light pipes per headlight. Each light pipe uses a single LED for illumination (Figure 1).

Figure 1. Upper and Lower light pipes illuminated.

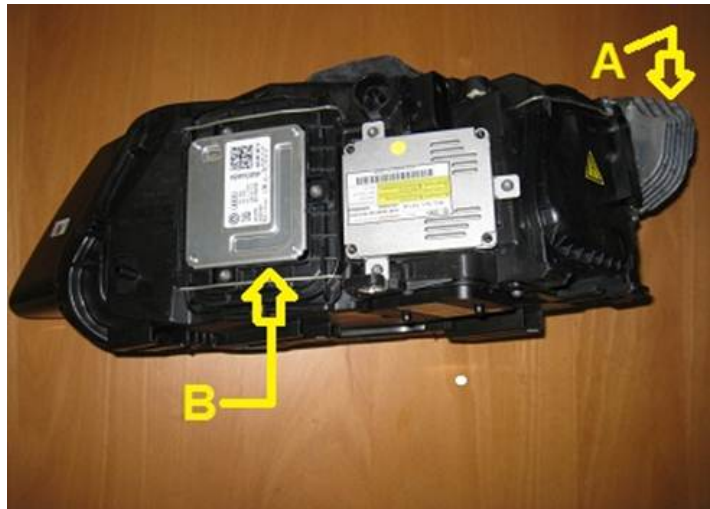
The LEDs with heatsinks are contained in a single module (Figure 2, A) mounted to the outer backside of each headlight.

Figure 2. Backside of headlight with LED heat sink (A) and LED control module (B).

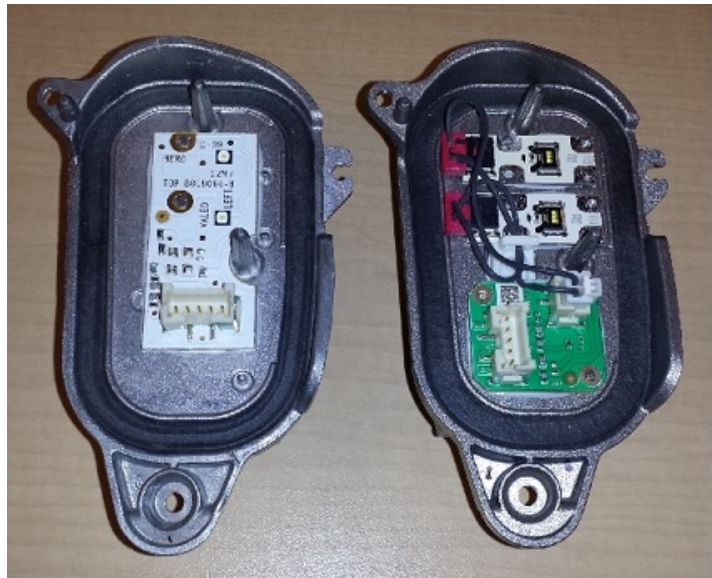
As of March 12th, 2013 production, the LED unit with heat sink has been updated (Figure 3). If a failure occurs, these parts do *not* need to be replaced in pairs.

Figure 3. Current (left) and early (right) style LED DRL units.

The appearance of the replacement part for the LED DRL has changed, but functionality is the same. If an LED DRL needs to be replaced, they do not need to be replaced as a pair.

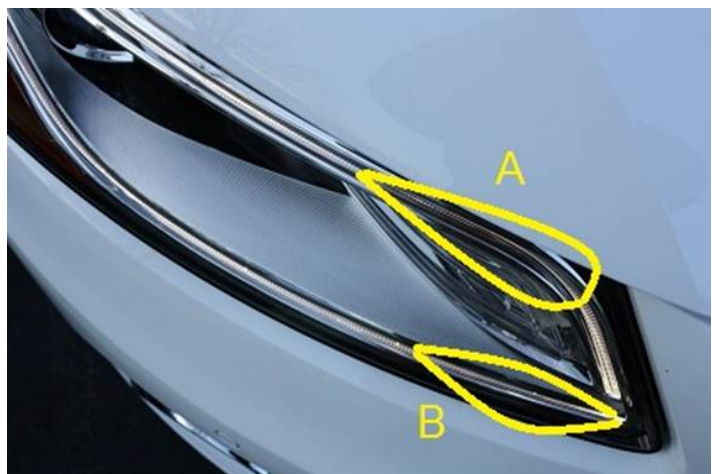
- A defect may be perceived for top-down viewing angle (Figure 4).

Figure 4. Upper light pipe perceived defect (A). Lower light pipe perceived defect (B).

Explain to the customer that the LED illumination appears differently to someone standing in front of the vehicle than it appears to oncoming traffic. The viewing angle of someone standing in front of the vehicle will give a visual effect of an LED DRL inoperative or partially-inoperative condition.

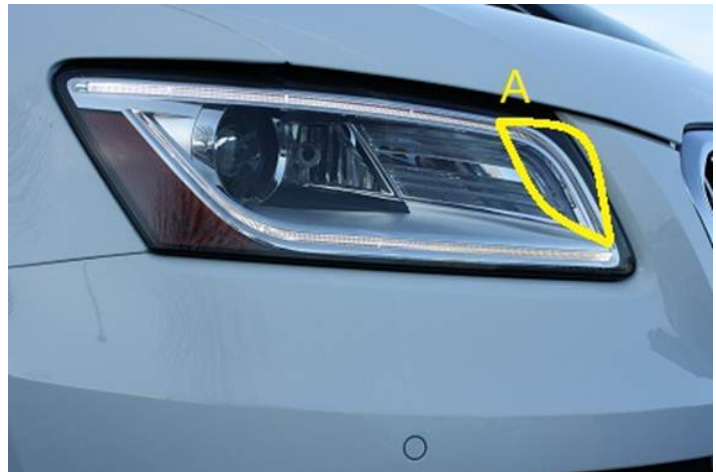
- A defect may be perceived for corner viewing angle (Figure 5).

Figure 5. Upper light pipe perceived defect (A).

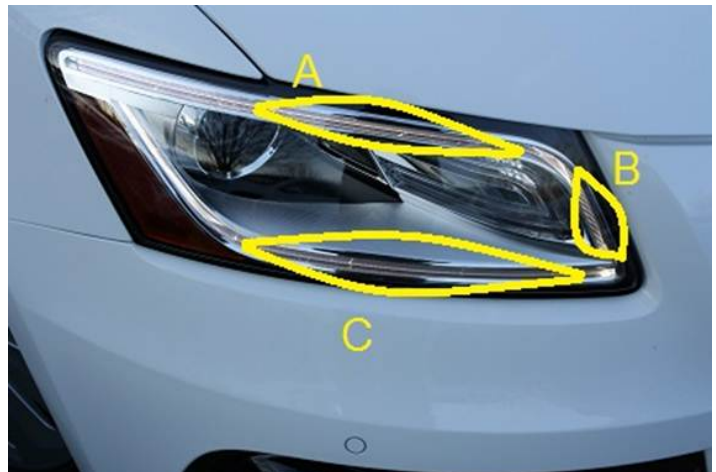
- A defect may be perceived for acute corner viewing angle (Figure 6).

Figure 6. Upper light pipe perceived defect (A, B). Lower light pipe perceived defect (C).

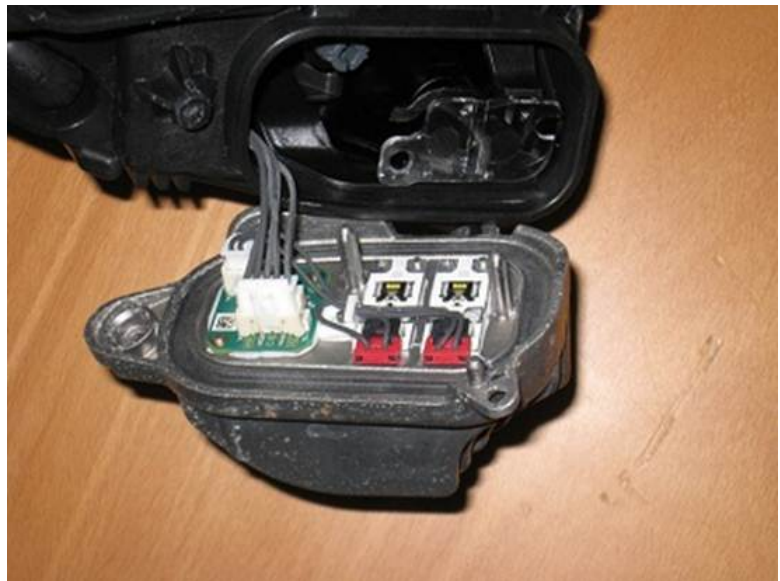
Figure 7: Dual surface mount LED unit exposed.

1. With ignition off, remove DRL control module and check red connector at module. Secure it, if loose. If necessary, remove red connector and reinstall to be sure connector is engaged properly. The wiring harness guide of the red terminal housing may impede connector engagement.
2. Turn ignition on to see if DRL is now operating to specifications. If it is not, proceed to step 3.
3. Remove headlight(s) according to the instructions in ElsaWeb. See *Repair Manual >> Electrical System >> Electrical Equipment >> 94 Exterior Lights, Switches >> Removal and Installation*.
4. With ignition off, remove LED DRL unit with heat sink from headlight housing (Figure 7).
5. With ignition off, inspect and secure all electrical connectors, if loose. Remove and secure the white connectors, even if they do not appear to be loose.

Be extra careful with red surface mount connectors. In general, a repair kit is not available for any internal headlight connectors.
