# Technical Service Bulletin

## 94 Headlight internal diagnosis before replacement, various concerns

94 14 49 2038058/1 August 11, 2014.

Model(s)	Year	VIN Range	Vehicle-Specific Equipment
A6	2011 - 2015	All	Not Applicable

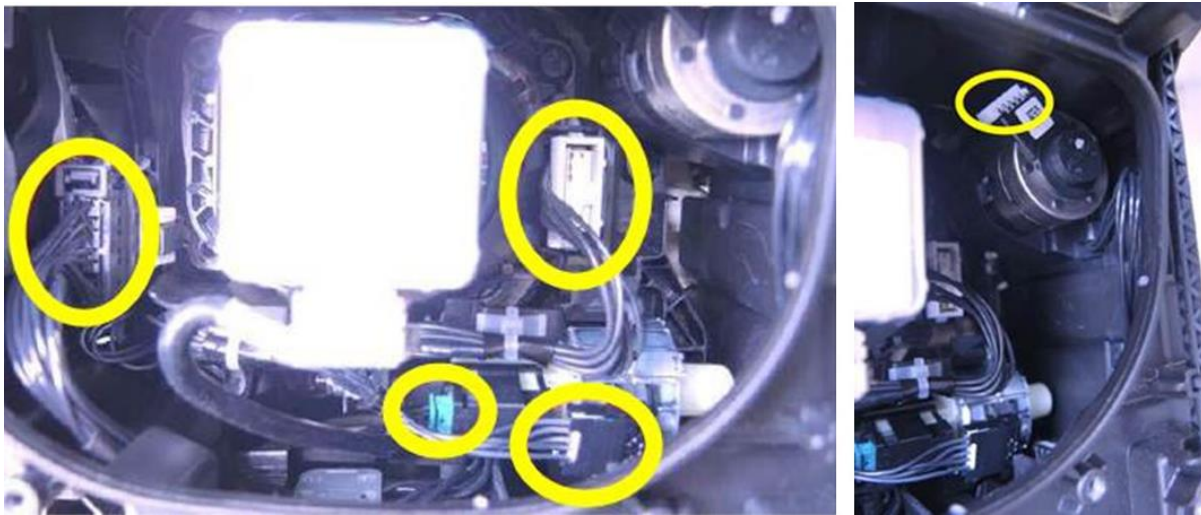
- If the vehicle is equipped with one of the following PR codes, check the connectors shown below (Figure 1):
  - **8Q3** (Automatic headlight-range adjustment dynamic (self-adjusting while driving))
  - **8Q5** (Headlight-range adjustment automatic/dynamic with dynamic bending light(AFS 1))
  - **8Q7** (Headlight-range adjustment).

**Figure 1.** Check these connectors on vehicles with PR codes 8Q3, 8Q5, and 8Q7.

3. If any connectors are not correctly plugged in, check connector for damage. If no damage is found, reconnect the connector. Do not use a screwdriver or other metal object. If all connectors were plugged in correctly, this bulletin does not apply.
4. Reconnect the headlight to the vehicle, then check the headlight operation. It is not necessary to fully install the headlight to test the headlight operation.
5. If headlight operation is fully restored, fit and adjust the headlight. Additional adaptations (radar sensor, overhead camera, night vision) may be necessary, depending on vehicle equipment.

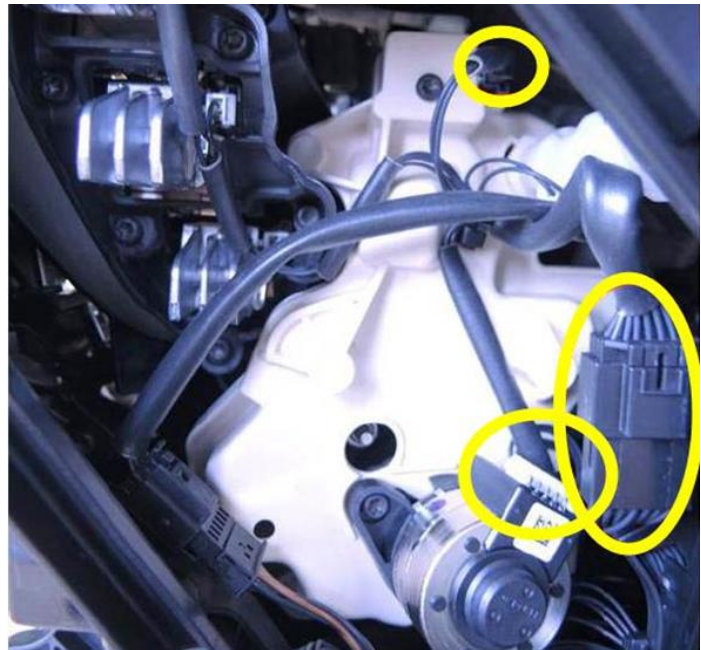
- If the vehicle is equipped with one of the following PR codes, check the connectors shown at right (Figure 2):
  - **8EX** (LED headlights)
  - **8EY** (LED headlights)

**Figure 2.** Check these connectors on vehicles with PR codes 8EX and 8EY.

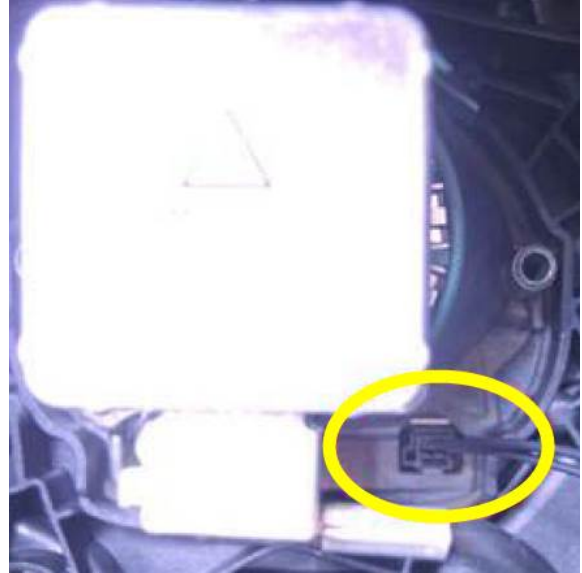
- If the vehicle is equipped with one of the following PR codes, check the connector at high beam shutter shown at right (Figure 3):
  - **8Q3** (Automatic headlight-range adjustment dynamic (self-adjusting while driving))
  - **8Q5** (Headlight-range adjustment automatic/dynamic with dynamic bending light(AFS 1))

**Figure 3.** Check this connector (connector at high beam shutter) on vehicles with PR codes 8Q3 and 8Q5.

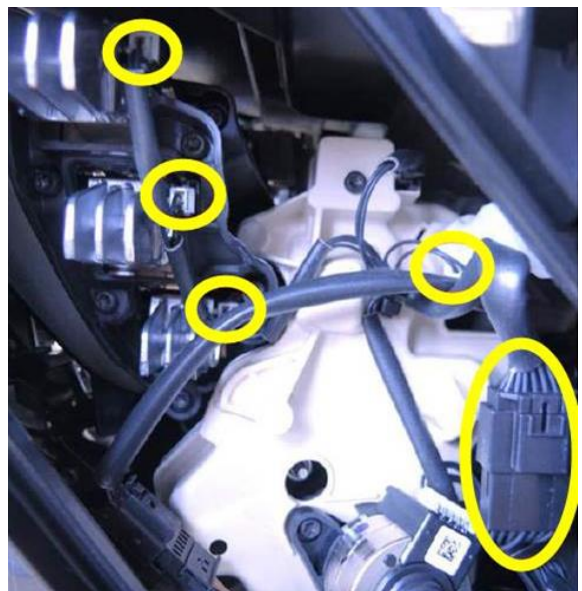
- If the vehicle is equipped with one of the following PR codes, check the connectors shown at right (Figure 4):
  - **8EX** (LED headlights)
  - **8EY** (LED headlights)

**Figure 4.** Check these connectors on vehicles with PR codes 8EX and 8EY.
