Technical Service Bulletin

94 Headlight internal diagnosis before replacement, various concerns

94 14 55 2038649/1 October 15, 2014.

Model(s)	Year	VIN Range	Vehicle-Specific Equipment
Q7	2010 - 2016	All	Not Applicable

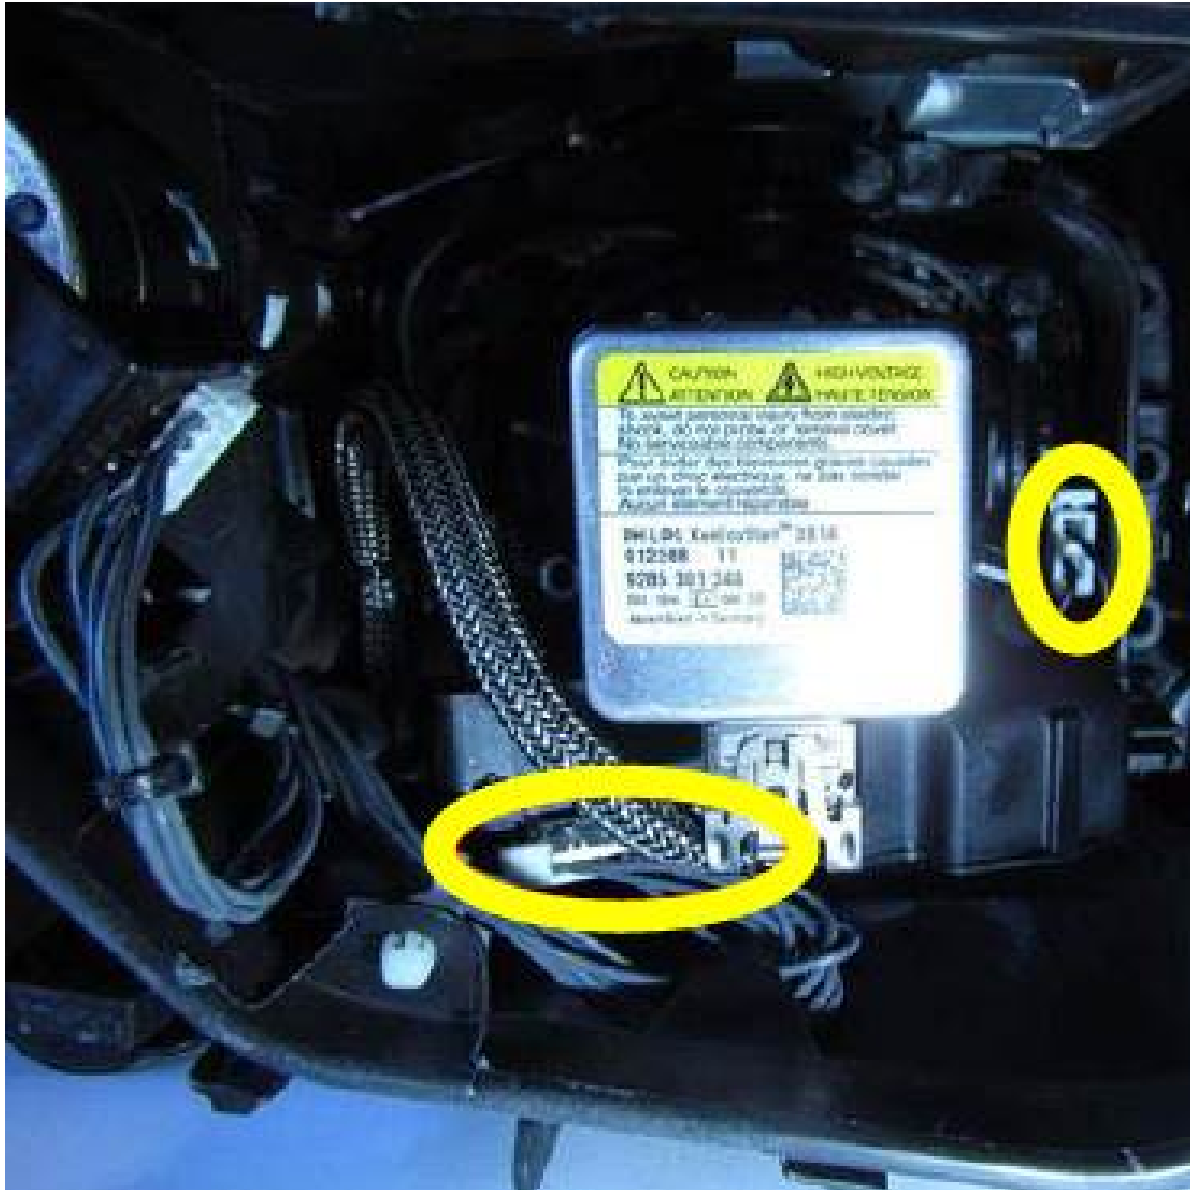
Connector in the headlight is not properly seated.

For symptom B (Xenon high beam inoperative):

Figure 2. Check these connectors.

3. If any connectors are not correctly plugged in, check connector for damage. If no damage is found, reconnect the connector. Do not use a screwdriver or other metal object. If all connectors were plugged in correctly, this bulletin does not apply.
4. Reconnect the headlight to the vehicle, then check the headlight operation. It is not necessary to fully install the headlight to test the headlight operation.
5. If headlight operation is fully restored, fit and adjust the headlight.

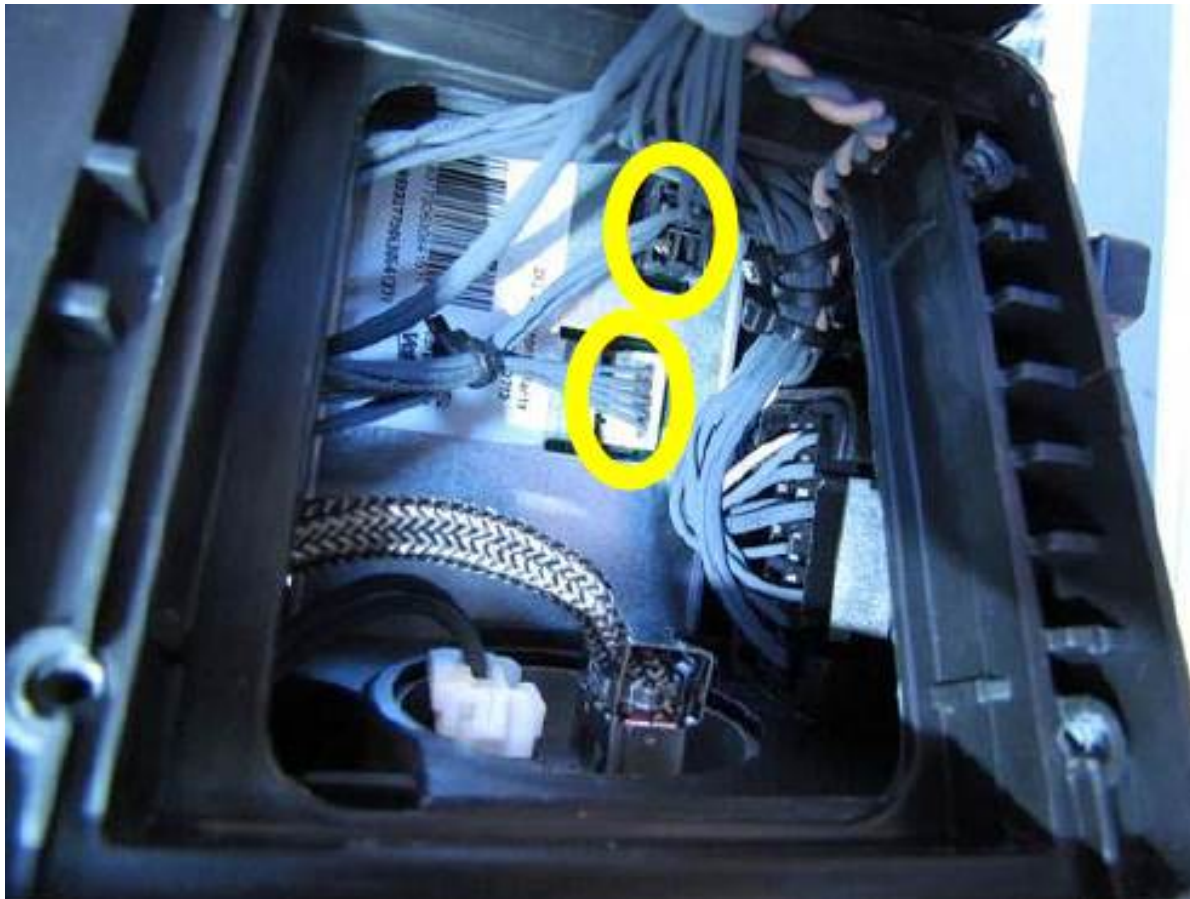
For symptom C (Daytime running light inoperative):

Figure 4. Check these connectors.
