Technical Service Bulletin

94 Headlight internal diagnosis before replacement, various concerns

94 14 56 2038727/1 October 16, 2014.

Model(s)	Year	VIN Range	Vehicle-Specific Equipment
A8	2010 - 2013	All	Not Applicable

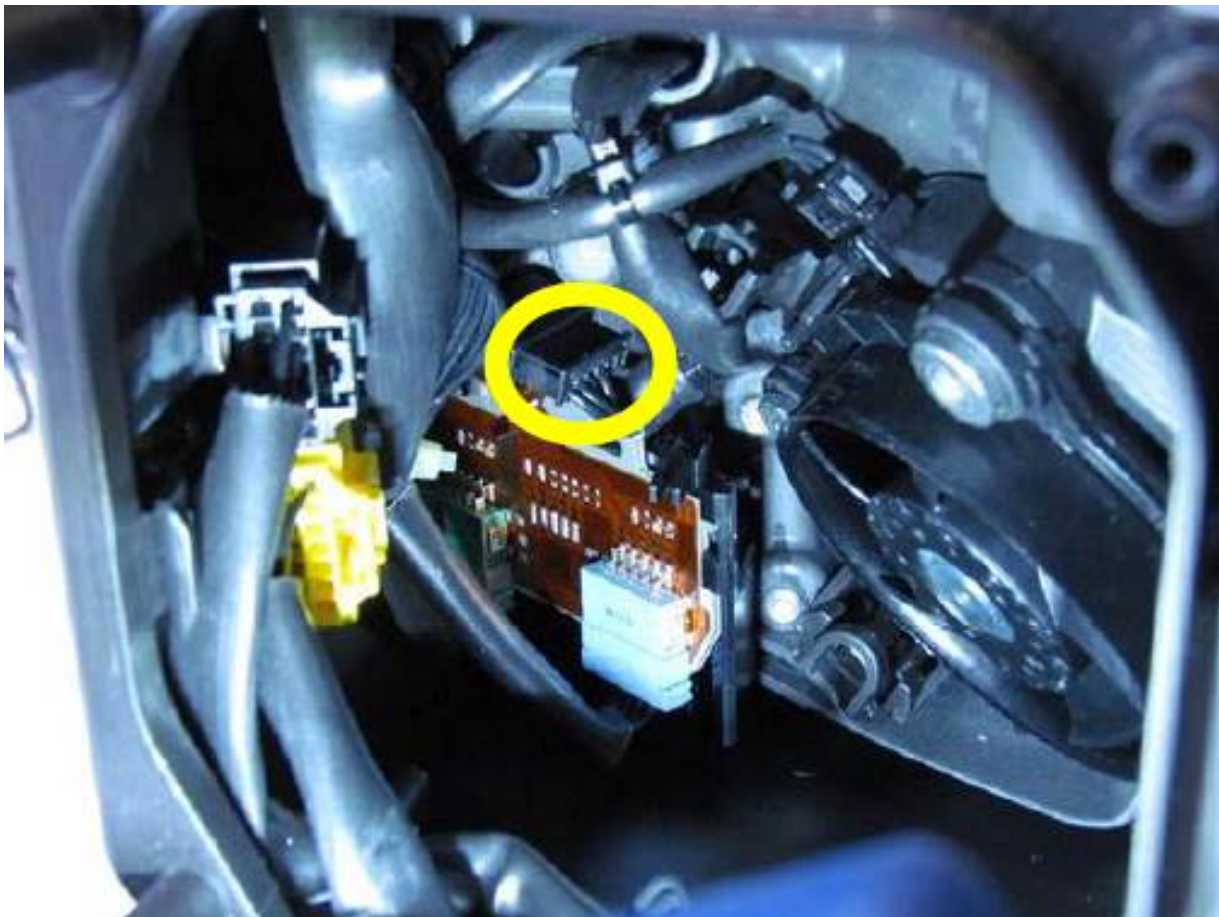
For symptom A (One or more LEDs in the low beam are inoperative on one side):

Figure 1. Check this connector.

3. If any connectors are not correctly plugged in, check connector for damage. If no damage is found, reconnect the connector. Do not use a screwdriver or other metal object. If all connectors were plugged in correctly, this bulletin does not apply.
4. Reconnect the headlight to the vehicle, then check the headlight operation. It is not necessary to fully install the headlight to test the headlight operation.
5. If headlight operation is fully restored, fit and adjust the headlight. Additional adaptations (radar sensor, Topview camera, night vision) may be necessary, depending on vehicle equipment.

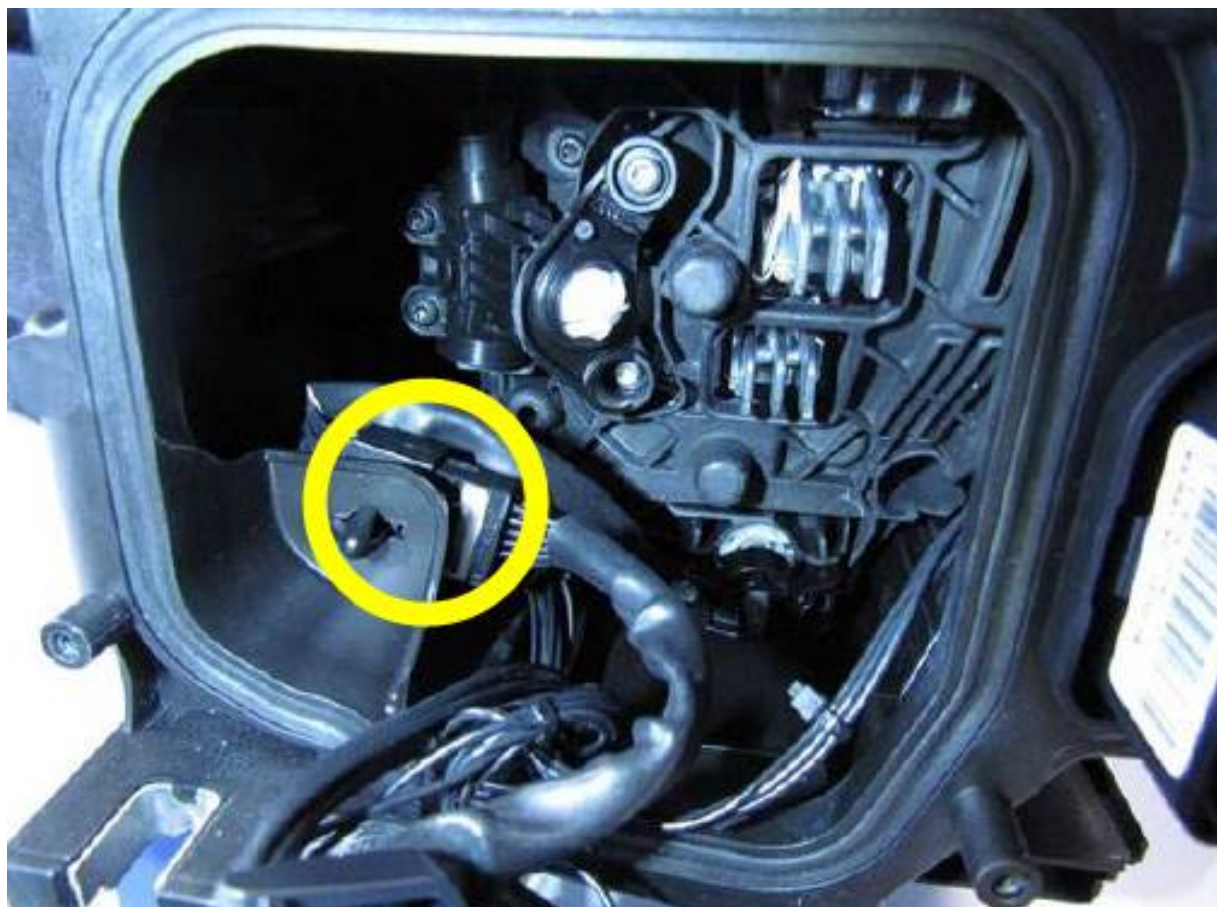
Figure 2. Check this connector.

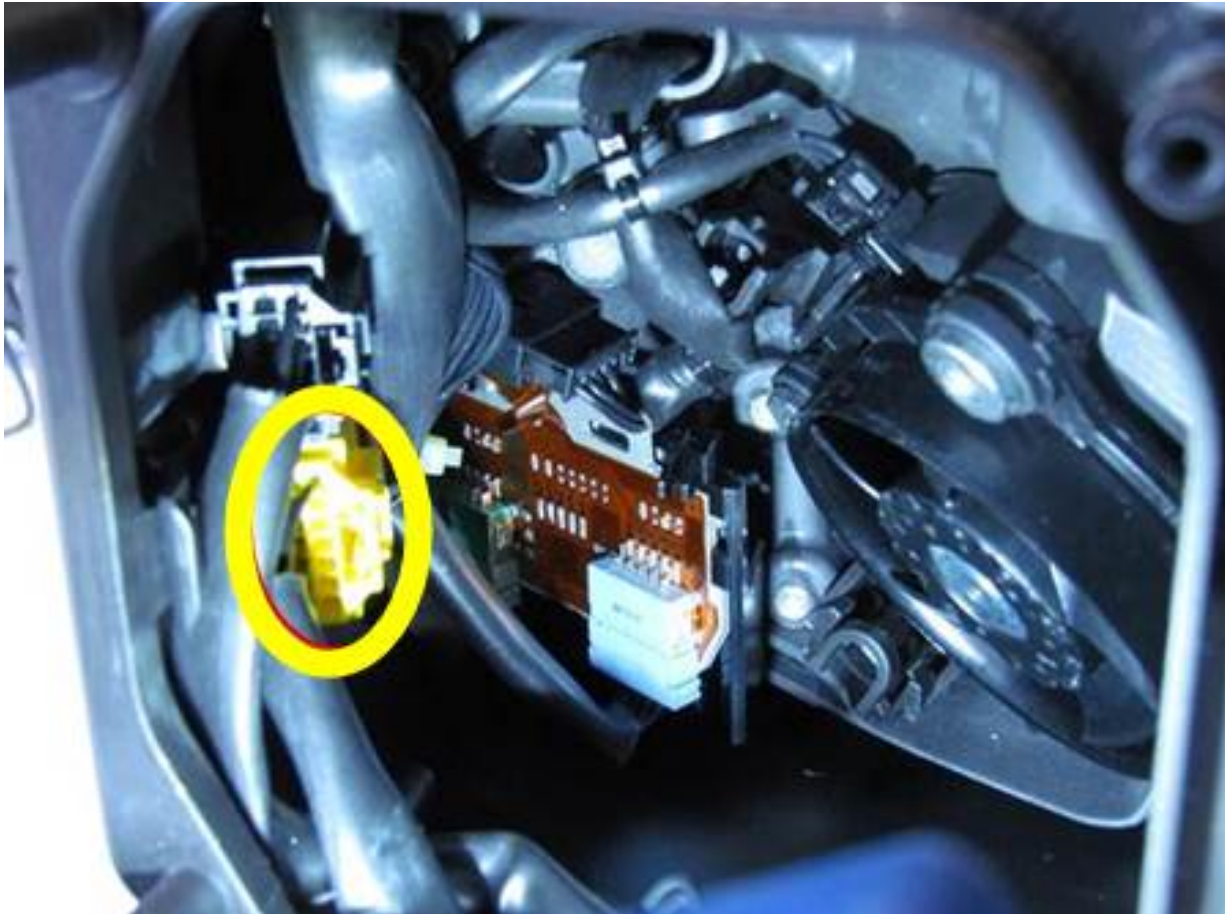
For symptom B (Internal cooling fan is inoperative in one headlight):

Figure 3. Check this connector.

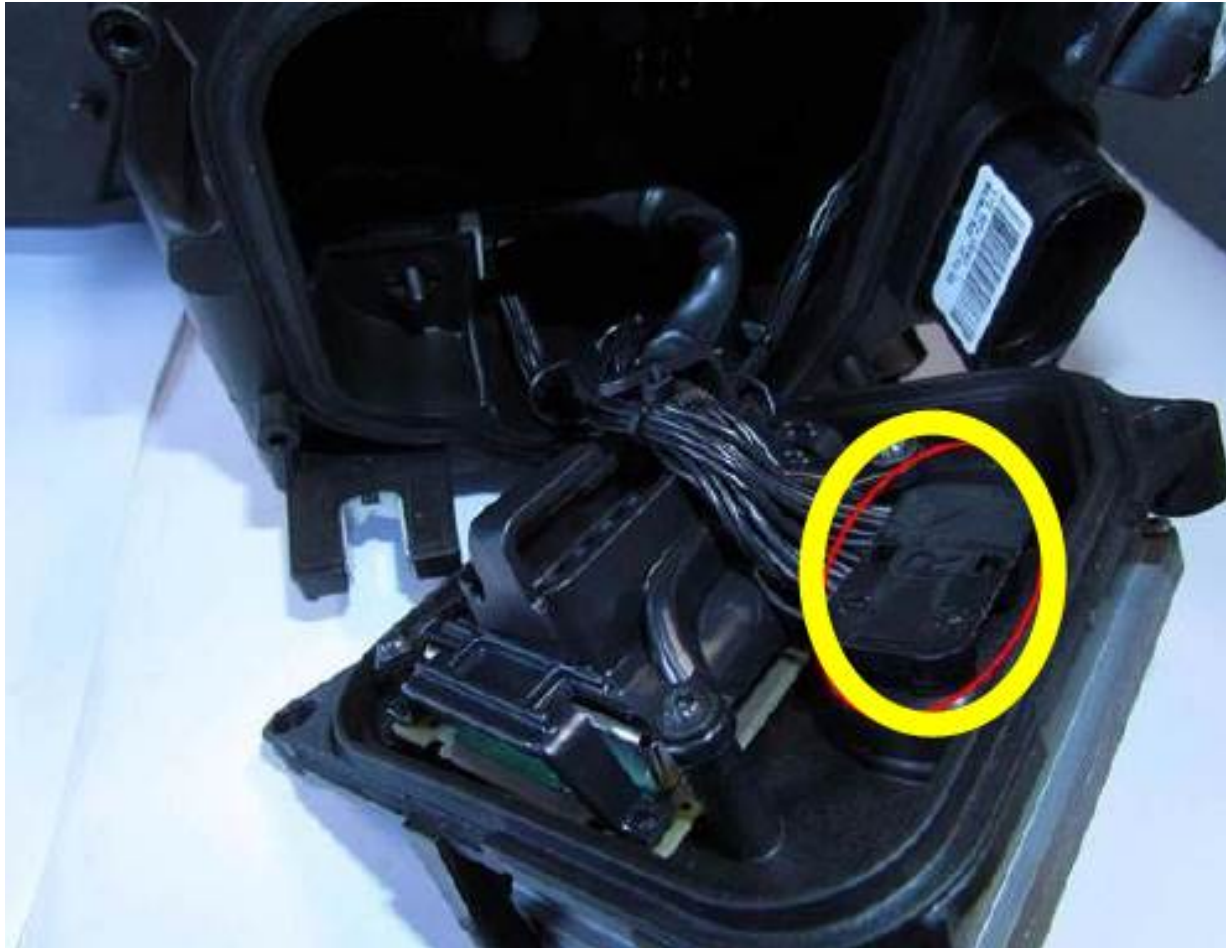
Figure 4. Check this connector.

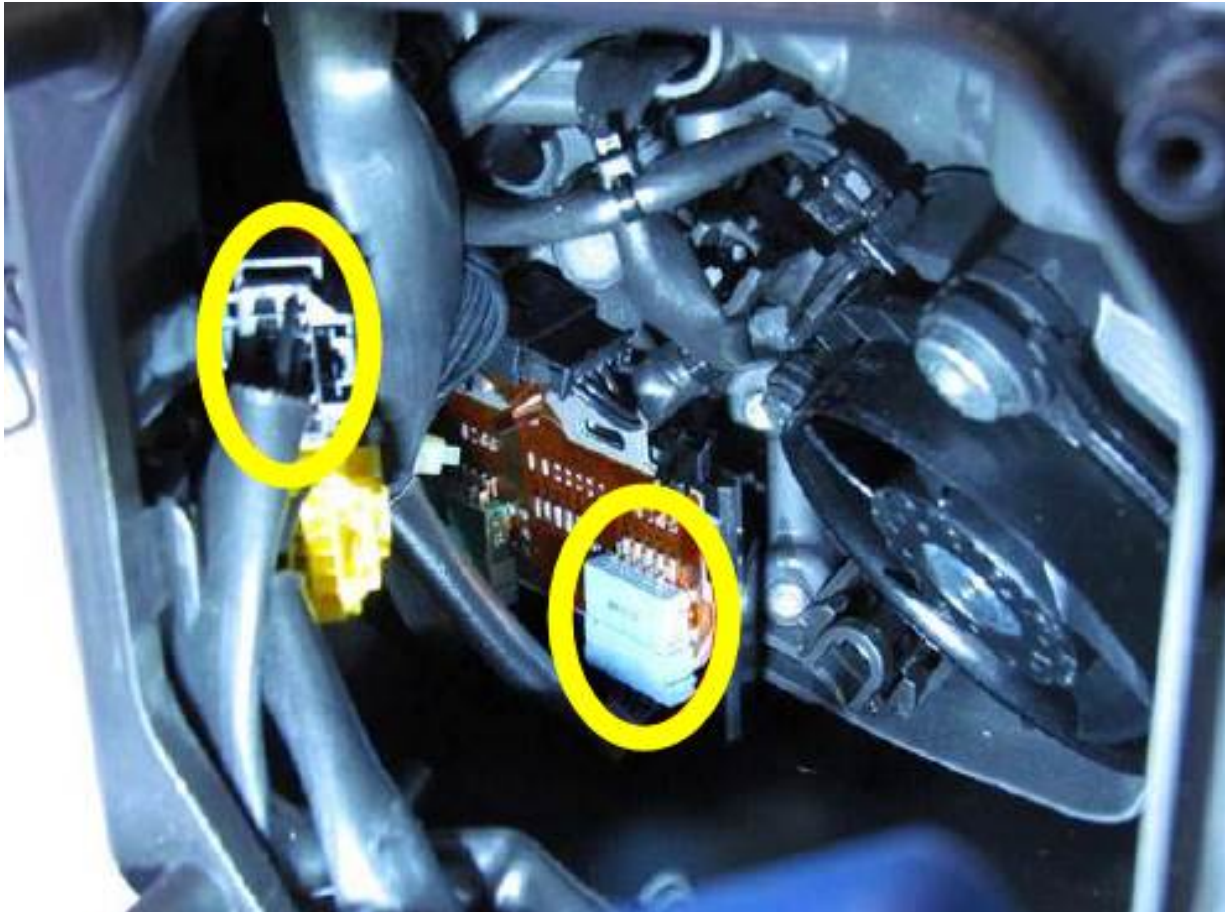
For symptom C (DRL inoperative on one side):

Figure 5. Check these connectors.

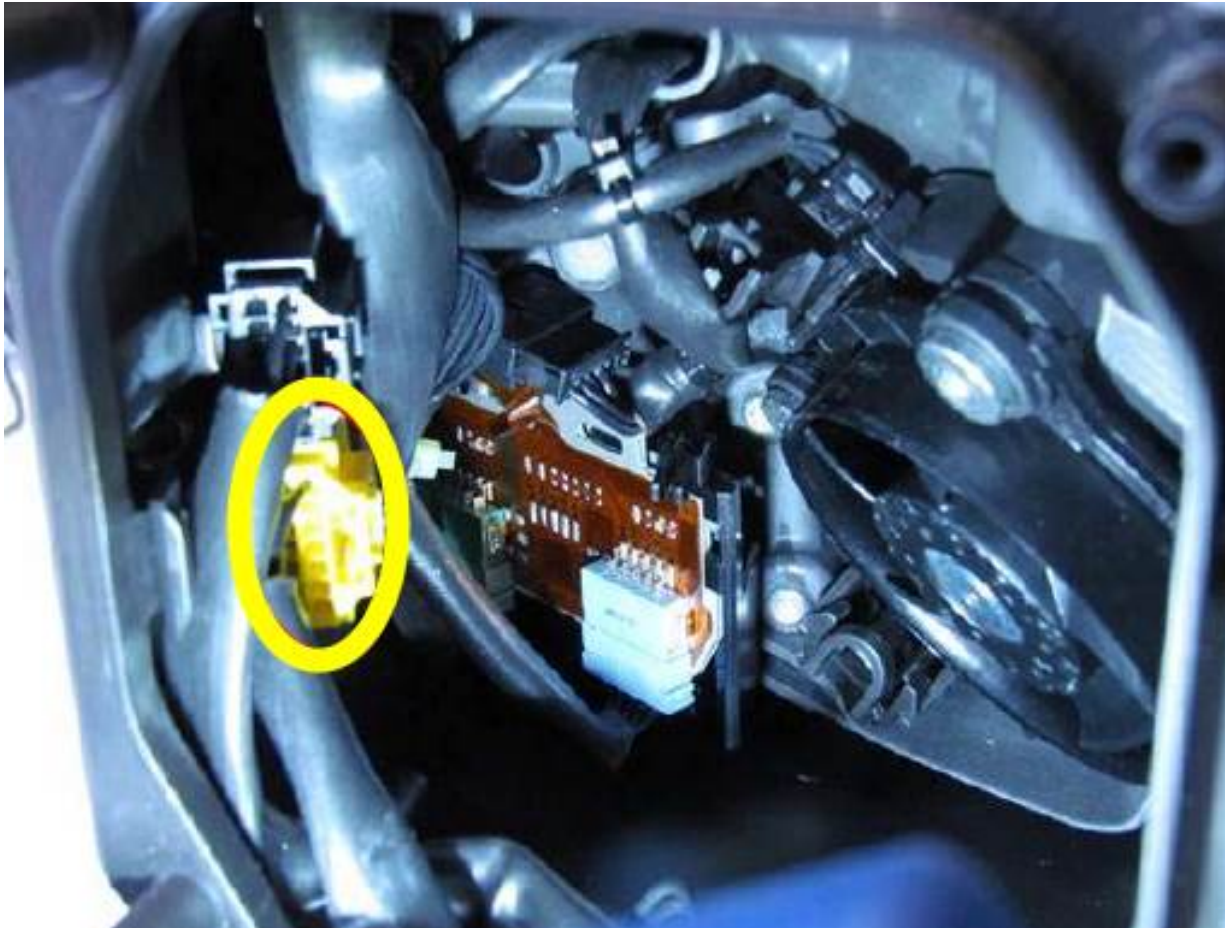
For symptom D (One or more LEDs in the high beam are inoperative on one side):

Figure 6. Check this connector.

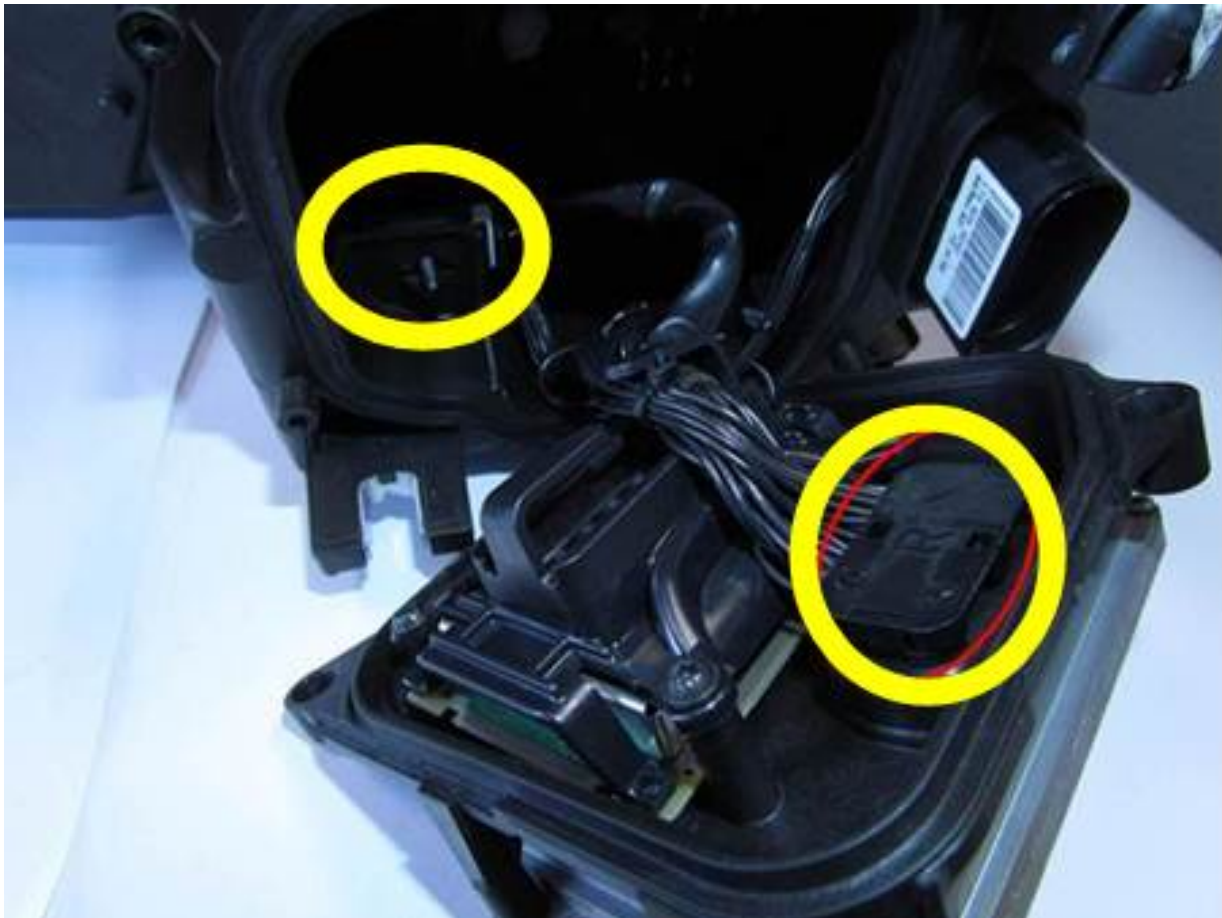
Figure 7. Check these connectors.

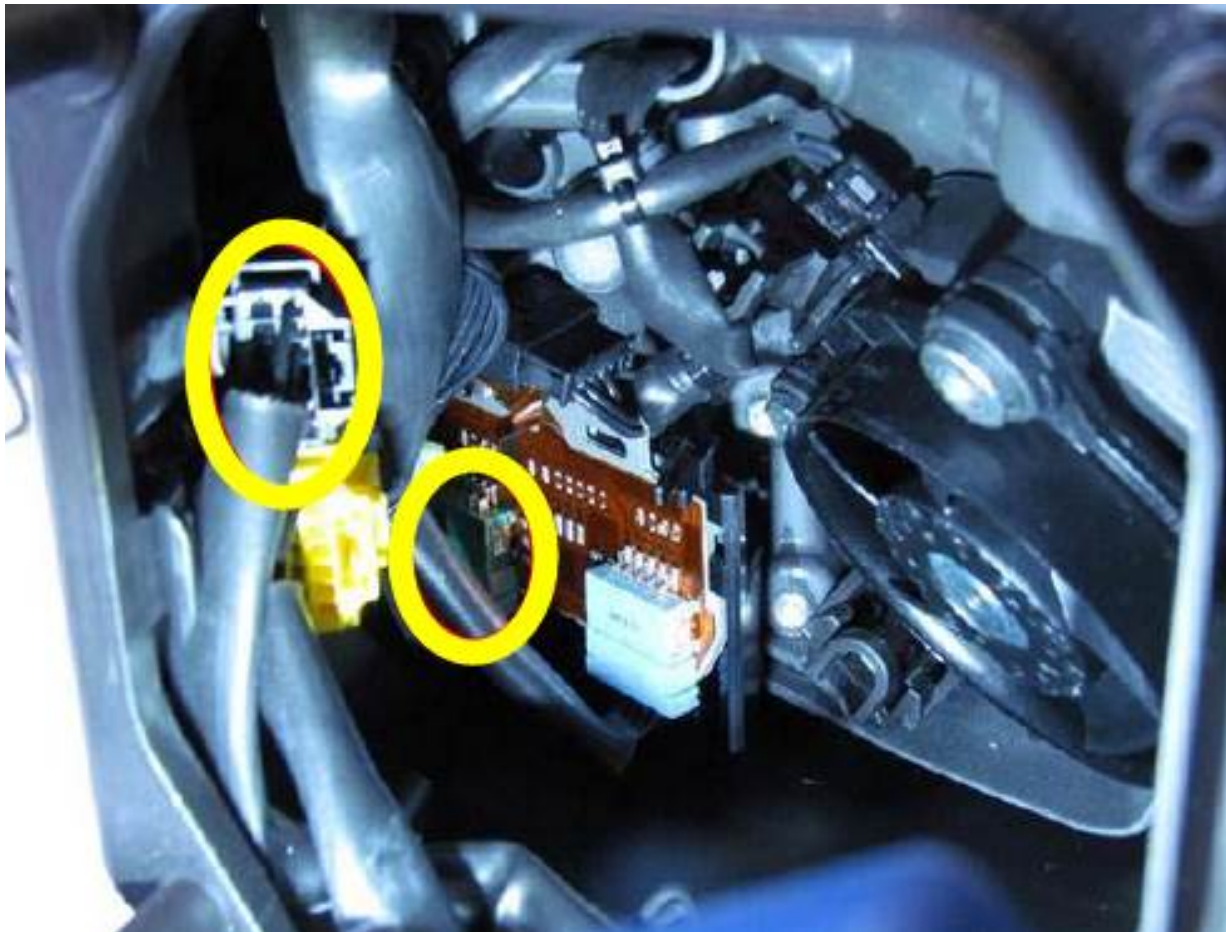
For symptom E (LED turn signal inoperative in one headlight):

Figure 8. Check these connectors.
