Technical Service Bulletin

94 Headlight internal diagnosis before replacement, various concerns

94 14 57 2038908/1 November 5, 2014.

Model(s)	Year	VIN Range	Vehicle-Specific Equipment
A8	2014 - 2016	All	Not Applicable

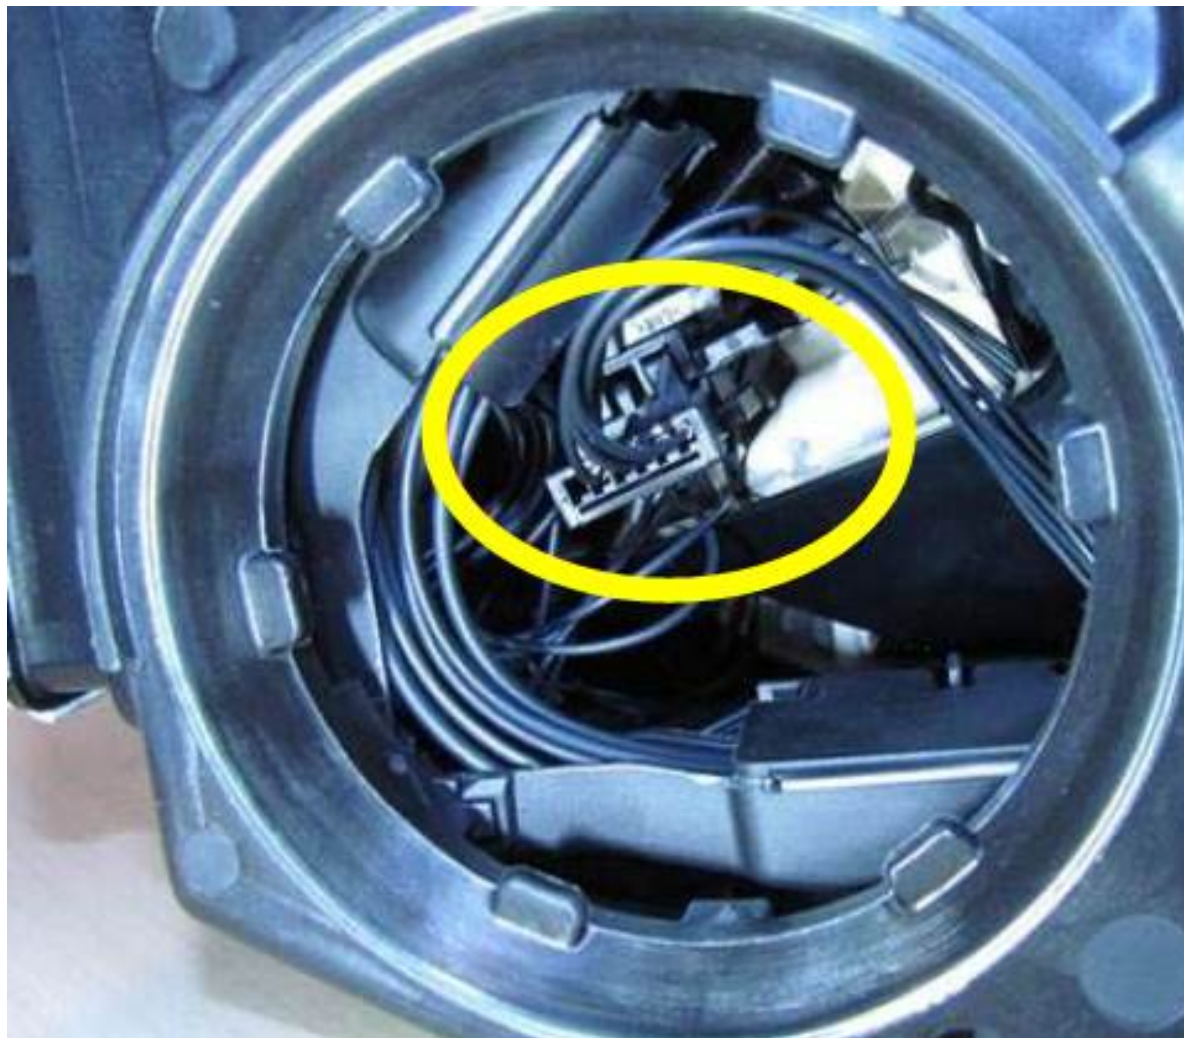
For symptom A (One or more LEDs in the low beam are inoperative on one side):

Figure 1. Check this connector.

3. If any connectors are not correctly plugged in, check connector for damage. If no damage is found, reconnect the connector. Do not use a screwdriver or other metal object. If all connectors were plugged in correctly, this bulletin does not apply.
4. Reconnect the headlight to the vehicle, then check the headlight operation. It is not necessary to fully install the headlight to test the headlight operation.
5. If headlight operation is fully restored, fit and adjust the headlight. Additional adaptations (radar sensor, Topview camera, night vision) may be necessary, depending on vehicle equipment.

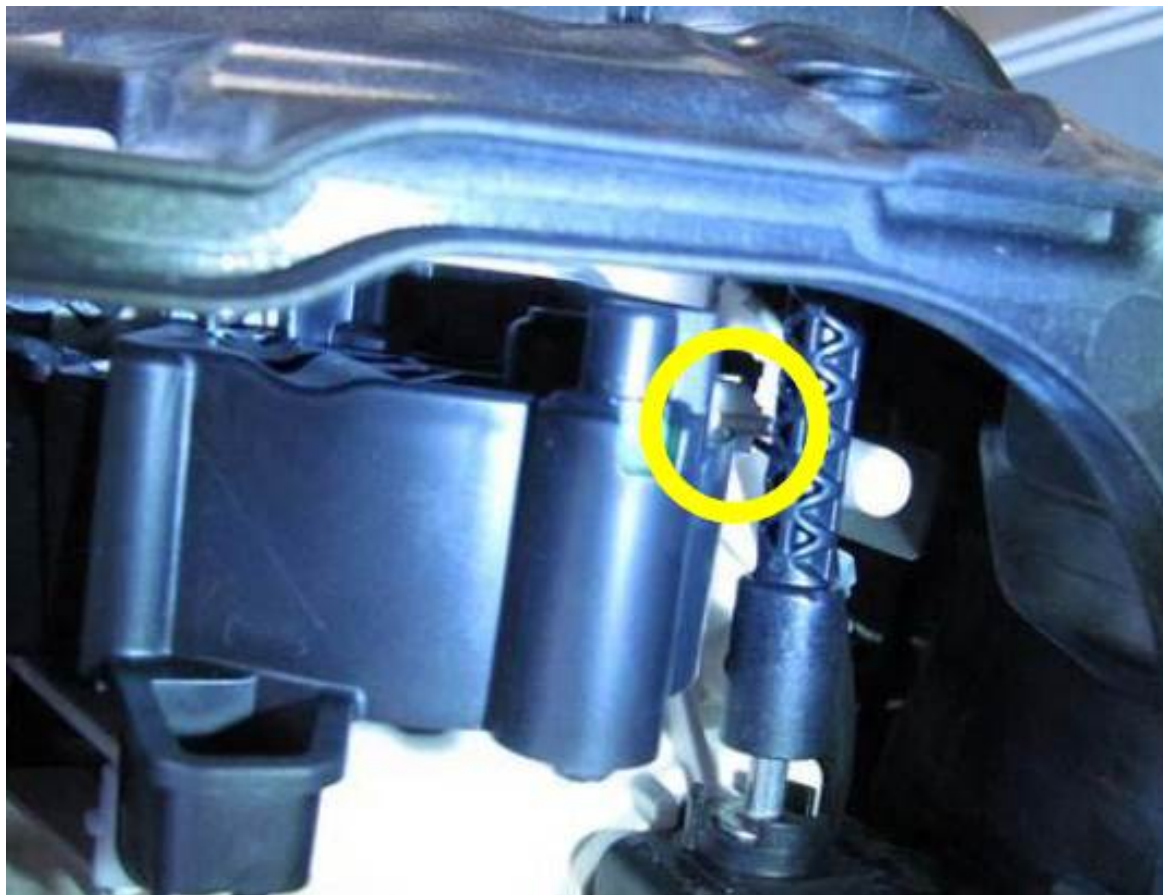
For symptom B (Internal cooling fan inoperative in one headlight):

Figure 2. Check this connector.

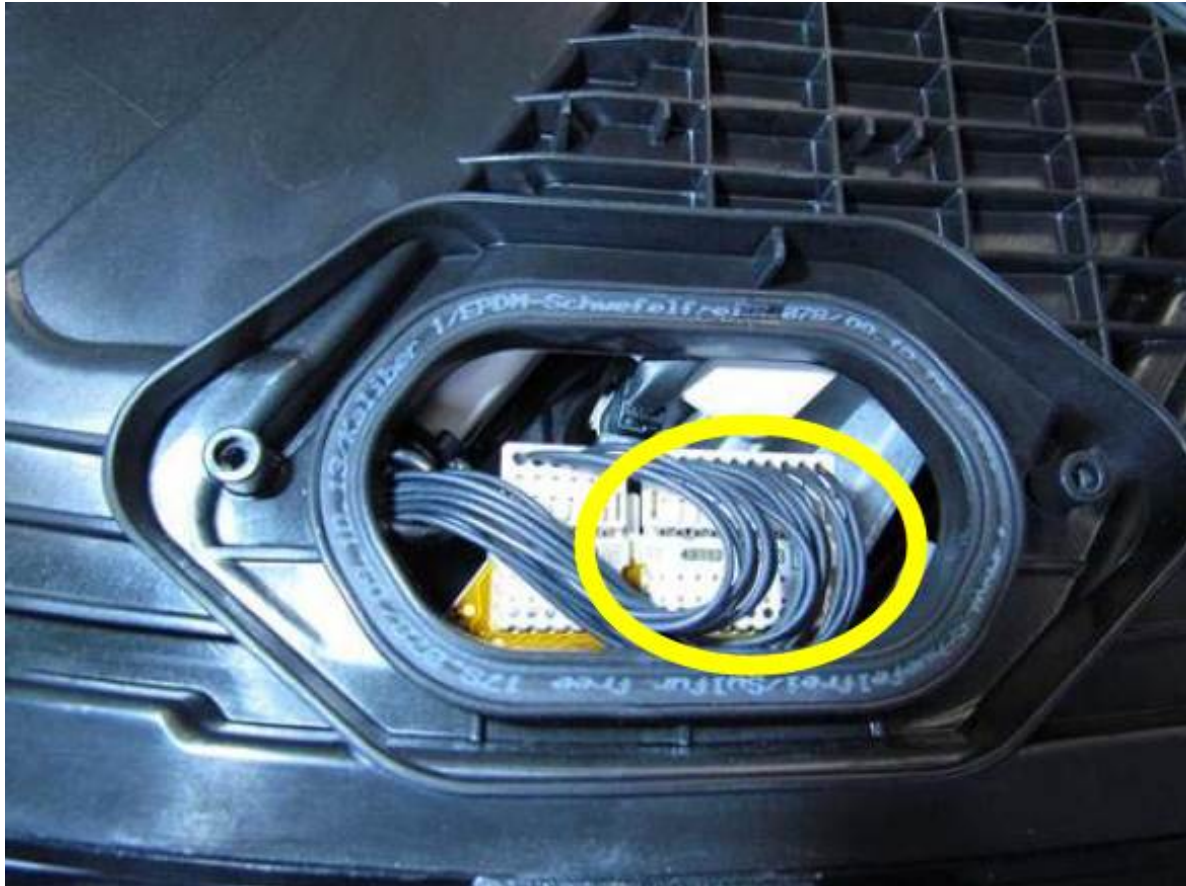
For symptom C (DRL inoperative on one side):

Figure 3. Check this connector.

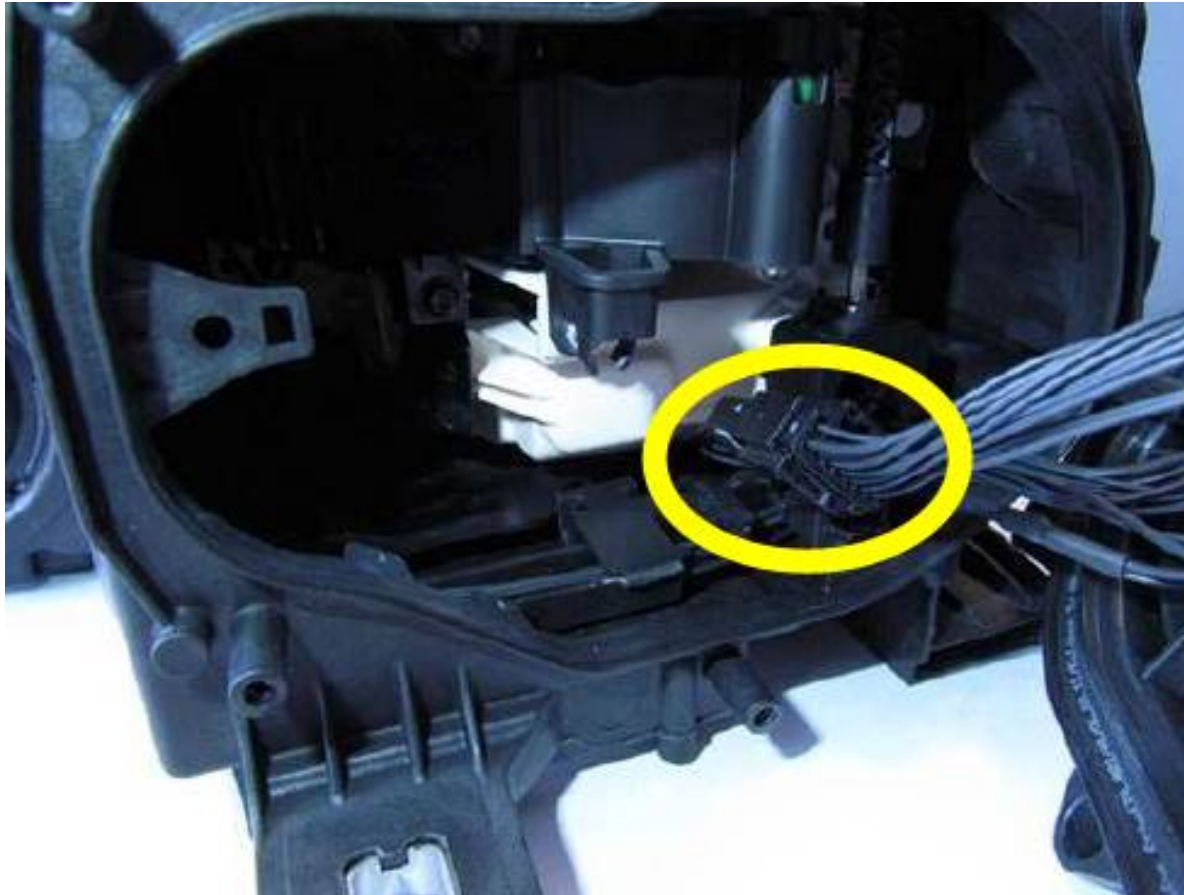
For symptom D (One or more LEDs in the high beam are inoperative on one side):

Figure 4. Check this connector.

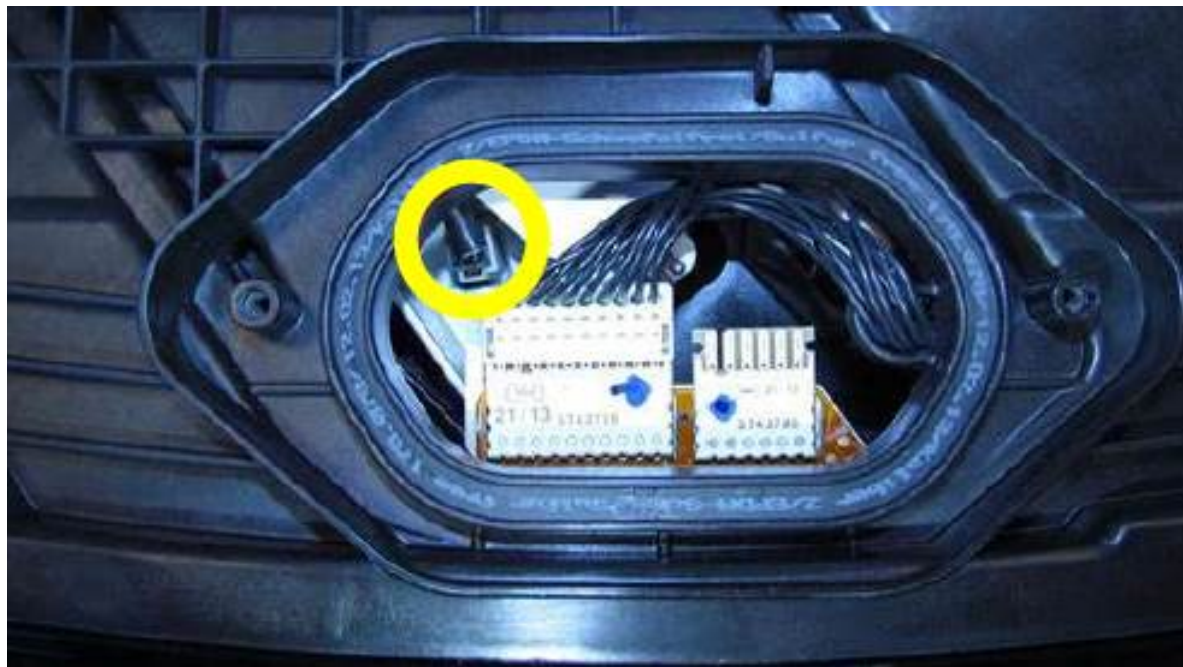
Figure 5. Check this connector.

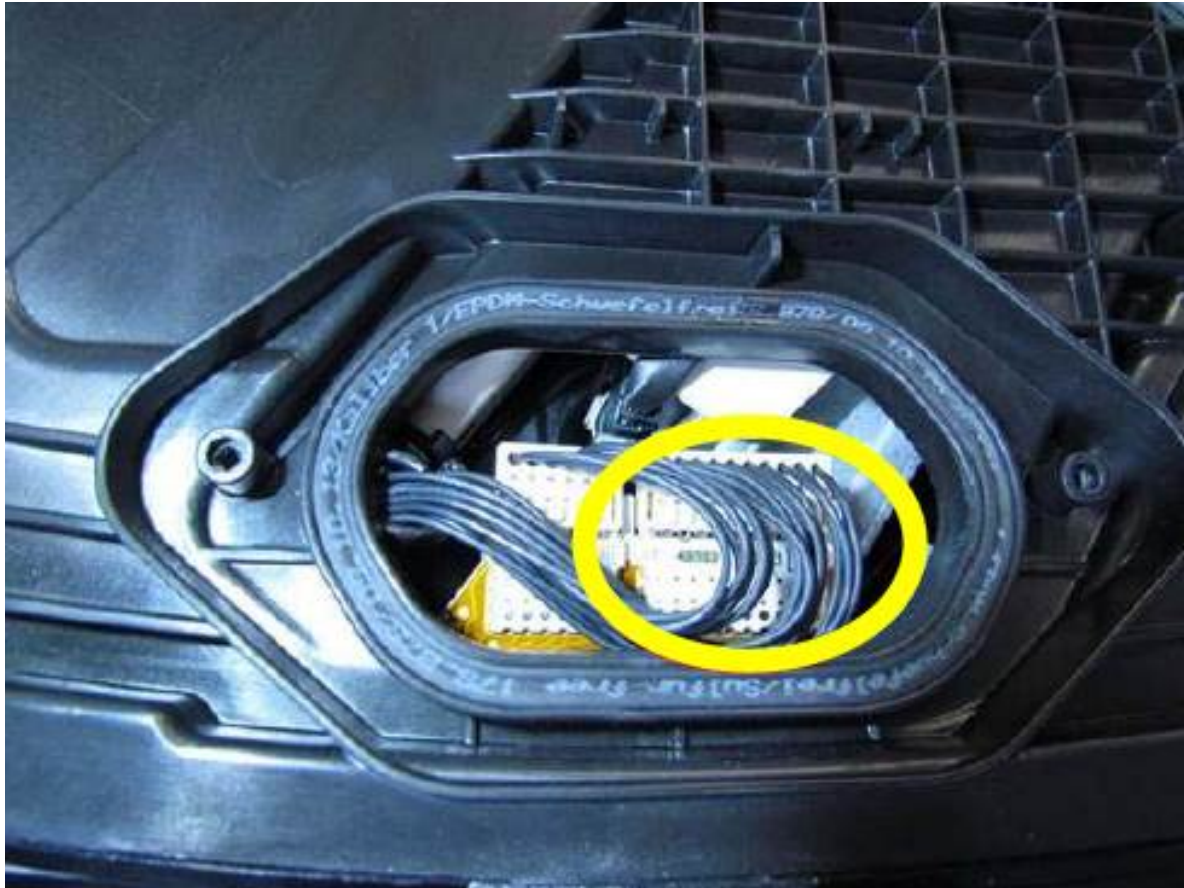
For symptom E (LED turn signal inoperative in one headlight):

Figure 6. Check this connector.
