Program Bulletin

CUSTOMER SATISFACTION PROGRAM

SUBJECT: Air Conditioning System Inoperative or Cools Intermittently

MODELS: 2013-2014 Chevrolet Spark

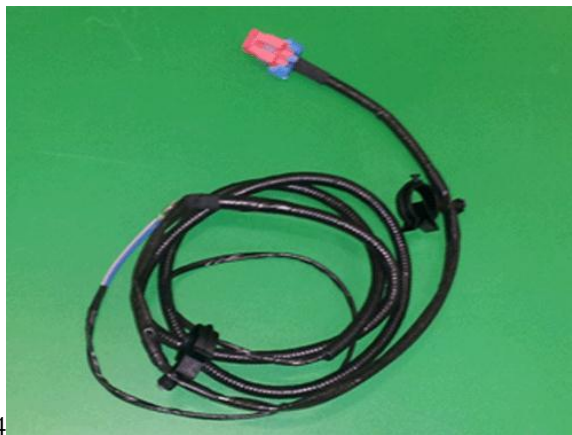
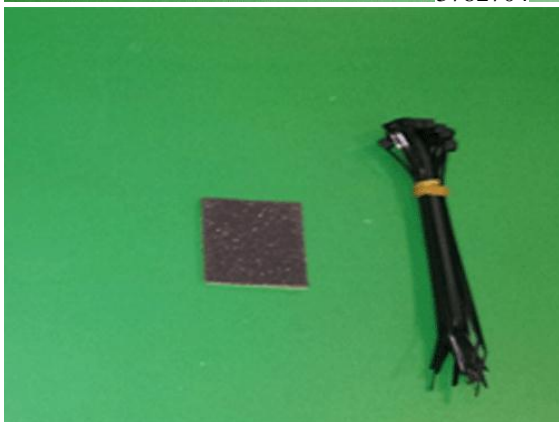
Wiring Harness Kit
