Program Bulletin

CUSTOMER SATISFACTION PROGRAM

SUBJECT: Air Conditioning System Inoperative or Cools Intermittently

MODELS: 2013-2014 Chevrolet Spark

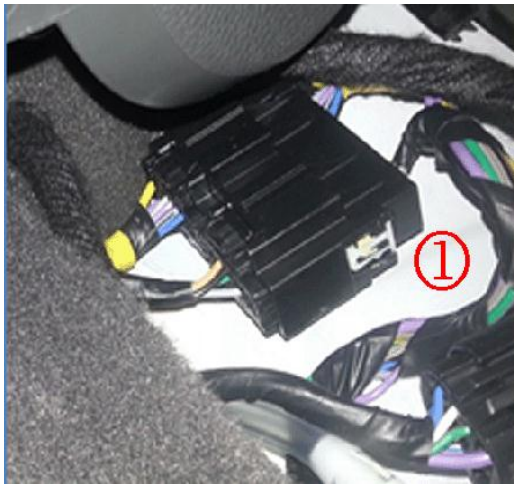
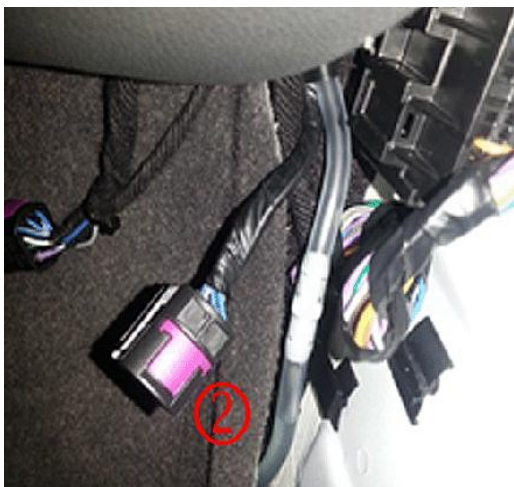
- (1) Inline Body Connector
- (2) IP Connector

8. Under the dash, disconnect the inline body connector and IP connector from the harness and disconnect the washer hose.
