Program Bulletin

CUSTOMER SATISFACTION PROGRAM

SUBJECT: Air Conditioning System Inoperative or Cools Intermittently

MODELS: 2013-2014 Chevrolet Spark

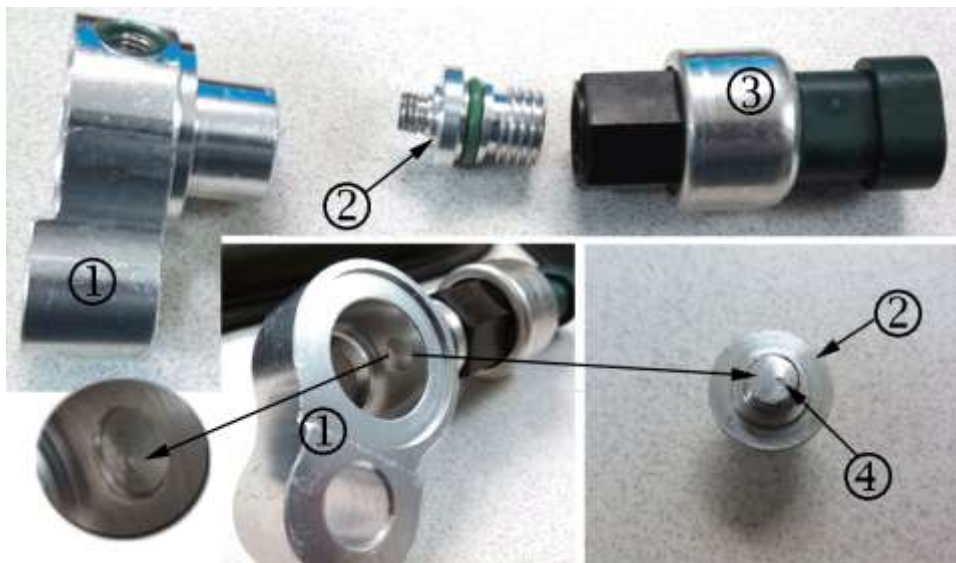
A/C Refrigerant Filter Kit

(1) Block Filter (2) Plug with 0.005 in Diameter Hole (3) Pressure Switch (4) 0.005 in Diameter Hole

Note: Do NOT attempt to drill the 0.005 in diameter hole bigger.
