# Service Bulletin

**SUBJECT:** Service Update for Inventory and Customer Vehicles  
Underbody Appearance  
Expires with Base Warranty

**MODELS:** 2014 Chevrolet Silverado 1500  
2014 GMC Sierra 1500

Subject: 14002A – Service Update Bulletin  
Underbody Appearance  
Warranty Transaction Information Revised

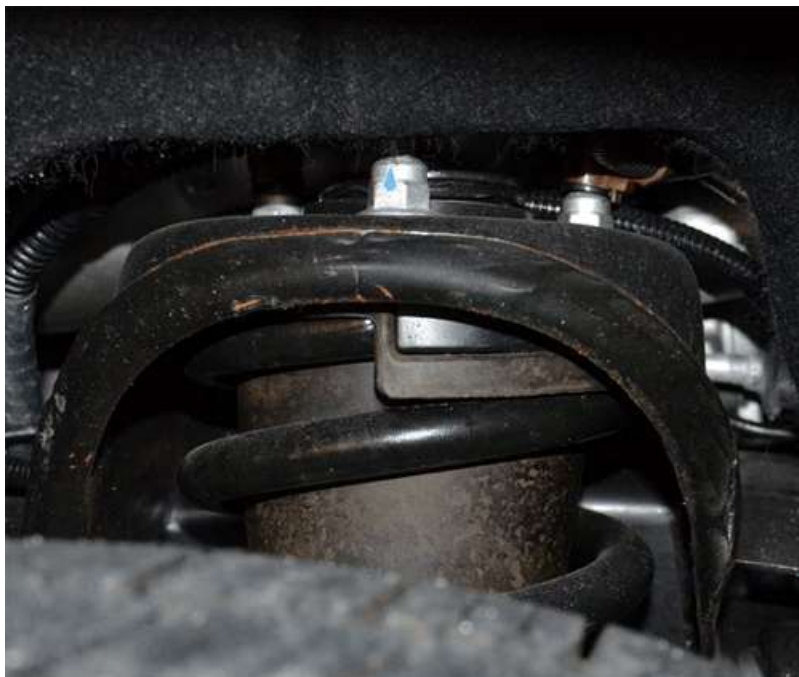
3686530

- Front spring mounts (visible through wheelhouse)

No Repair Required

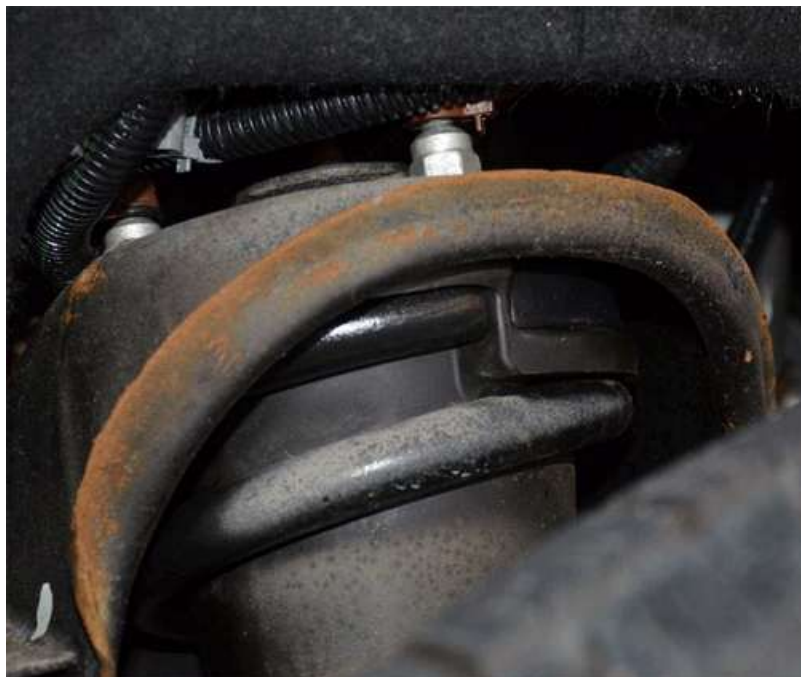
3686529

Repair Required

1. Any loose rust or coating should be wire brushed off.
2. Using a rag and general purpose adhesive remover, wipe down the affected repair area.
3. For the front spring mounts, frame and body mounts, apply a coat of Daubert Nox-Rust® P/N X-121B “One Coat Rust Preventative Coating” (aerosol), or equivalent.
4. For the rear axle assembly and rear shock mounts, apply a coat of Lloyds Kryptonite Metal Treatment P/N 36502 Life Long Rust Protection (14 ounce aerosol), or equivalent.

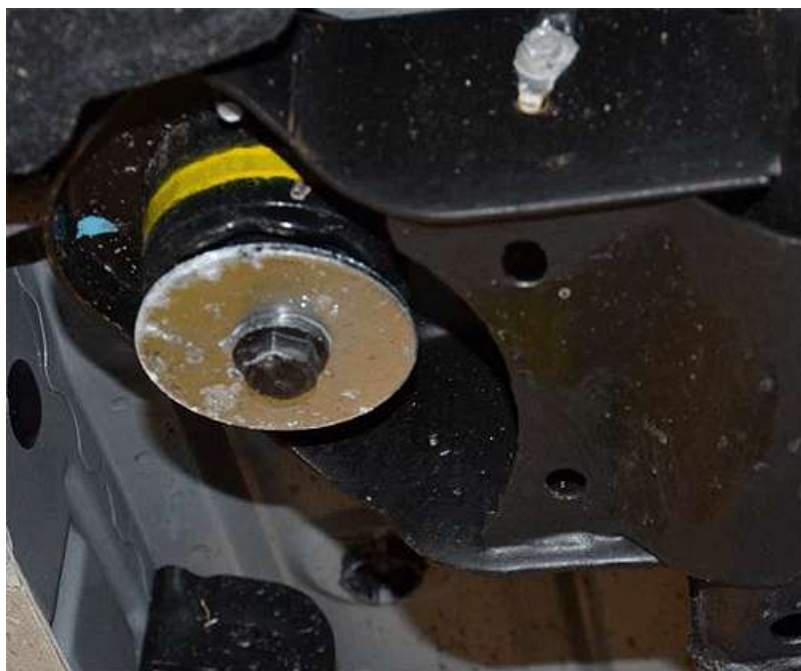
3686510

- Body mounts (visible underneath door(s))

No Repair Required

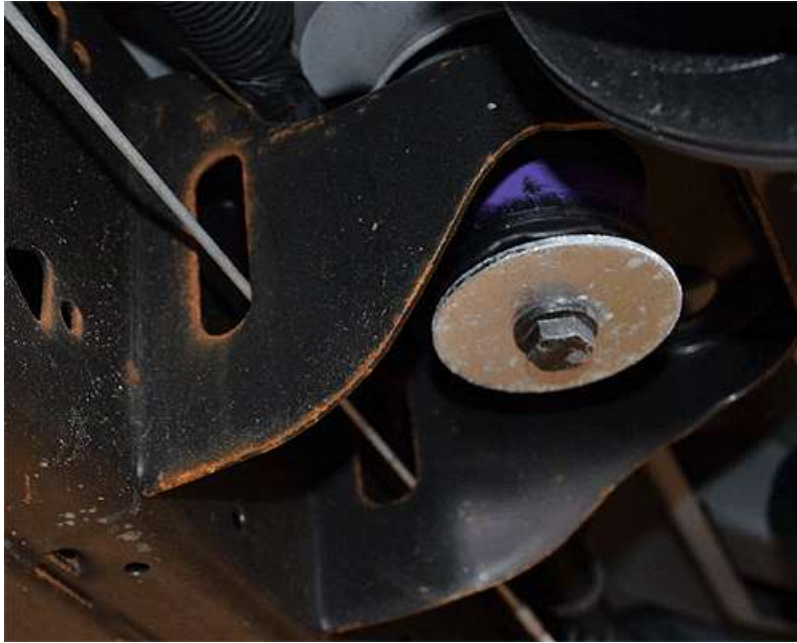
3686508

Repair Required

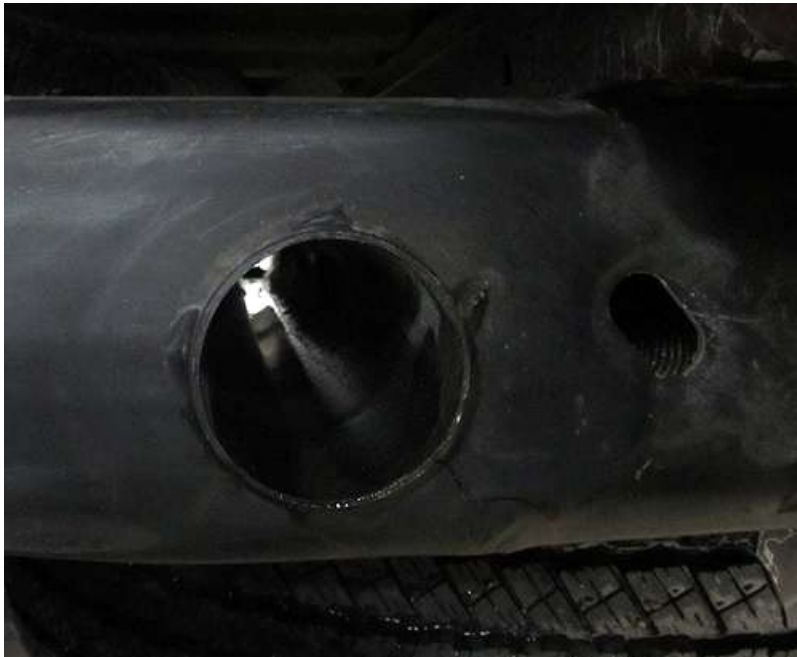
3687198

- Frame and flanges (visible through wheelhouse and underneath door(s))

No Repair Required

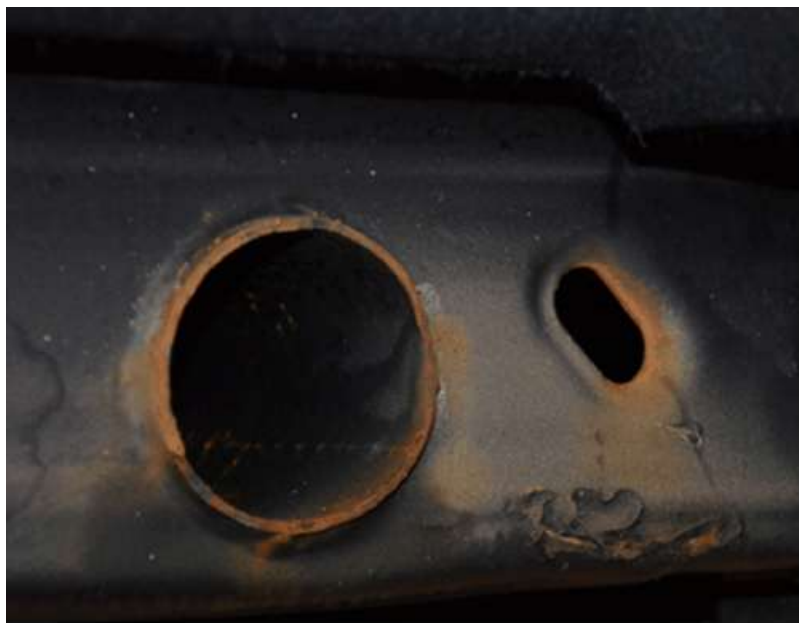
3687196

Repair Required

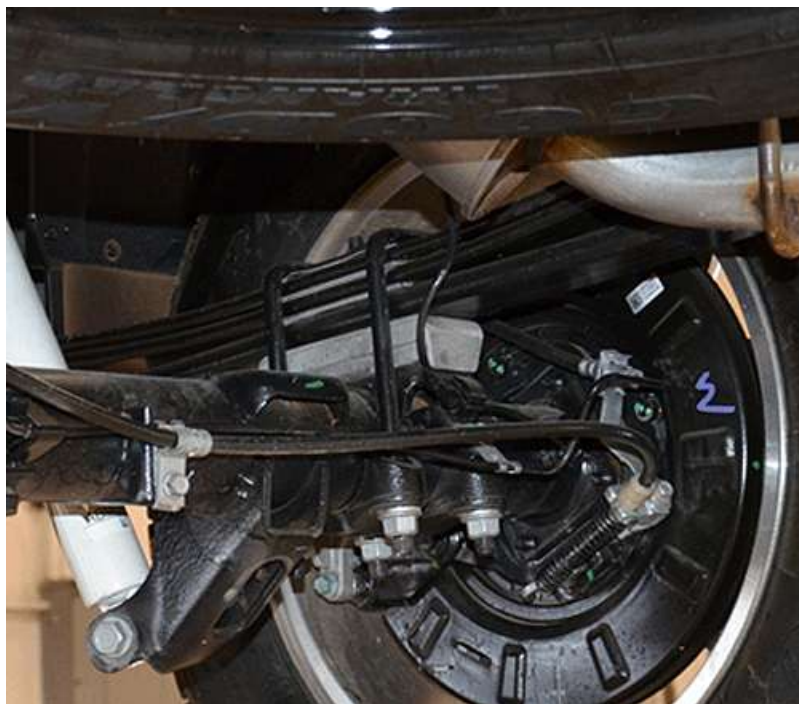
3687935

- Rear shock lower mounts

No Repair Required

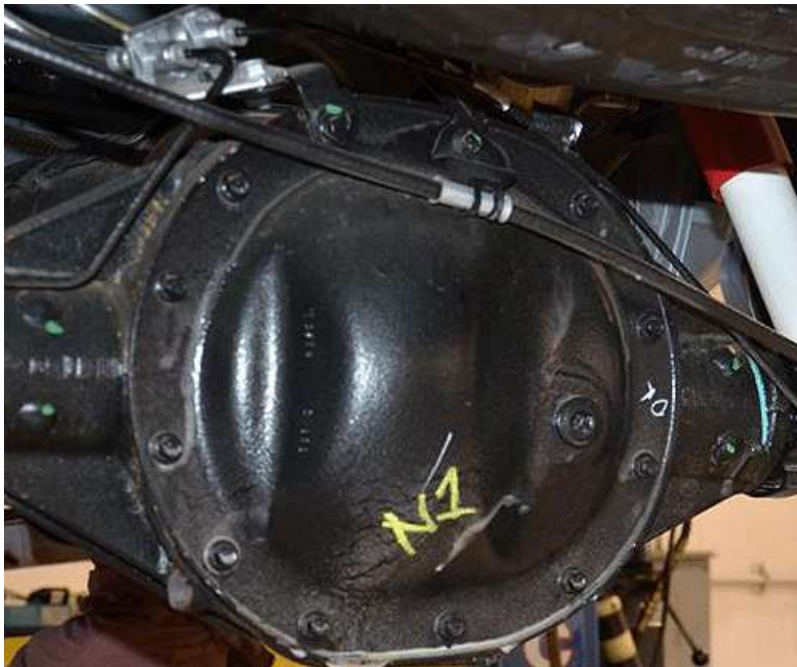
3686527

- Rear axle assembly

No Repair Required
