Recall Bulletin

PRODUCT SAFETY RECALL

SUBJECT: Diesel Fuel Transfer Pump Tube Nut Torque

MODELS: 2015 Chevrolet Silverado HD 2015 GMC Sierra HD Equipped with Diesel Engine (LML) and Dual Fuel Tanks (N2N)

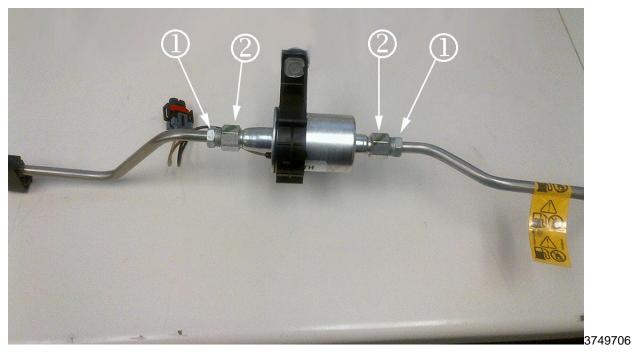
General Motors has decided that a defect which relates to motor vehicle safety exists in some 2015 model year heavy duty Chevrolet Silverado and GMC Sierra vehicles equipped with a diesel engine (LML) and dual fuel tanks (N2N). The fuel pipe tube nuts on each side of the diesel fuel transfer pump may not have been properly torqued. Diesel fuel may leak at the fuel transfer pump if there is fuel in the rear tank and the transfer pump activates to transfer fuel to the forward fuel tank. If there is fuel leakage and an ignition source is present, a fire could occur.

Note: Use a backup wrench to prevent the fuel transfer pump from turning. Hold the larger nut (2) in place while tightening the smaller tube nut (1).

3. Tighten the tube nuts (1) on both sides of fuel transfer pump to 30 Nm (22 lb-ft).
