# Recall Bulletin

## PRODUCT SAFETY RECALL

**SUBJECT:** Front Axle Right Half Shaft Fracture

**MODELS:** 2013-2014 Chevrolet Cruze  
Equipped with 1.4L Turbo Engine (LUV)

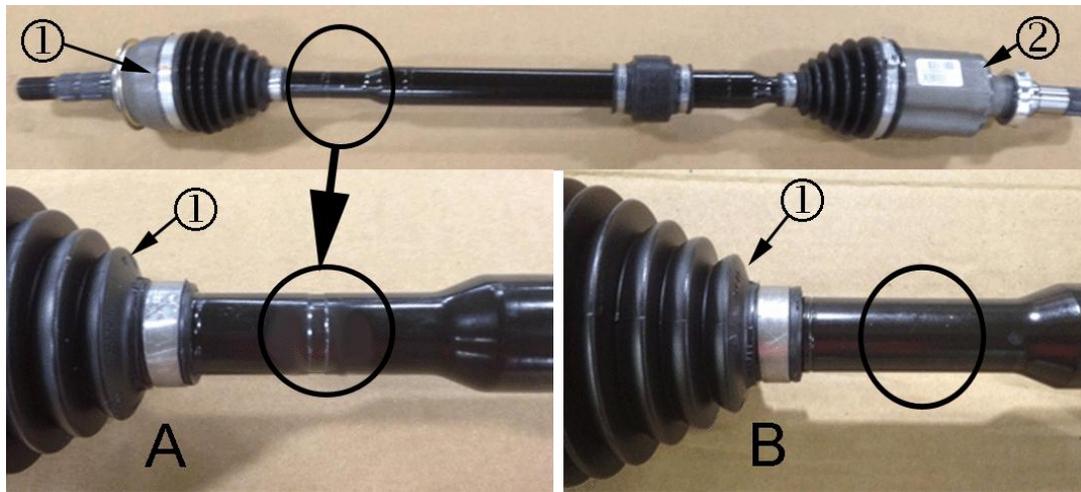
3773590

1. Raise and support the vehicle. Refer to *Lifting and Jacking the Vehicle* in SI.
2. Inspect the right (passenger side) half shaft near the front wheel. Determine if a machined groove is present on the half shaft.

(1) Wheel Side of Half Shaft (2) Transmission Side of Half Shaft (A) Machined Groove (B) No Groove

- If the machined groove is present (A) on the half shaft, no further action is required. Lower the vehicle.
  - If the machined groove is NOT present (B) on the half shaft, proceed to step 3.
3. Inspect the right (passenger side) half shaft near the transmission. Determine if a green stripe is present on the half shaft.

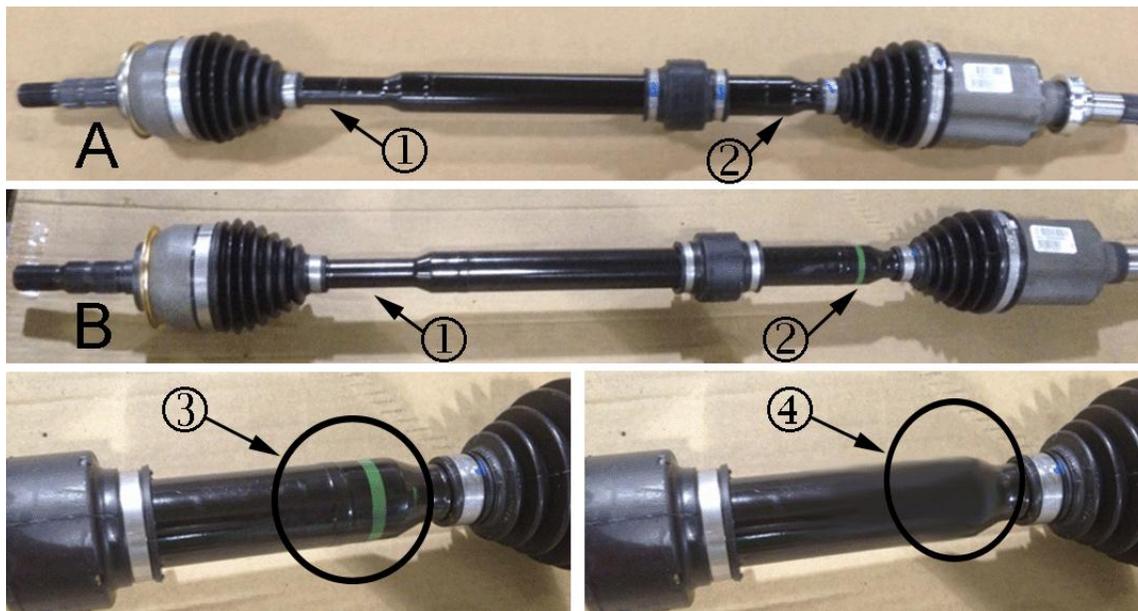
3773595

(1) Wheel Side of Half Shaft (2) Transmission Side of Half Shaft (A) Automatic Transmission (B) Manual Transmission (3) Green Stripe (4) No Stripe

- If a green stripe is present (3) on the half shaft, no further action is required. Lower the vehicle.

**Note:** Replace the half shaft if a blue stripe or no stripe (4) is present.

- If a green stripe is NOT present on the half shaft, replace the half shaft. Refer to *Front Wheel Drive Shaft Replacement ---Right Side* in this bulletin.
