Recall Bulletin

PRODUCT SAFETY RECALL

SUBJECT: Front Axle Right Half Shaft Fracture

MODELS: 2013-2014 Chevrolet Cruze
Equipped with 1.4L Turbo Engine (LUV)

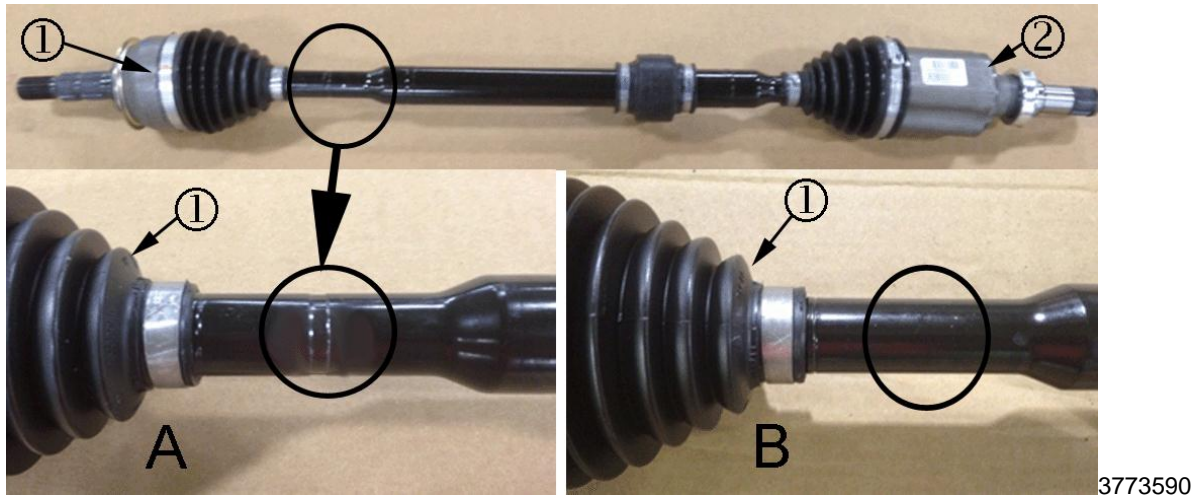
Service Part Number 13371628 (Auto Trans)

1. Inspect outboard side of the half shaft (longer portion of shaft between CV joint and isolator). Determine if a machined groove is present on the half shaft.
 - If the machined groove is present (A) on the half shaft, the part can be used for service.
 - If the machined groove is NOT present (B) on the half shaft, proceed to step 2.
2. Inspect the inboard side of the shaft (shorter portion between rubber isolator and boot) for a green stripe, green dot or combination of green stripe and green dot.
 - If these markings are present, this part can be used for service.
 - If no green strip, green dot, or green stripe and dot is present, this part should be returned to General Motors under special return bulletin G_000018785 dated March 18, 2014.

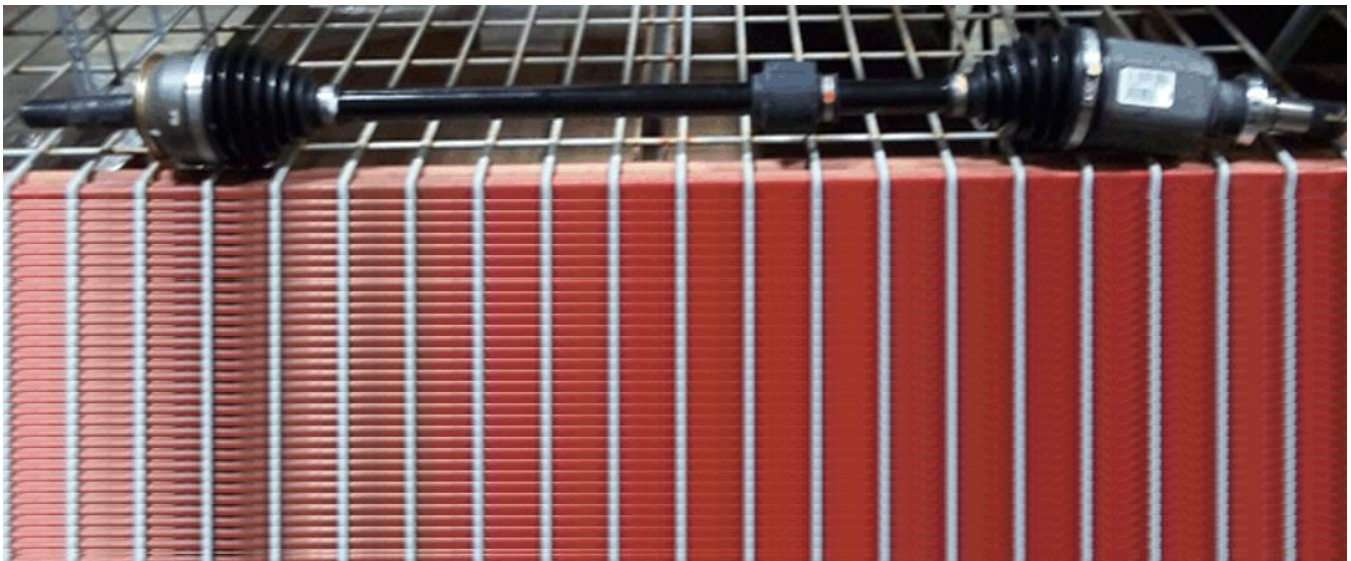
Service Part Number 13334705 (Auto Trans)

Note: Any additional paint marks found on this shaft can be disregarded.

1. Part can ONLY be used if the outboard side of the half shaft (longer portion of shaft between CV joint and isolator) is a solid painted bar shaft. Same diameter across entire shaft. There are no other identifications on the half shaft to look for.
 - If the part is a solid painted bar shaft, it can be used for service.
 - If part is a tubular non-painted bar shaft, then the half shaft assembly is to be scrapped from inventory.

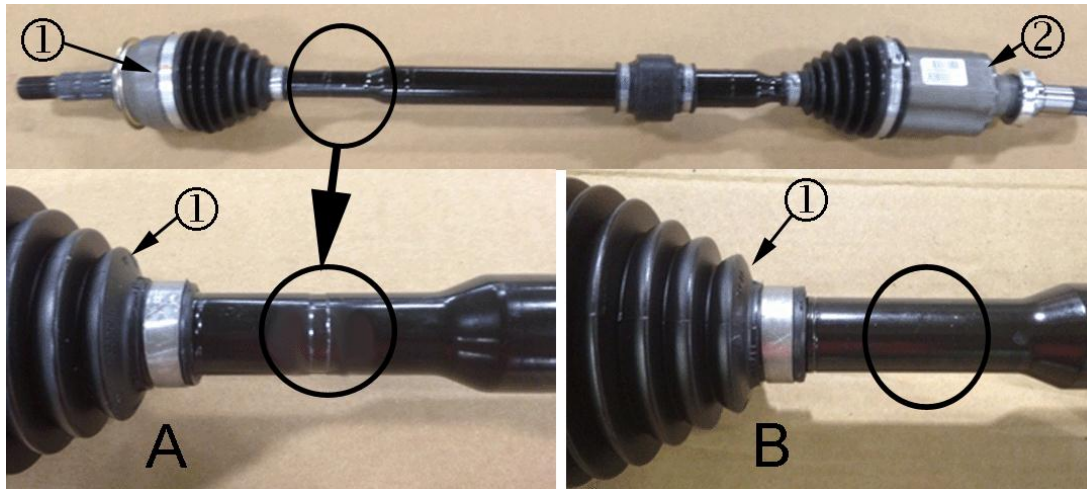
1. Raise and support the vehicle. Refer to *Lifting and Jacking the Vehicle* in SI.
2. Inspect the right (passenger side) half shaft near the front wheel. Determine if a machined groove is present on the half shaft.

(1) Wheel Side of Half Shaft (2) Transmission Side of Half Shaft (A) Machined Groove (B) No Groove

- If the machined groove is present (A) on the half shaft, no further action is required. Lower the vehicle.
 - If the machined groove is NOT present (B) on the half shaft, proceed to step 3.
3. Inspect the right (passenger side) half shaft near the transmission. Determine if a green stripe, green dot, or green stripe and green dot is present on the half shaft bar.

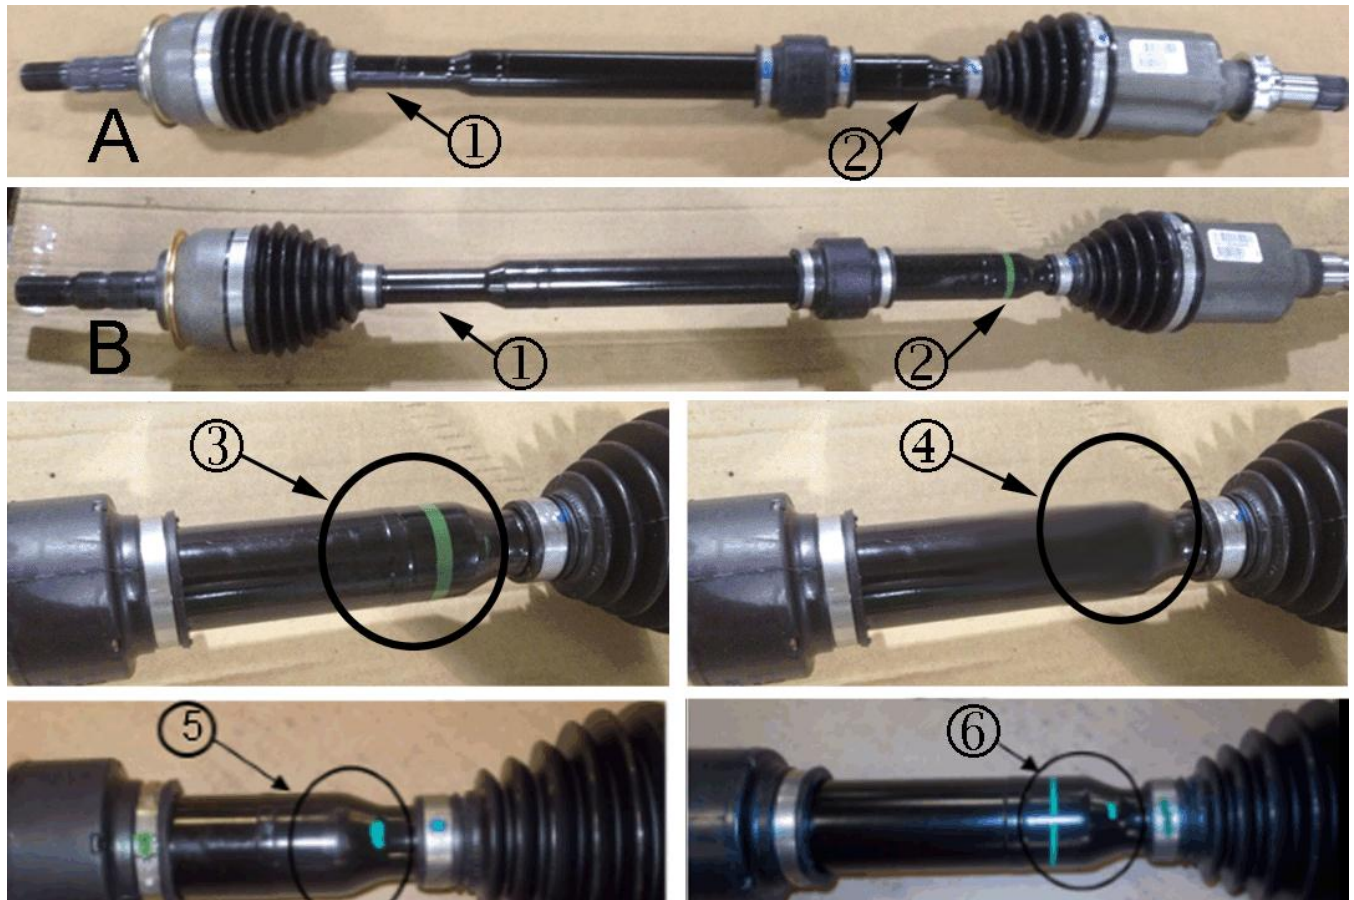
3802203

- (1) Wheel Side of Half Shaft (2) Transmission Side of Half Shaft (A) Automatic Transmission (B) Manual Transmission (3) Green Stripe (4) No Stripe (5) Green Dot (6) Green Stripe and Green Dot

- If a green stripe, green dot, or a green stripe and green dot is present (3, 5, or 6) on the half shaft, no further action is required. Lower the vehicle.

Note: Replace the half shaft if a blue stripe, blue dot or no stripe (4) is present.

- If a green stripe, green dot or green stripe and green dot is NOT present on the half shaft, replace the half shaft. Refer to *Front Wheel Drive Shaft Replacement ---Right Side* in this bulletin.
