# Recall Bulletin

## PRODUCT SAFETY RECALL

**SUBJECT:** Front Axle Right Half Shaft Fracture

**MODELS:** 2013-2014 Chevrolet Cruze  
Equipped with 1.4L Turbo Engine (LUV)

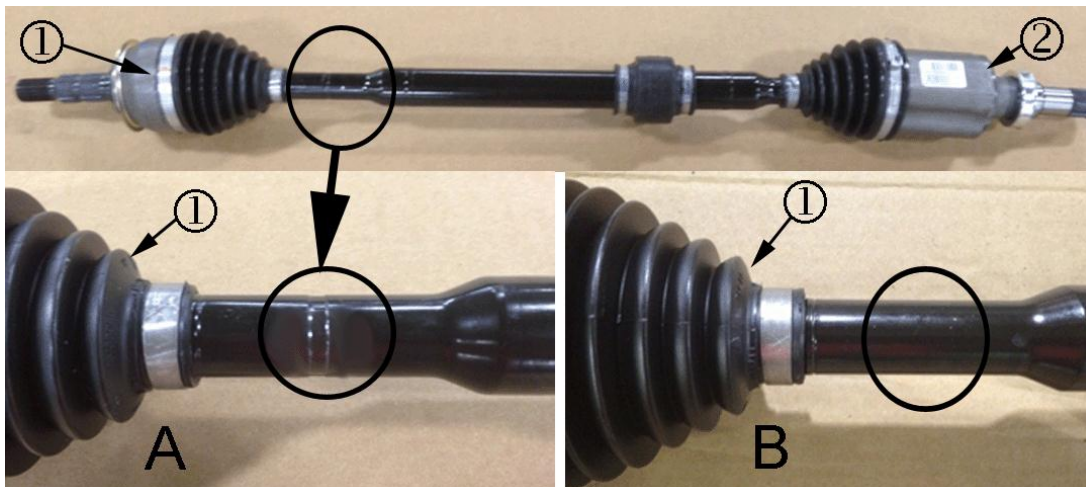
3773590

1. Inspect outboard side of the half shaft (longer portion of shaft between CV joint and isolator). Determine if a machined groove is present on the half shaft.
  - If the machined groove is present (A) on the half shaft, the part can be used for service.
  - If the machined groove is NOT present (B) on the half shaft, proceed to step 2.
2. Inspect the inboard side of the shaft (shorter portion between rubber isolator and boot) for a green stripe, green dot or combination of green stripe and green dot.
  - If these markings are present, this part can be used for service.
  - If no green strip, green dot, or green stripe and dot is present, this part should be returned to General Motors under special return message G\_0000187857 dated March 18, 2014 (US) or GMP 2014-073 dated March 17, 2014 (CN).

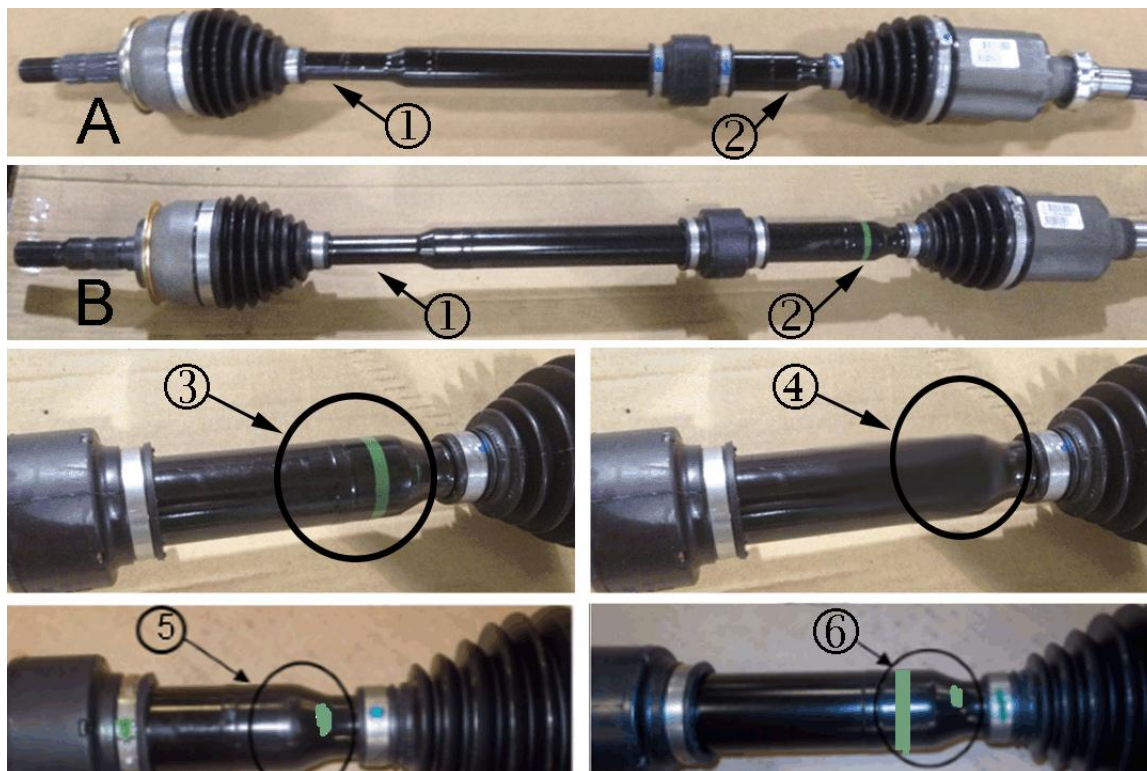
3802789

- If a green stripe, green dot, or a green stripe and green dot is present (3, 5, or 6) on the half shaft, no further action is required. Lower the vehicle.

**Note:** Replace the half shaft if a blue stripe, blue dot or no stripe (4) is present.

- If a green stripe, green dot or green stripe and green dot is NOT present on the half shaft, replace the half shaft. Refer to *Front Wheel Drive Shaft Replacement ---Right Side* in this bulletin.
