Recall Bulletin

PRODUCT EMISSION RECALL

SUBJECT: Oxygen Sensor Fracture

MODELS: 2011-2013 Chevrolet Express
2011-2013 GMC Savana
Cutaway Equipped with Gasoline Engine

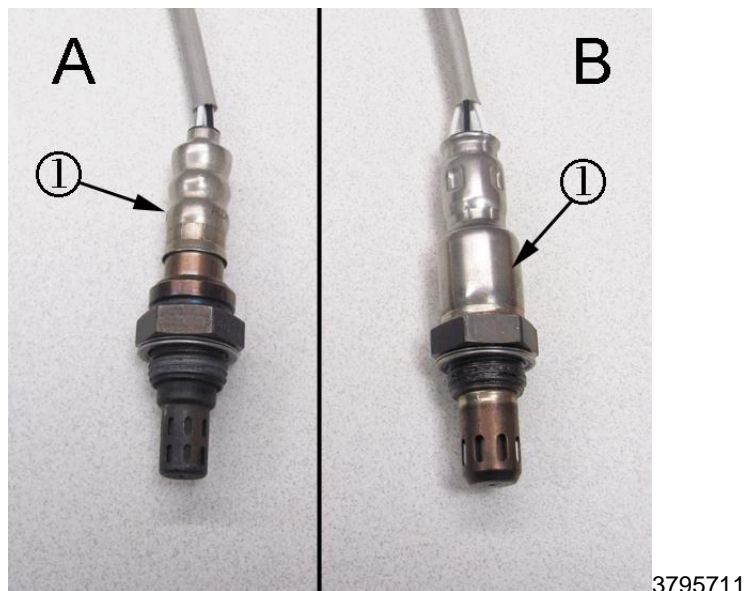
(A) First Design Heated Oxygen Sensor (B) Second Design Heated Oxygen Sensor (1) Location of Part Number

3. Determine if a first design (A) or second design (B) heated oxygen sensor is installed using a light and mirror.

- If a second design (B), P/N 12637297, heated oxygen sensor is installed, no further action is required. Lower the vehicle. Refer to *Lifting and Jacking the Vehicle* in SI.
 - If a first design (A), P/N 12656071 or P/N 12612571, heated oxygen sensor is installed, remove the sensor and replace it with a second design heated oxygen sensor. Refer to *Heated Oxygen Sensor Replacement –Bank 2 Sensor 2* in SI and *Heated Oxygen Sensor Replacement –Bank 1 Sensor 2* in SI.
4. After installing the new heated oxygen sensors, reprogram the ECM. Refer to *Engine Control Module Programming* in this bulletin.
