# Recall Bulletin

## PRODUCT EMISSION RECALL

**SUBJECT:** Oxygen Sensor Fracture

**MODELS:** 2011-2013 Chevrolet Express  
2011-2013 GMC Savana  
Cutaway Equipped with Gasoline or Liquefied Petroleum Gas (LPG) Fuel Engines

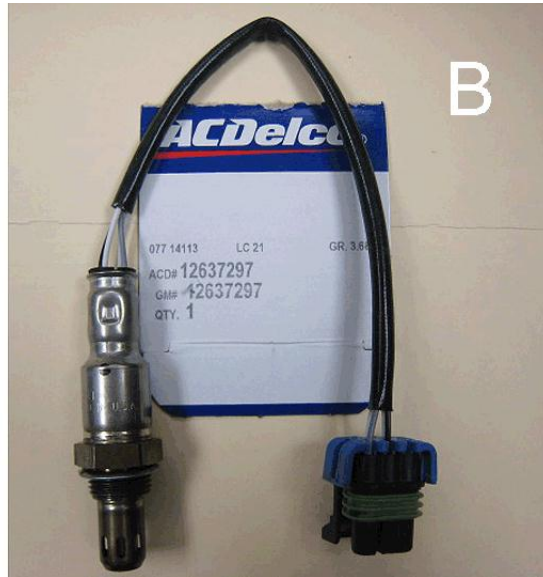
3961549

(A) 2011 through early 2013 OE production first design male connector. Replace the part with a second design part with a male connector, P/N 12637297. (B) 2011 through 2013 second design service part, P/N 12637297. Do NOT replace this part unless the part has failed. If the part has failed, replace the part with the second design part with a male connector, P/N 12637297.

3. Determine if a first design (A) or second design (B) heated oxygen sensor is installed using a light and mirror.
  - If a second design (B), P/N 12637297, P/N 12656071 heated oxygen sensor is currently installed, no further action is required. Lower the vehicle. Refer to *Lifting and Jacking the Vehicle* in SI.
  - If a first design (A), P/N 12612571, heated oxygen sensor is in place, remove the sensor and replace it with a second design heated oxygen sensor. Refer to *Heated Oxygen Sensor Replacement –Bank 2 Sensor 2* in SI and *Heated Oxygen Sensor Replacement –Bank 1 Sensor 2* in SI.
