# Recall Bulletin

## PRODUCT SAFETY RECALL

**SUBJECT:** Electric Power Steering Assist

**MODELS:** 2008 Chevrolet Malibu  
2008 Pontiac G6  
2008 Saturn Aura

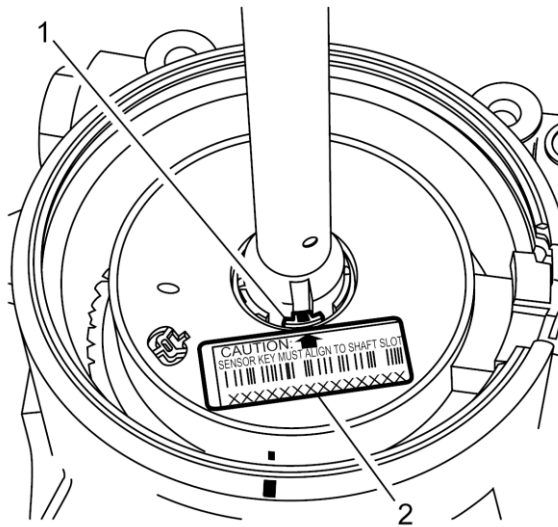
3824308

3. Document the last 9 digits of the NEW steering shaft torque sensor on the vehicle repair order. The serial number is located on the bottom of the caution label (2).
4. Remove the power steering assist motor. Refer to *Power Steering Assist Motor Replacement* in SI.
5. Install a new power steering assist motor. Refer to *Power Steering Assist Motor Replacement* in SI.

- If the steering column was replaced during the August 2008 to present time frame, do NOT replace the steering shaft torque sensor.
  - If the power steering motor controller module was replaced during the August 2008 to present time frame, do not replace the power steering motor controller module.
1. Remove the steering shaft torque sensor. Refer to *Steering Shaft Torque Sensor Replacement* in SI.
  2. Install a new steering shaft torque sensor. Refer to *Steering Shaft Torque Sensor Replacement* in SI.
