Recall Bulletin

Bulletin No.: 14121A Date: March 2014

SUBJECT: Transmission Oil Cooler Connection

MODELS: 2014 Chevrolet Silverado Light Duty Regular Cab, Double Cab, Crew Cab

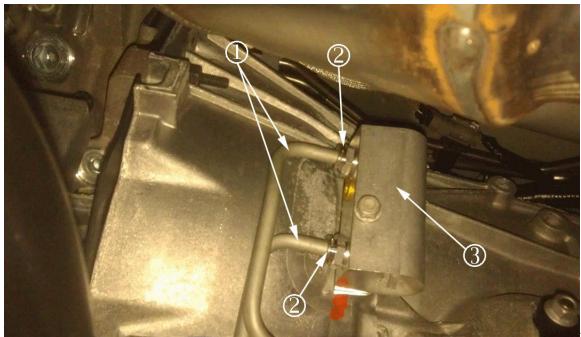
3792999

- (1) Transmission Cooler Lines (2) Quick Connect Fittings (3) Thermal Bypass Valve
- 2. Inspect the transmission cooler lines where they connect to the thermal bypass valve.
 - 2.1 Determine if the upper and lower transmission cooler lines are installed correctly by performing a visual inspection of the transmission cooler line connections into the thermal bypass valve.

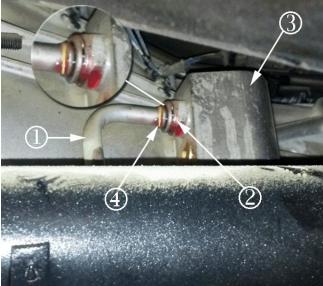
3793000

Photograph shows a fluid leak at the quick connect fitting (2) of the transmission cooler line (1) and thermal bypass valve (3).

2.2. Inspect the area around the thermal bypass valve (3) and the end of the transmission cooler line (1) for evidence of a fluid leak.

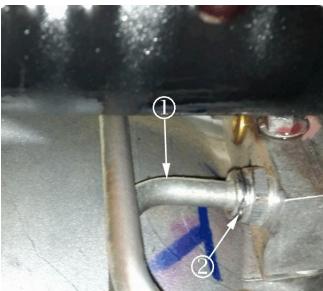
3793301

The transmission cooler line (1) is fully seated into the thermal bypass valve. Notice that a yellow line is NOT present and there is no evidence of a fluid leak.

2.3 Ensure the transmission cooler lines (1) are fully seated into the thermal bypass valve (3).

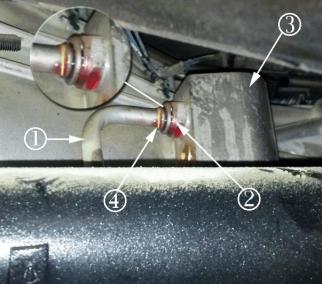
3793000

The transmission cooler line (1) is NOT fully seated into the thermal bypass valve. Notice that a yellow line (4) is present and there is evidence of a fluid leak.

Note: The yellow band should not be visible above the top of the fitting itself. If it is visible above the top of the fitting, then the pipe is not fully inserted and seated, refer to illustration.

• If a yellow mark (4) is present, remove and replace the transmission cooler line with a new line. Refer to *Transmission Fluid Cooler Inlet and Outlet Pipe Replacement* in SI.
