Recall Bulletin

PRODUCT SAFETY RECALL

SUBJECT: Transmission Shift Cable Fracture

MODELS: 2004-2007 Chevrolet Malibu Maxx
2004-2008 Chevrolet Malibu
2005-2008 Pontiac G6
2007-2008 Saturn AURA
Equipped with 4-Speed Automatic Transmission (ME7/MN5)

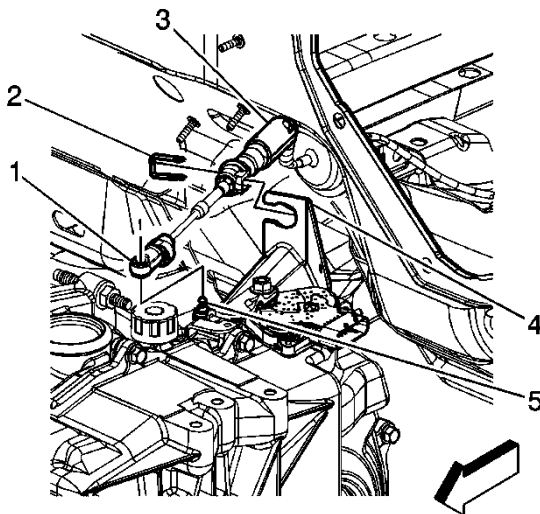
1765068

2. Remove and discard the shift cable bracket (4) attached to the transmission.

1. Remove and discard the floor shift control cable. Refer to *Floor Shift Control Cable Replacement* in SI.

3. Install a new floor shift control cable and new bracket. Refer to *Floor Shift Control Cable Replacement* in SI.

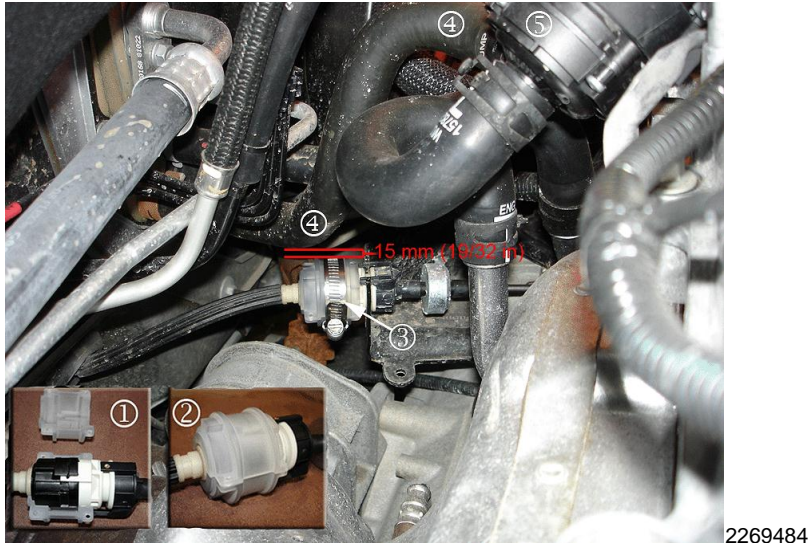
Hybrid vehicle shown. Combustion engine vehicle is similar.

- (1) Clam Shell in Two Pieces
- (2) Clam Shell Around Shift Cable Locking Tabs
- (3) Clamp on Clam Shell
- (4) Inlet Coolant Hose and
- (5) Heater Cooler Pump.

4. Install the clam shell (1) (2) over the shifter cable locking tabs.
5. Install the service clamp over the clam shell (3). Position the clamp fastener head away from the inlet coolant hose (4). **Tighten the clamp to 4 N·m (35 lb-in).**
6. Ensure that there is 15 mm (19/32 in) of clearance between the inlet coolant hose (4) and the clam shell (3). On hybrid equipped vehicles, it may be necessary to reposition the inlet coolant hose (4) to achieve the required 15 mm (19/32 in) of clearance. **To reposition the inlet coolant hose (4) on hybrid equipped vehicles, locate the heater cooler pump (5) and perform Steps 6.1-6.5.**

Caution: Do not kink or damage the inlet coolant hose (4) when repositioning the hose to obtain the 15 mm (19/32 in) clearance. To avoid damaging the hose clamp, use J-38185 or equivalent hose clamp pliers to loosen the hose clamp.
